# Kidwelly Flood Investigation Report

A report into the flooding events of the 4<sup>th</sup> and 20<sup>th</sup> October 2021 at Clos Y Helyg, Parc Pendre, Llys Gwenllian, Ferry Road, Cae Ffynnon, Ger Y Castell, Ger Y Gwendraeth and Kidwelly Industrial Estate – as required under section 19 of the Flood and Water Management Act 2010.

<b>Title of document</b>	Kidwelly Flood Investigation Report
<b>Document date</b>	September 2022
<b>Authors</b>	Carmarthenshire County Council
<b>Service responsible</b>	Flood Defence and Coastal Protection, Waste and Environmental Services
<b>Department</b>	Environment
<b>Review</b>	Cath Abbott Flood Defence and Coastal Protection Engineer Environment Department, Carmarthenshire County Council
<b>Approval</b>	Ben Kathrens Flood Defence and Coastal Protection Manager Environment Department, Carmarthenshire County Council
<b>Published</b>

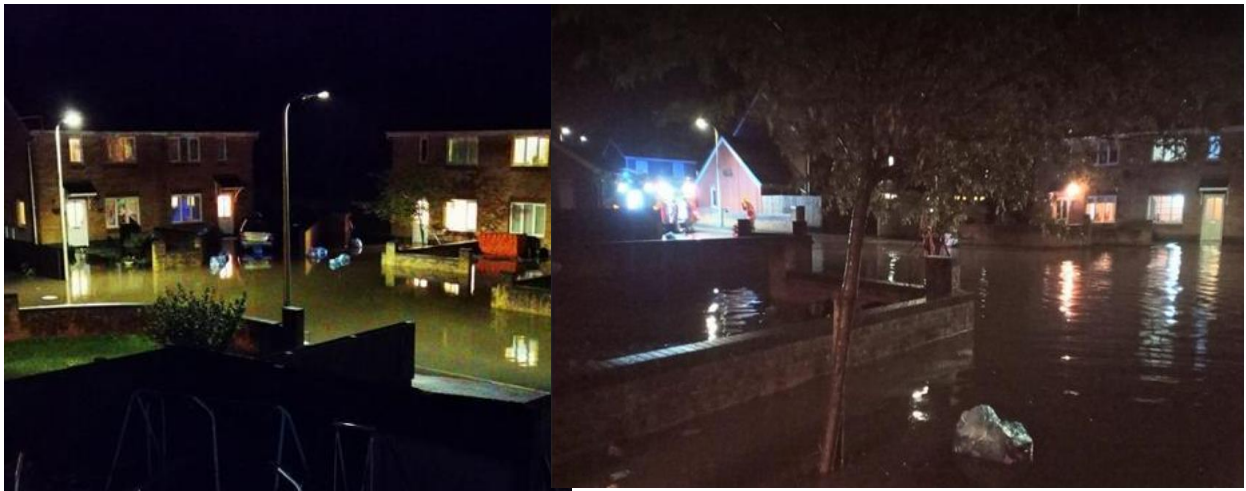
Figure 6 - Photos of the flooding at Clos Yr Helyg on the 4<sup>th</sup> October 2021 (Gemma Wilby).

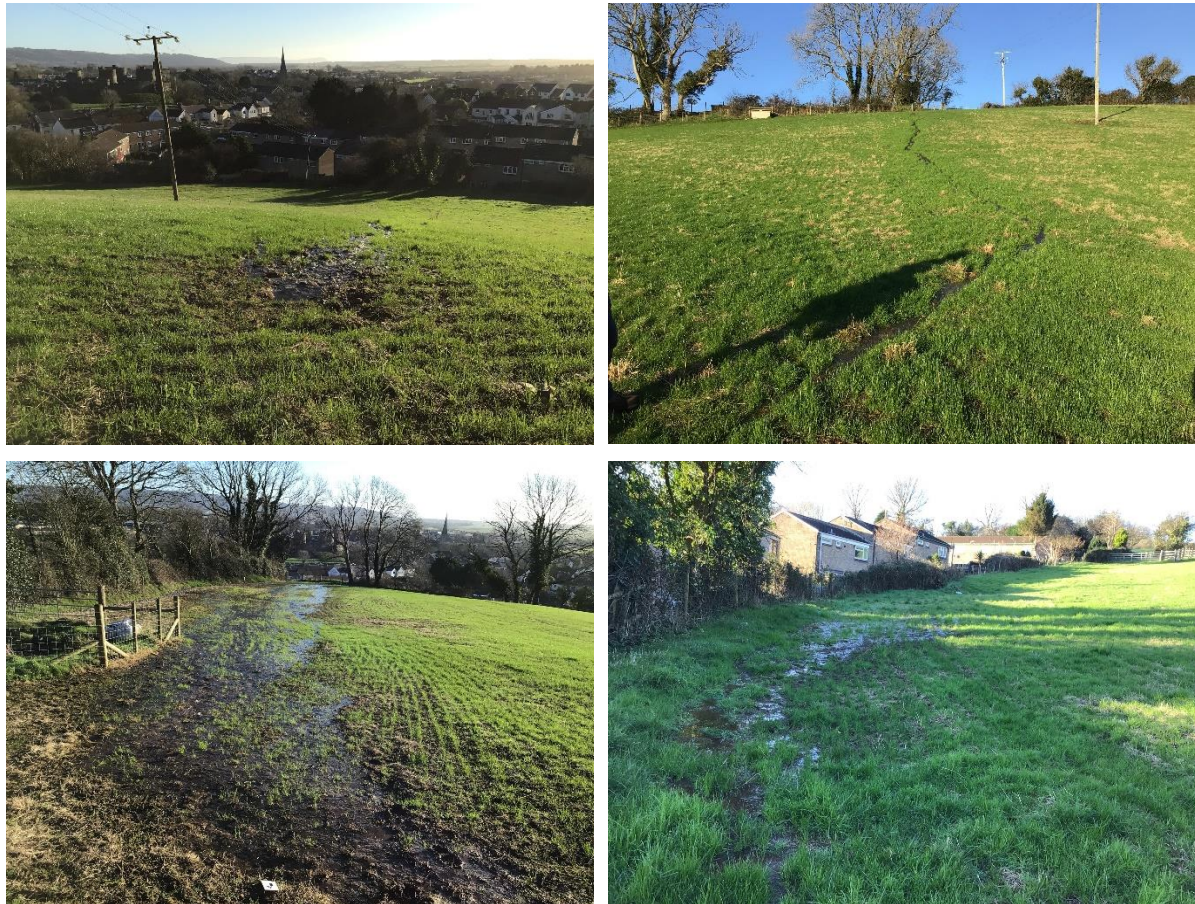
- 4.4.3 On the 12<sup>th</sup> January 2022, officers from Pobl and CCC's FDCP team visited Llys Gwenllian to discuss the drainage issues. After an inspection of the area, CCC officers inspected the fields to the north of Llys Gwenllian. There they observed multiple springs discharging water which subsequently flow down to the rear of Llys Gwenllian (Figure 18).

Figure 18 – Photographs of the springs discharging water towards Llys Gwenllian.

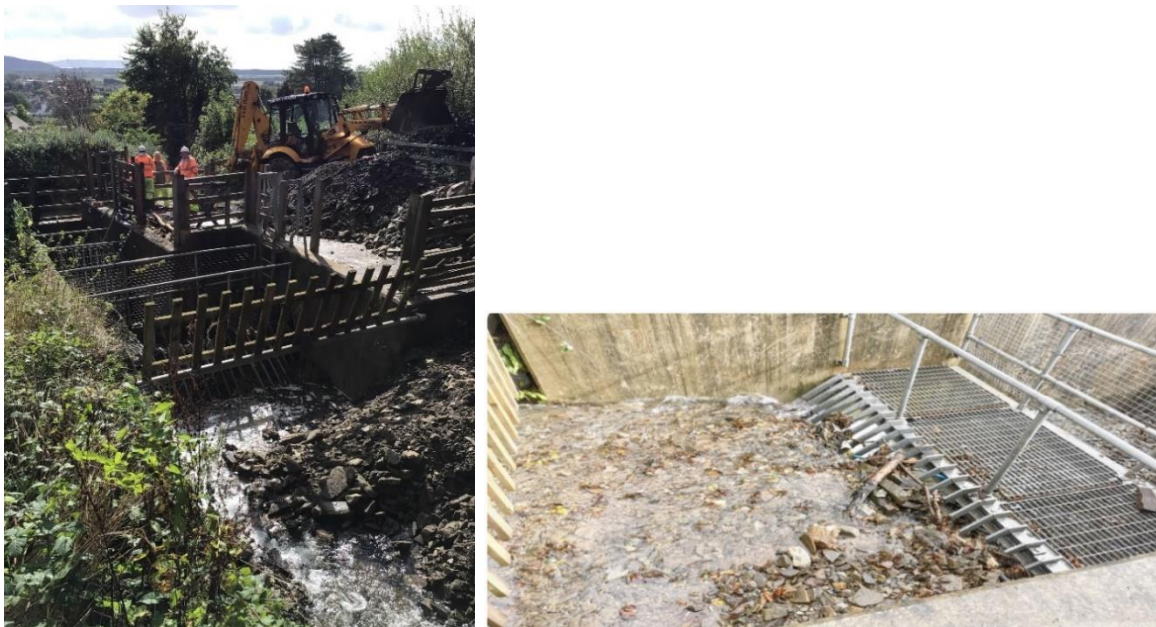
Figure 22 - Photos of the debris removed after the flooding event on the 4<sup>th</sup> October 2021 at Cae Ffynnon.

6.2.8 An officer from the FDCP Team attended site immediately and began an investigation into the event. He discovered that 1 home had been flooded internally, but as many as 15 had significant external flooding.

6.2.9 A local contractor was brought in to clear the upstream channel above Cae Ffynnon of any blockages and undertake bank repairs where damage had occurred.

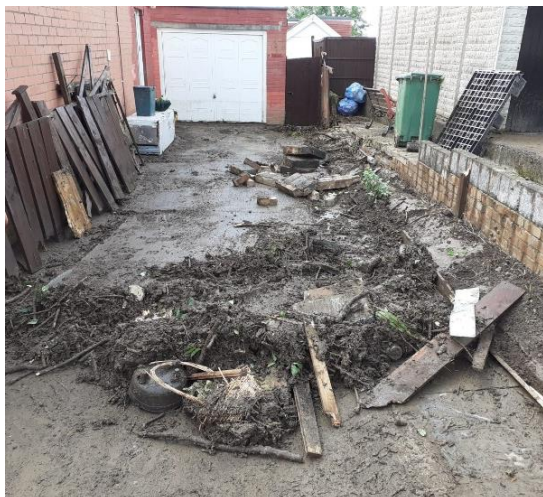
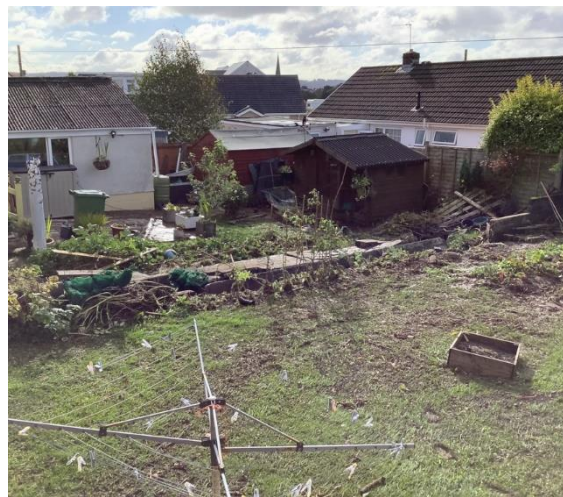
Figure 23 - Photo of the debris removed after the flooding event on the 4<sup>th</sup> October 2021 at Ferry Road.

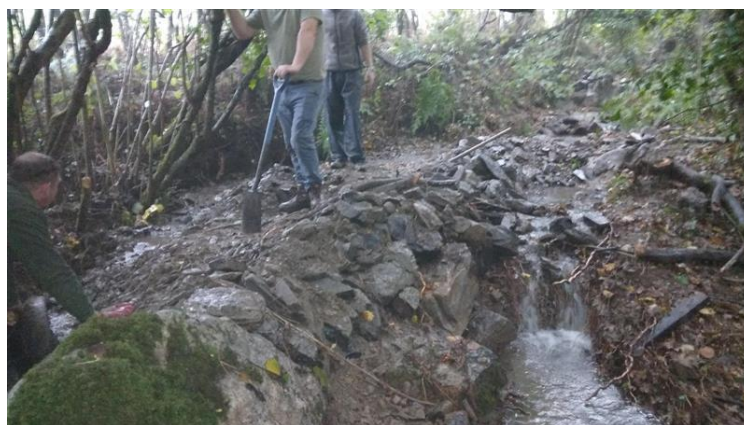
Figure 24 – Photo of Kidwelly residents unblocking the Cae Ffynnon watercourse north of Cae Ffynnon. In the picture, the water is flowing down the footpath, the watercourse is where the men are standing.

- 6.7.3 Initially, there were many hypotheses pertaining to the source and cause of the flooding. It is now clear that the flooding that occurred on both the 4<sup>th</sup> and 20<sup>th</sup> October 2021 was caused by the ordinary watercourse above Cae Ffynnon breaking its banks. Water escaping the watercourse was unable to re-join the channel and was funneled down the footpath to the rear of Cae Ffynnon and then on to Ferry Road.

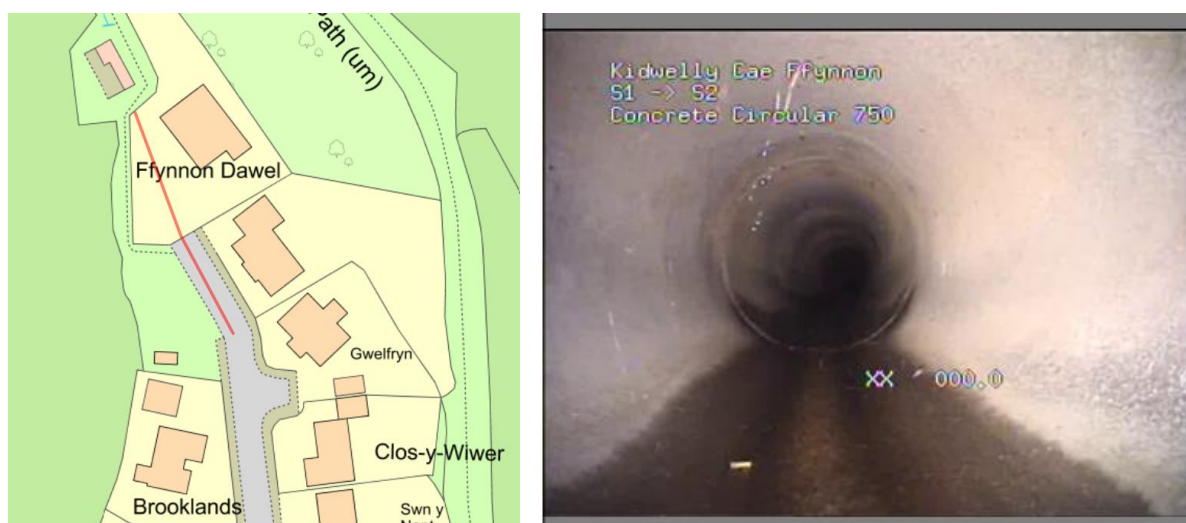
6.6.1.3 Downstream of the [Cae Ffynnon Trash Screen](#), (see section 5.6.2.1) there is an approximately 265 meter long section of privately owned, culverted watercourse, as denoted in Figure 28. This section of culvert is a concrete pipe, 750mm in diameter, which was last surveyed on the 24<sup>th</sup> September 2018. No defects or concerns were noted during that survey and the culvert is regarded as being in good condition.

Figure 28 - The private section of culverted watercourse at Cae Ffynnon Kidwelly.

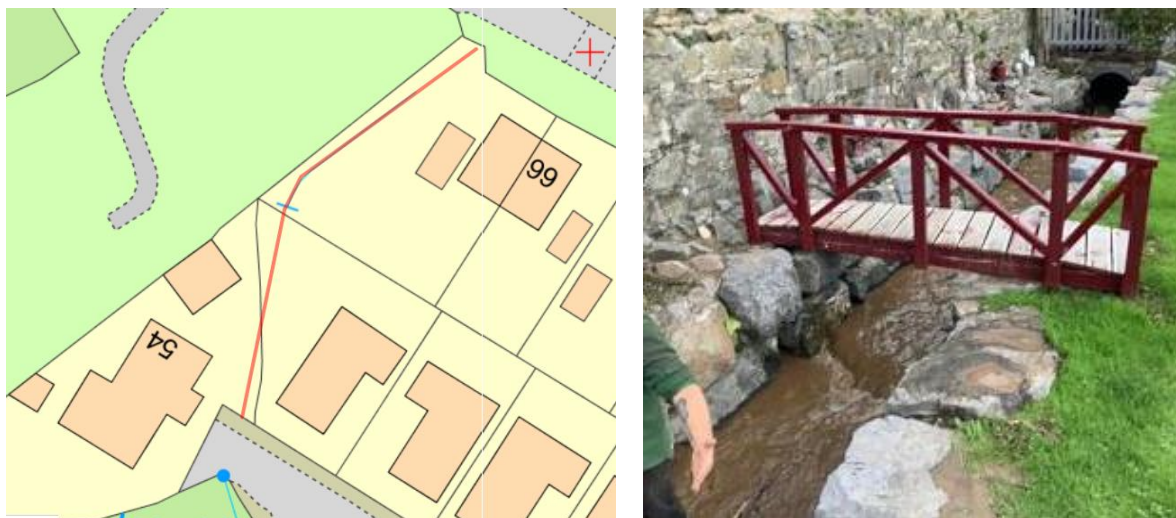
6.6.1.4 In addition to the above, the lower reaches of the ordinary watercourse are also in private ownership, as denoted in Figure 29 below. There are two sections where the watercourse is culverted in a 900mm diameter culvert. The condition of this culvert is unknown at the time of writing but the catchment analysis suggests that a 900mm diameter pipe is of sufficient size to contain and convey flood flows to the necessary standard namely 1 in 100 (1% AEP).

6.6.1.5 Between the two privately owned culverted sections of watercourse, there is an open section of privately owned watercourse as depicted in Figure 29 below. The evaluation undertaken as a part of this investigation has concluded that flood flows will not be contained in this open channel.

Figure 29 - Photos of the private sections of watercourse at 68 Ferry Road, Kidwelly.

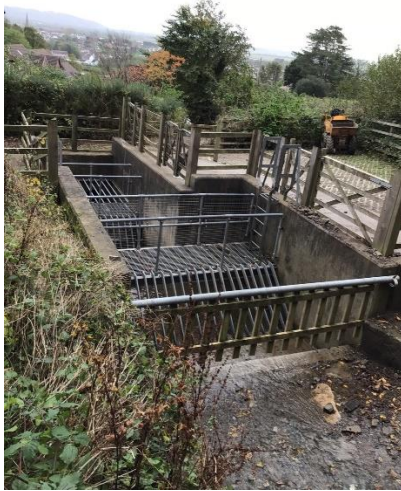
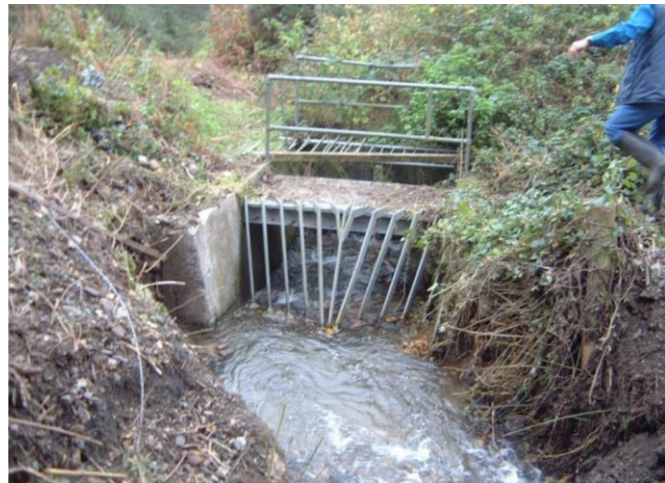
Figure 30 – On the left, the new trash screen as seen today, on the right, the screen that was replaced in 2014.

6.6.2.1.3 An evaluation undertaken as a part of this investigation has concluded that this asset is fit for purpose, with the ability to manage flood flows up to the 1 in 100-year annual probability flood event (1% AEP). **Error! Reference source not found.** below depicts the flood modelling outputs and shows no predicted flooding during the modelling of this storm event.

6.6.2.1.2 The Cae Ffynnon trash screen was upgraded in 2014/2015, as a part of a £70,000 CCC FDCP capital works scheme in the area.

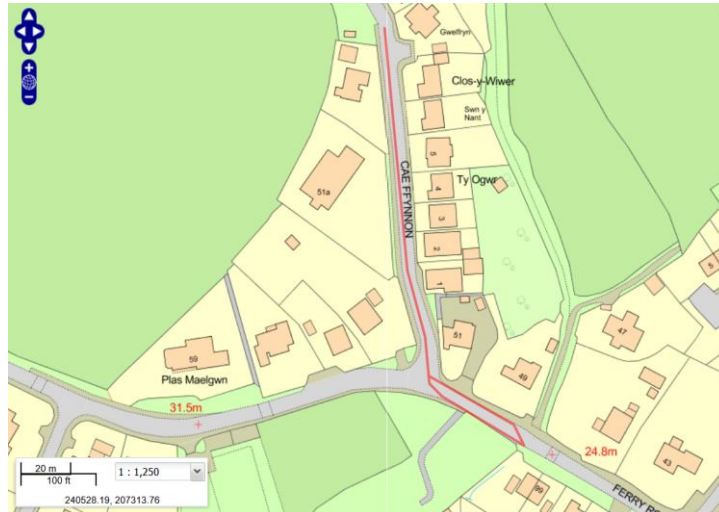
Figure 33 - CCC owned section of the Cae Ffynnon watercourse.

6.6.2.2.3 This section of culvert is concrete and 750mm in diameter. It was last surveyed on the 24<sup>th</sup> September 2018. No issues or defects were noted.

6.6.2.2.4 At the bottom of Cae Ffynnon, the culverted watercourse bifurcates and there is a mixture of pipe sizes ranging from 450mm to 900mm. The 2018 culvert survey did highlight that a section of this culvert was damaged and that broken pieces of the culvert were trapped in the structure.

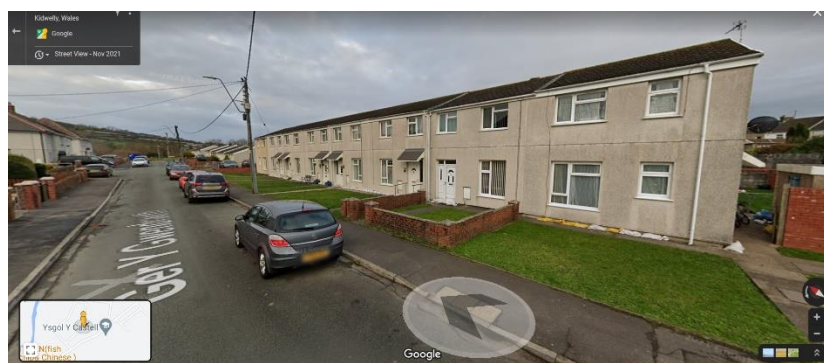
Figure 37 – Photo of the properties at Ger Y Gwendraeth that were flooded.

7.4.4 The Property Maintenance Supervisor noted that houses No.1-7 on Ger Y Gwendraeth lie beneath the level of the road. As such water flooding from the highway flows down to the dwellings and causes flooding.

- 7.4.1 The Highways team checked all highway gullies to ensure that they were clear.
- 7.4.2 The CCC Property Maintenance team had a sub-contractor attend houses No.1-7 Ger Y Gwendraeth and clear the drainage system.
- 7.4.3 Properties at 1-7 Ger Y Gwendraeth also received de-humidifiers and repairs were undertaken to damaged doors and flooring. Aco-drainage has been installed to manage the surface water.

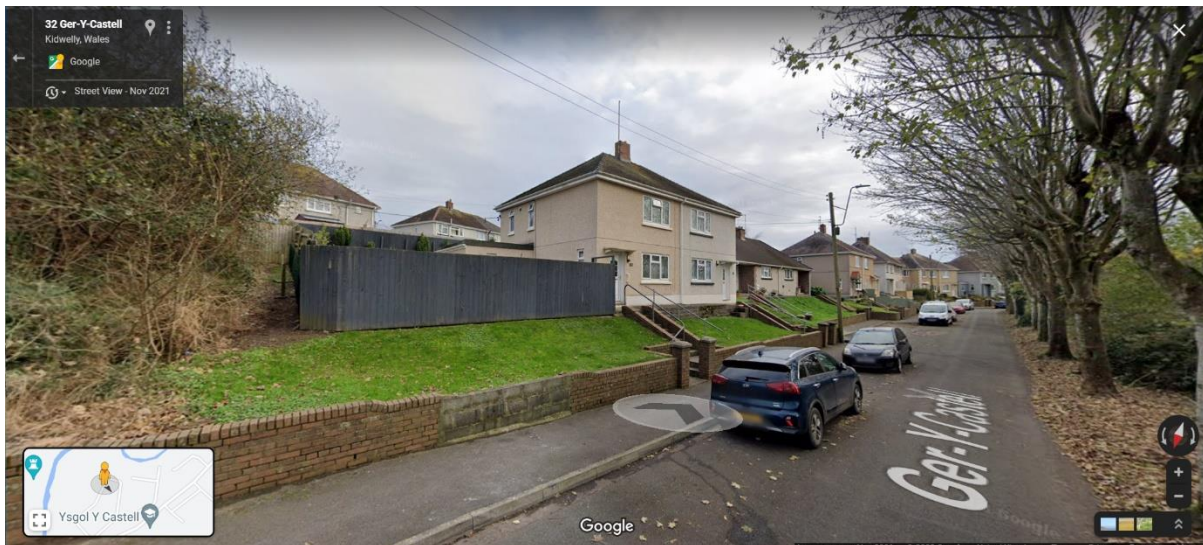
Figure 38 – Photo of 32 Ger Y Castell that had internal flooding from the rear.

7.4.6 It was noted that No.32 Ger Y Castell lies towards the bottom corner of the estate and is lower than surrounding properties. Detailed plans of the drainage servicing this area are not currently available.

7.4.5 At No.32 Ger Y Castell the Property Maintenance team had a contractor come and clear the private drainage which was full of leaves and debris. They then installed aco-drainage at the rear of the property and provided de-humidifiers. Walls were replastered and damaged doors and skirting replaced.

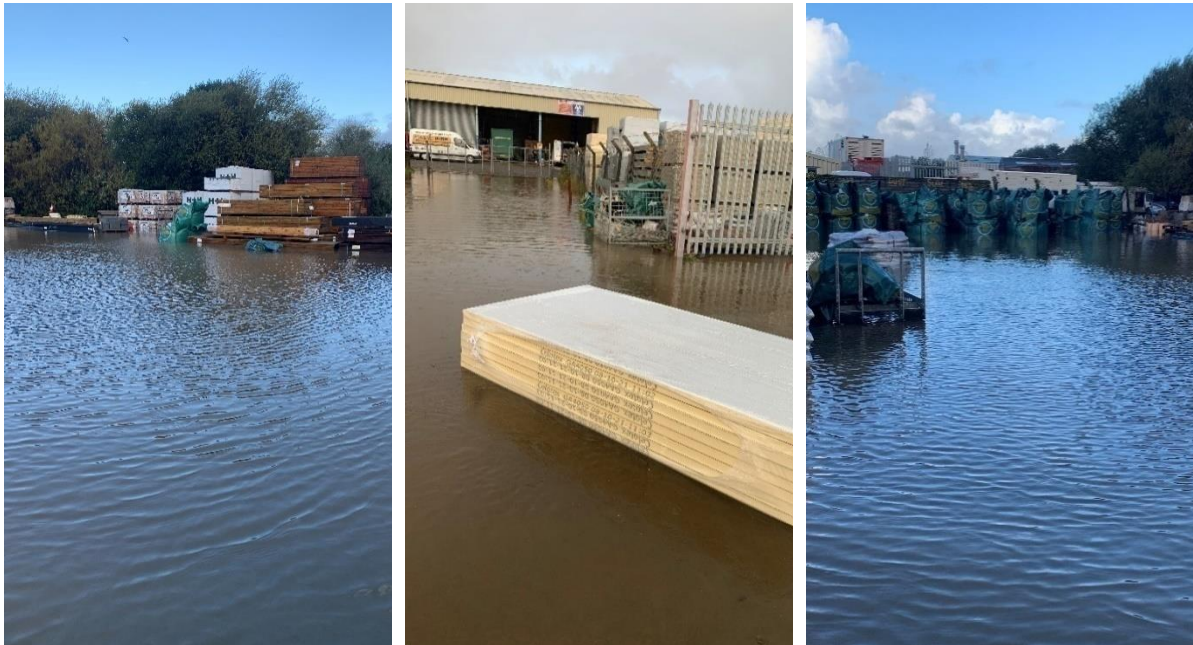
Figure 42 – Photos of the flooding at Kidwelly Industrial Estate on the 20th October 2021.
