# Section 19 Flood Investigation Report

Llansteffan, Carmarthenshire

JUNE 2024

FINAL REPORT

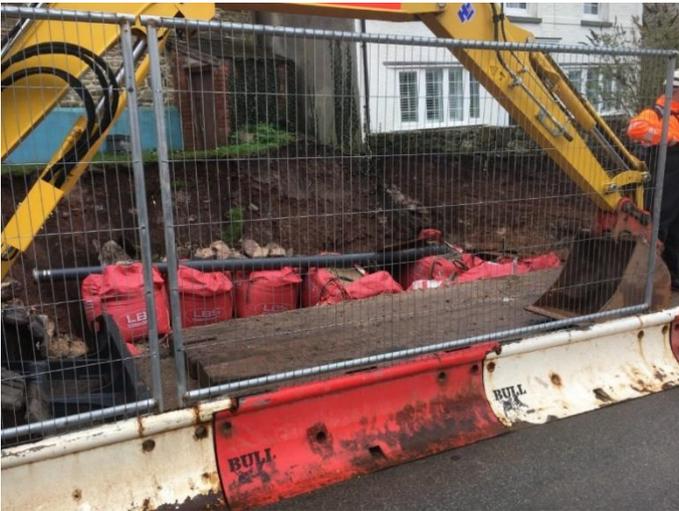
At the top of Water Lane next to the Bethany Baptist Church, the mid-section of the Nant Janc culvert incurred damage during the December-January flood events and underwent significant repair during Spring 2024 as shown in the images below.

*Works at the High Street Bridge. Image taken 19.03.24*

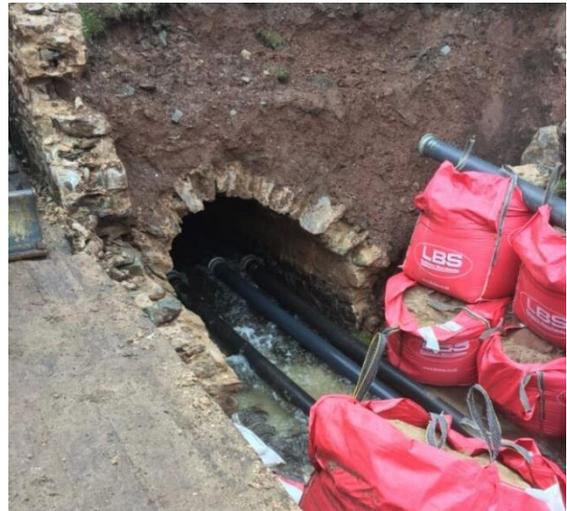
*Looking upstream at the works to the High Street Bridge. Image taken 19.03.24*

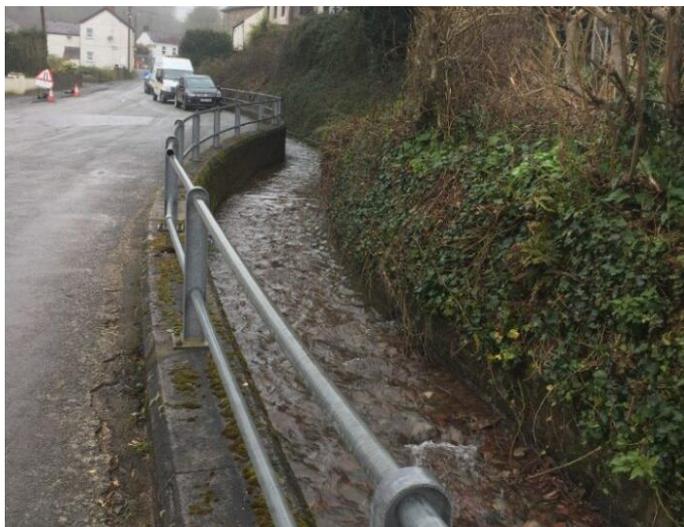
Along Water Lane, the retaining wall which forms the right-hand bank of the Nant Jac is approximately 15 cm high (above the road level) with metal railings above it. At certain points, the retaining wall shows signs of damage, particularly in the areas where the stream apparently overtops onto the road. This indicates that the retaining wall is serving a purpose of keeping flows in the channel up to a certain depth. However, this retaining wall may also prevent overtopped water from being able to re-enter the stream lower down.

*Looking upstream the engineered channel of the Nant Jac along Water Lane*

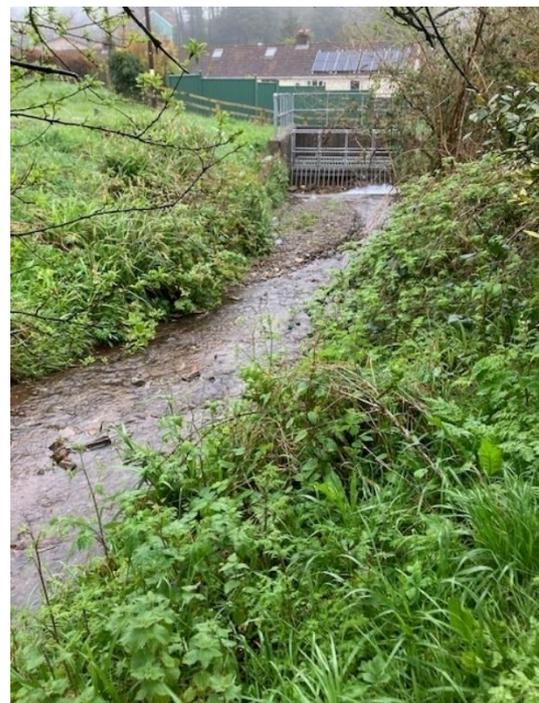
Behind these houses is a substantial trash screen that was observed during the site visit (20<sup>th</sup> March 2024) to be operating well. The stream is then culverted underneath the footpath, Glan-Y-Mor and

Unnamed watercourse at Llansteffan: debris screen

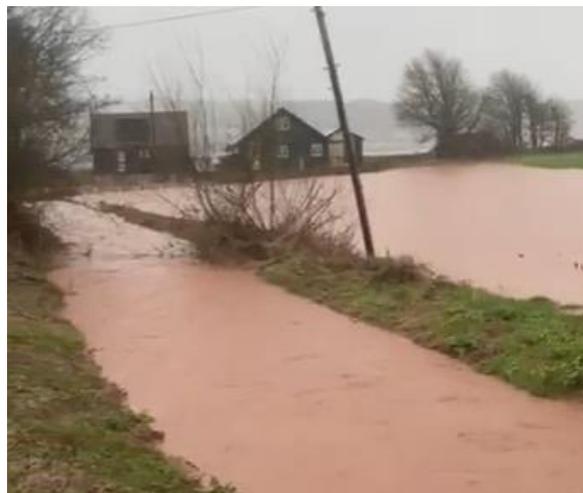
*Looking downstream towards the Towy Estuary during Winter 23/24 storms*

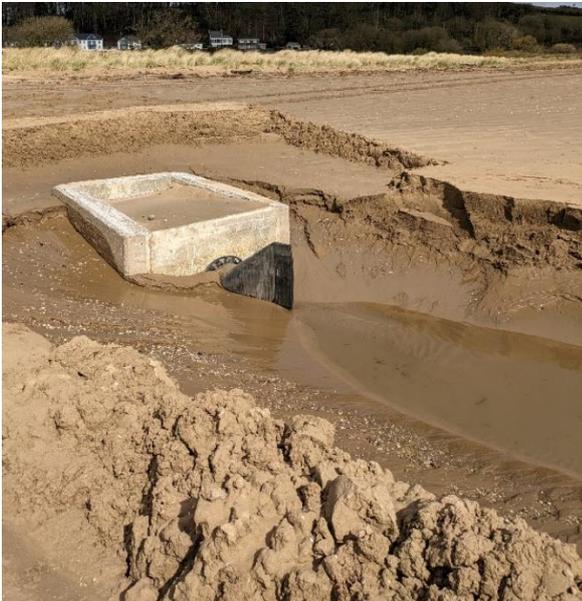
2. Short Outfall

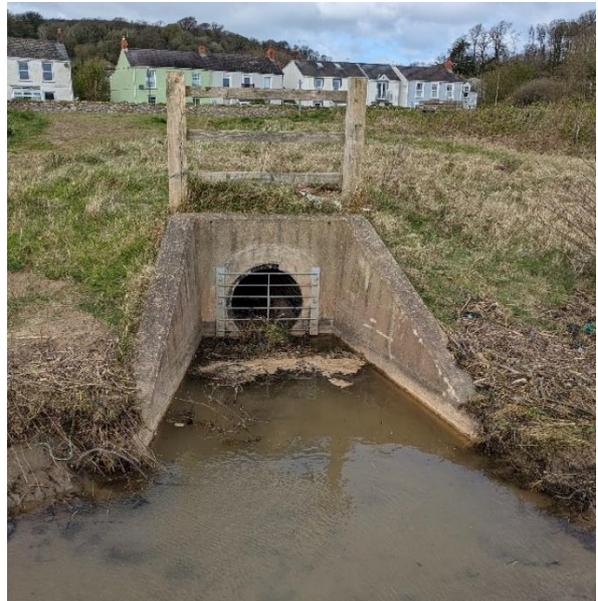
3. Long Outfall

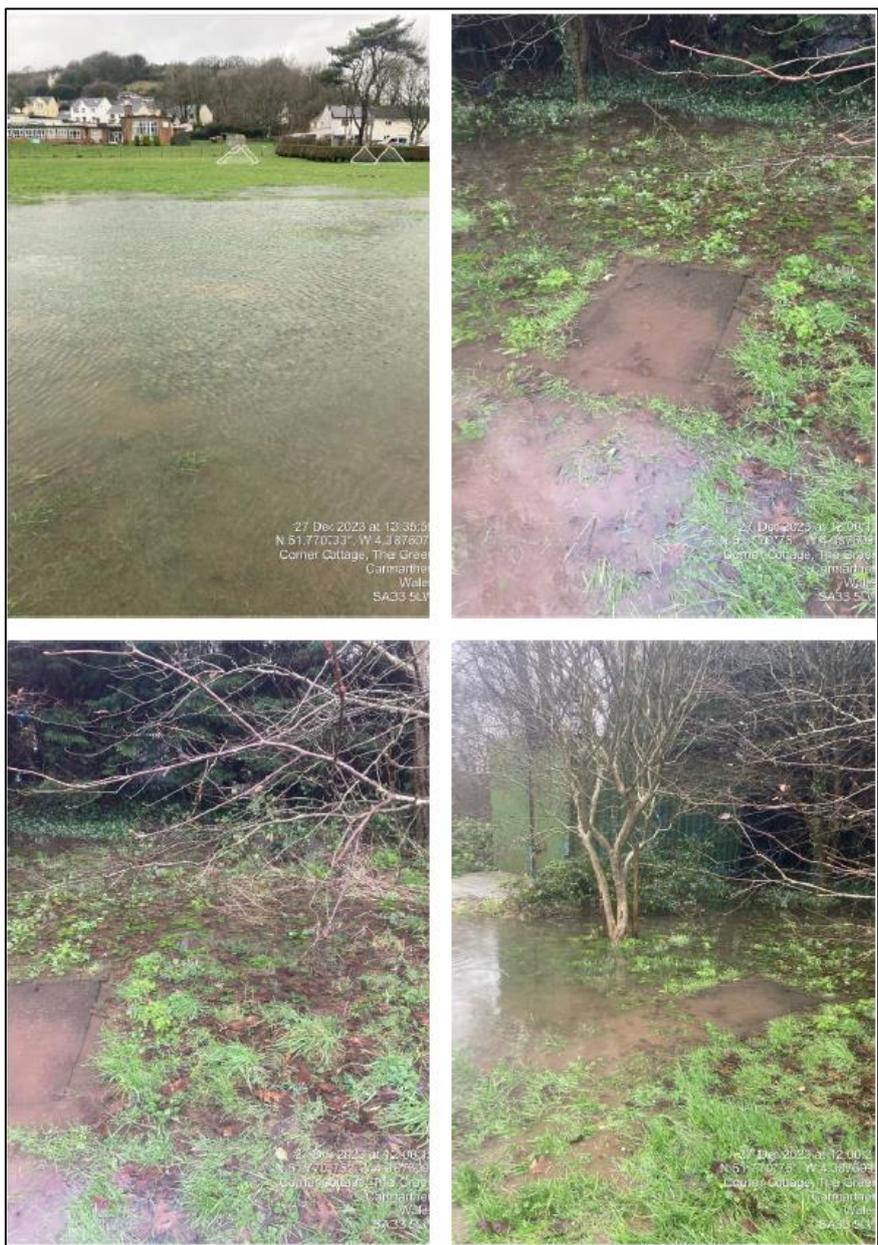
the connection between the two systems. DCWW have provided photos taken on 27 December 2023 (Figure 4-13) and this clearly shows the saturated conditions prior to the flood event and manholes under water. This account aligns with residents' accounts that surface water was unable to drain from the low-lying area prior to the event. This was likely to be as a result of the primary (Middle) outfall from the surface water system being buried under the beach, in conjunction with prolonged periods of rainfall and saturated ground conditions.

Figure 4-13: Images of the Morfa and the vicinity of the DCWW Pumping Station on 27 December 2023

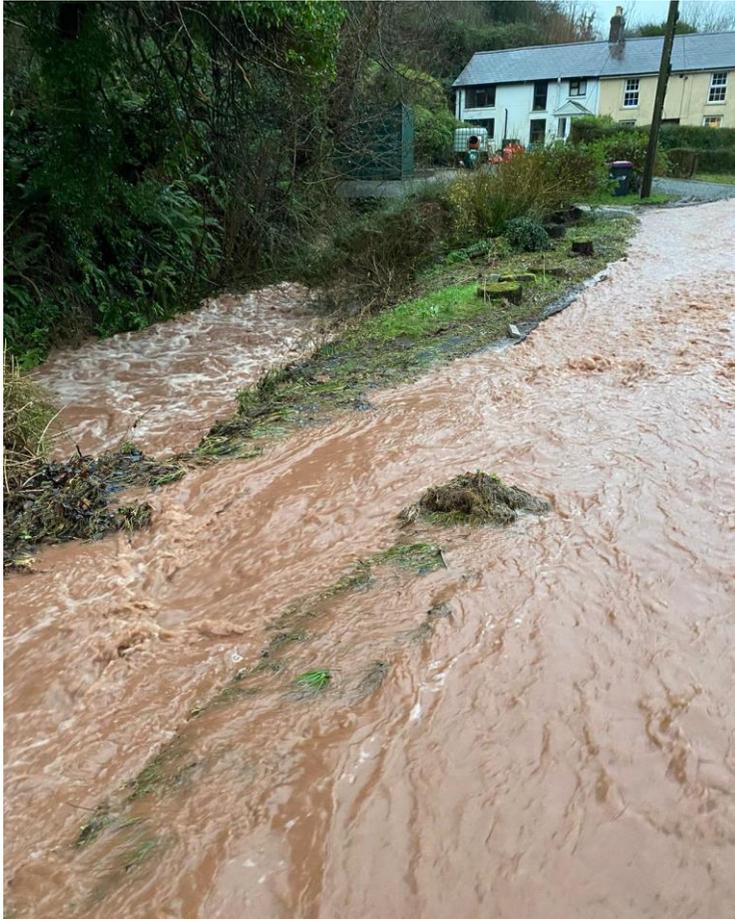
*Figure 1: Flooding on Mill Pond Lane as a result of high water levels in the Nant Jac. Taken on 31 December 2023.*

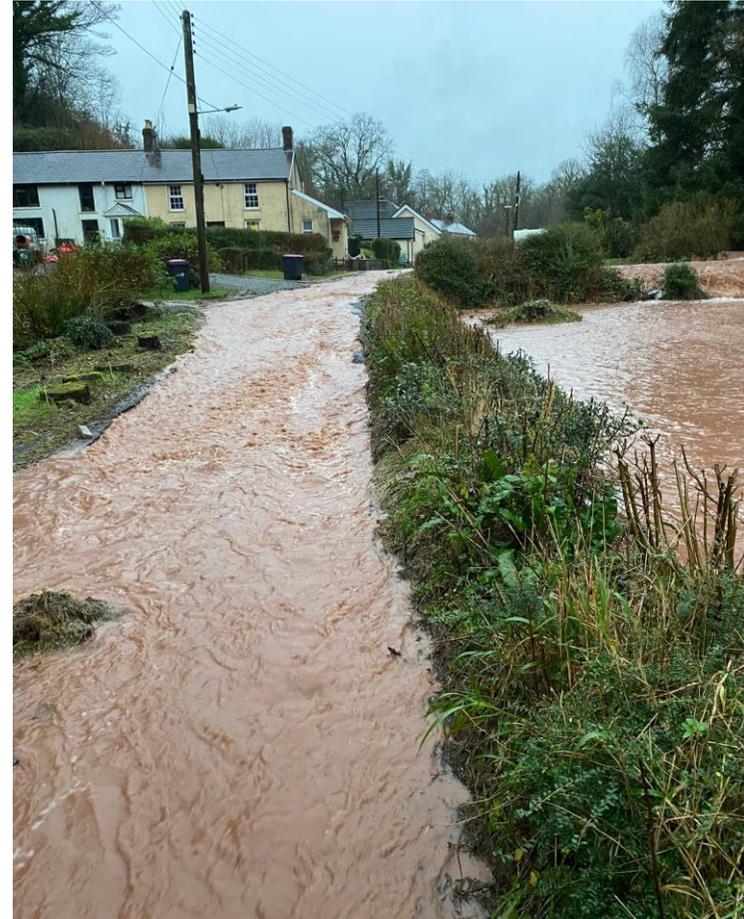
*Figure 2: Flooding on Mill Pond Lane as a result of high water levels in the Nant Jac. Taken on 31 December 2023.*

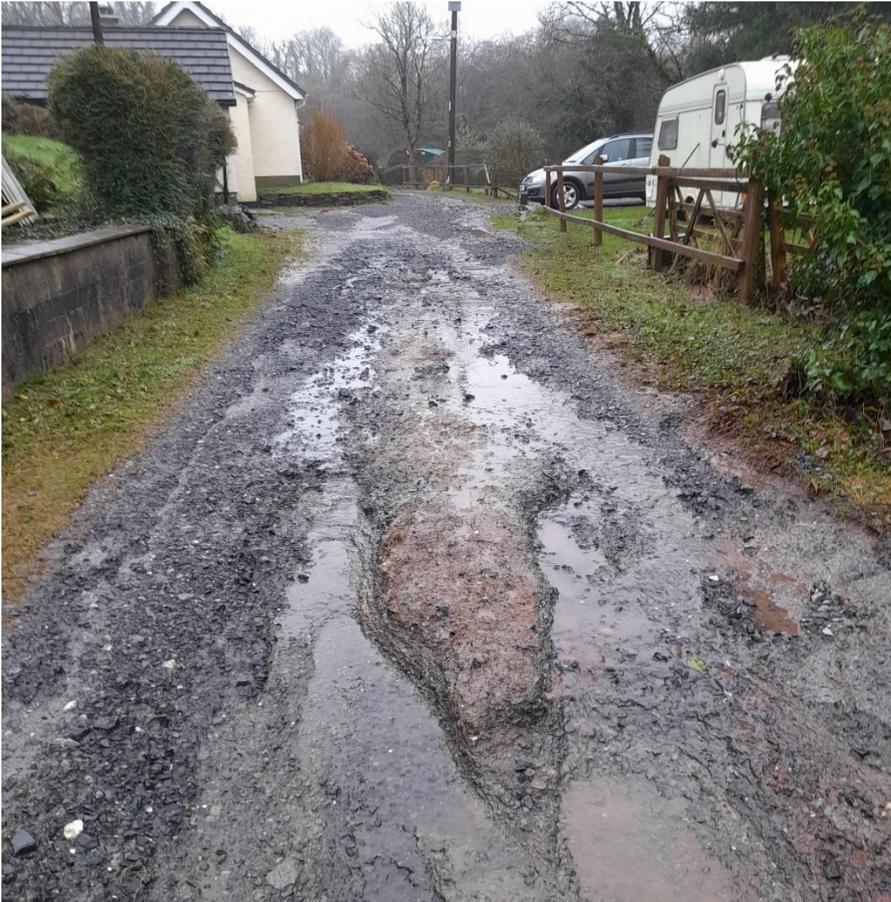
*Figure 3: Damage to Mill Pond Lane as a result of flooding. Taken on 2 January 2024.*

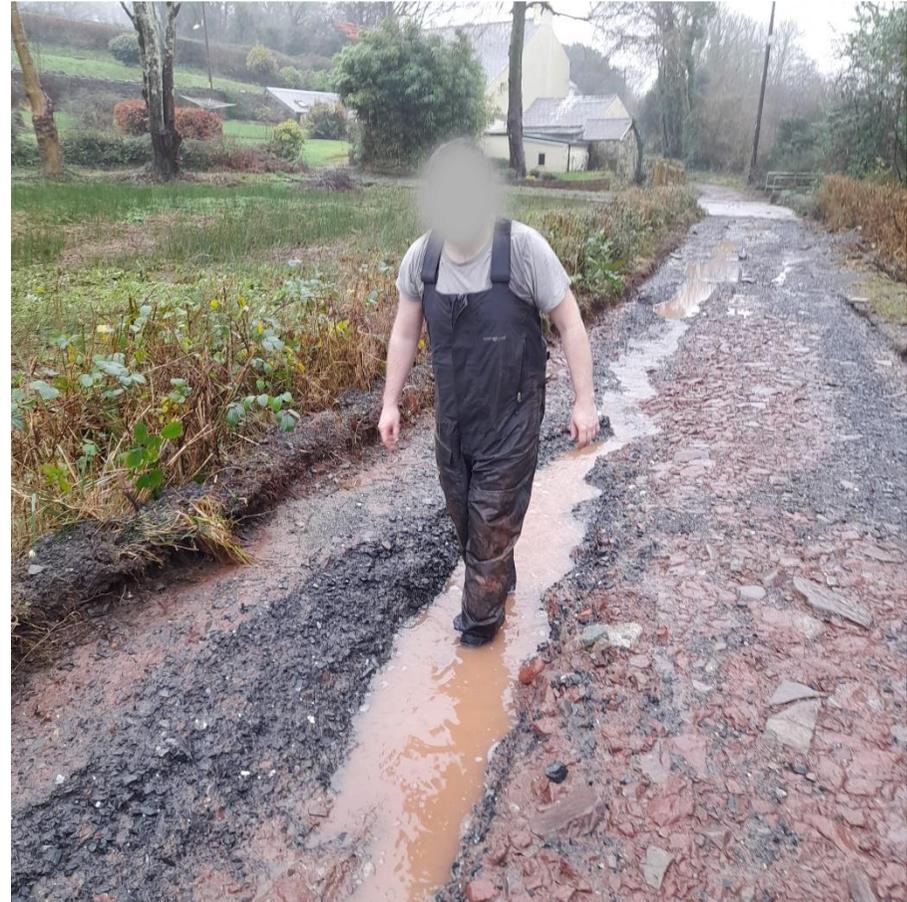
*Figure 4: Damage to Mill Pond Lane as a result of flooding. Taken on 2 January 2024.*

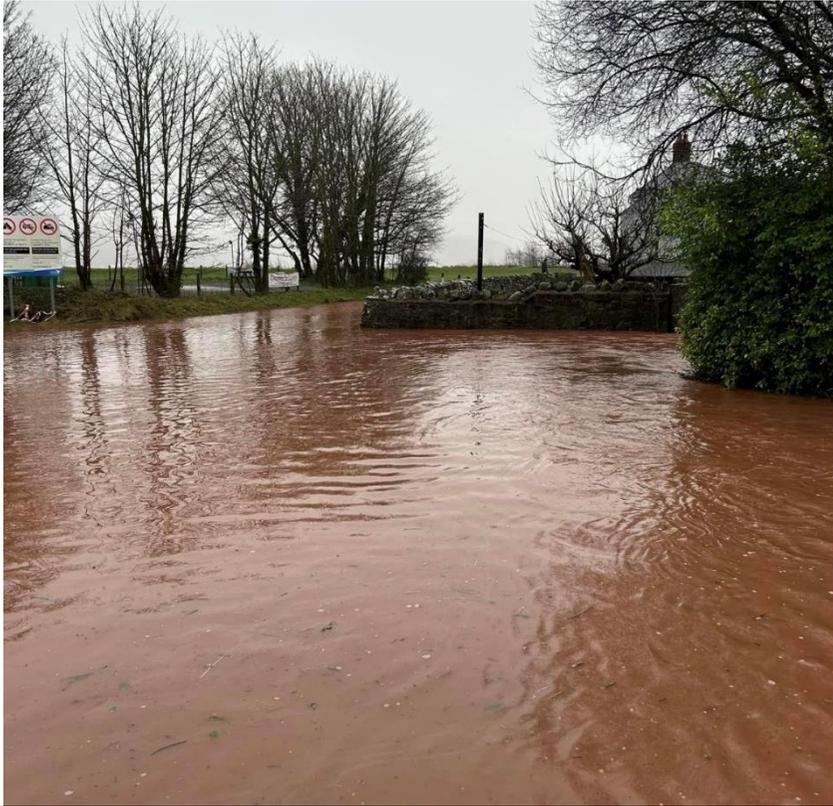
*Figure 5: Flooding at the junction of The Green and Water Lane. Taken 31 December 2023.*

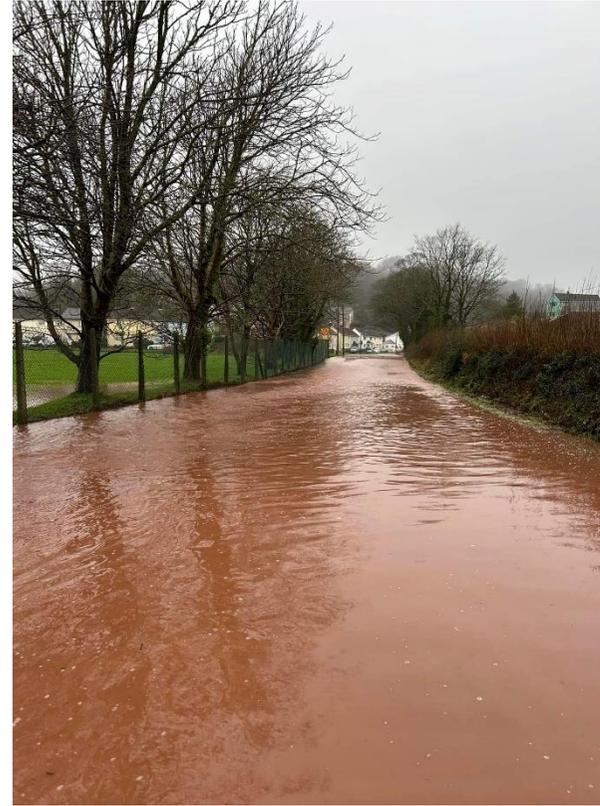
*Figure 6: Water Lane flooding. Taken during Winter 23/24 flood events (date unknown)*

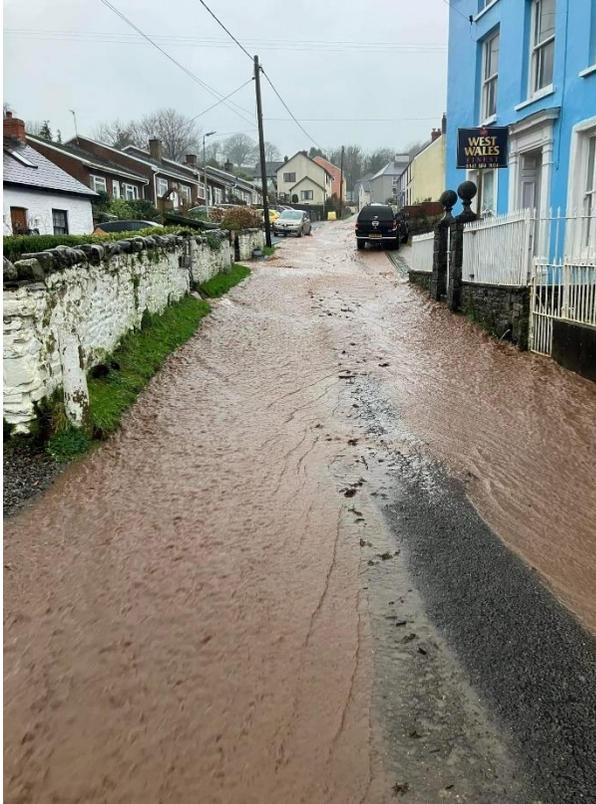
*Figure 7: Surface water run-off on Old School Lane. Taken during Winter 23/24 flood events (date unknown)*

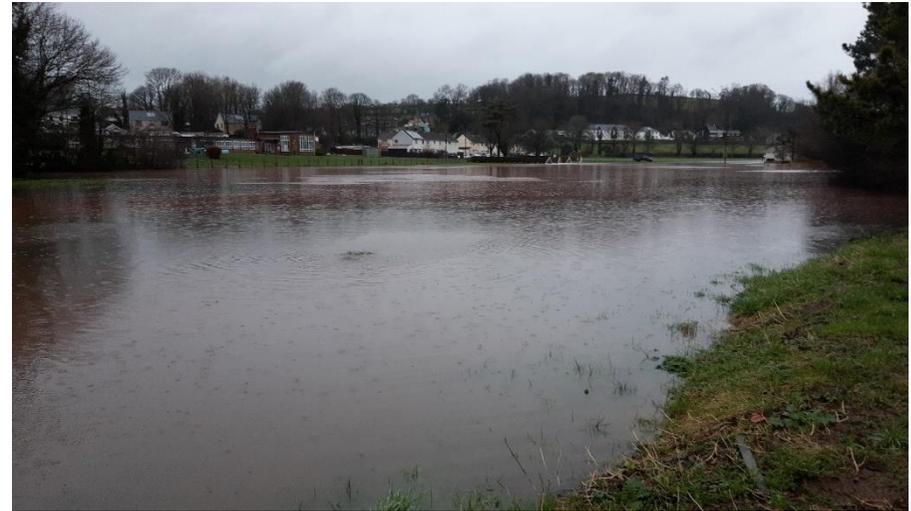
*Figure 8: Flooding of the Morfa. Taken during Winter 23/24 flood events (date unknown)*

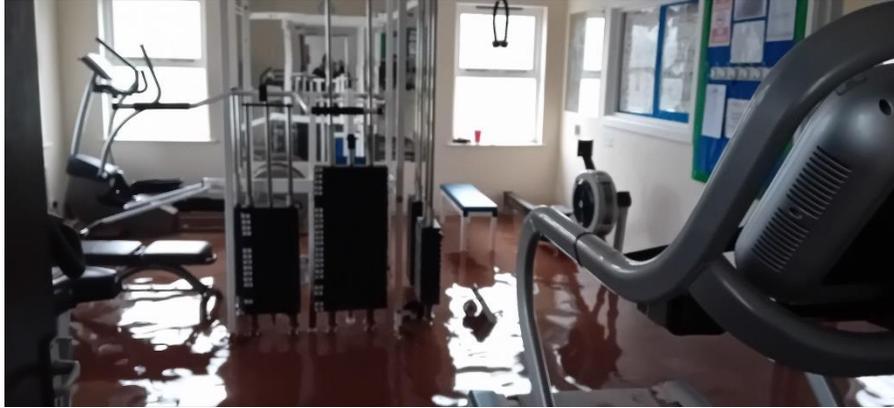
*Figure 9: Internal flooding in the Llansteffan Sports and Social Club. Taken during Winter 23/24 flood events (date unknown)*

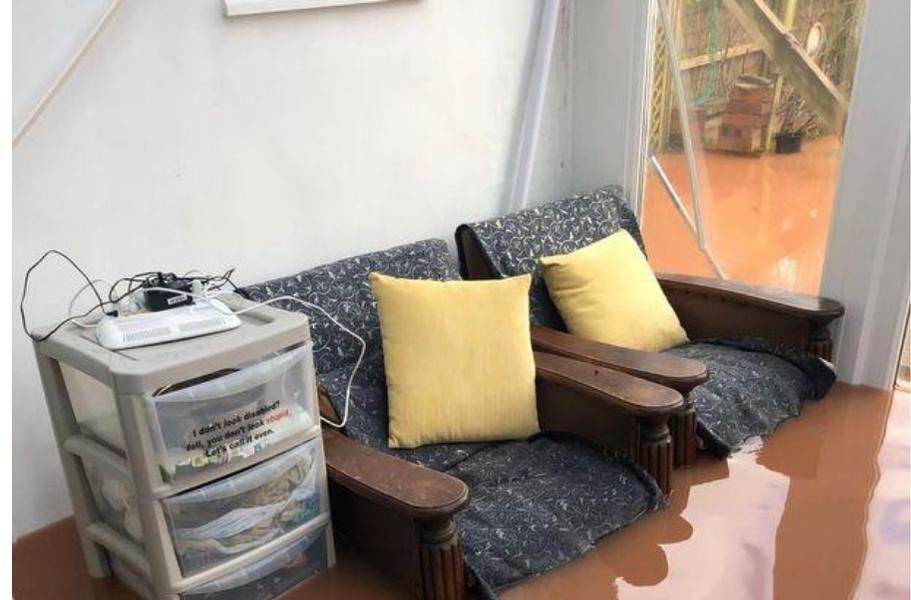
*Figure 10: Internal flooding at The Green. Taken during Winter 23/24 flood events (date unknown)*

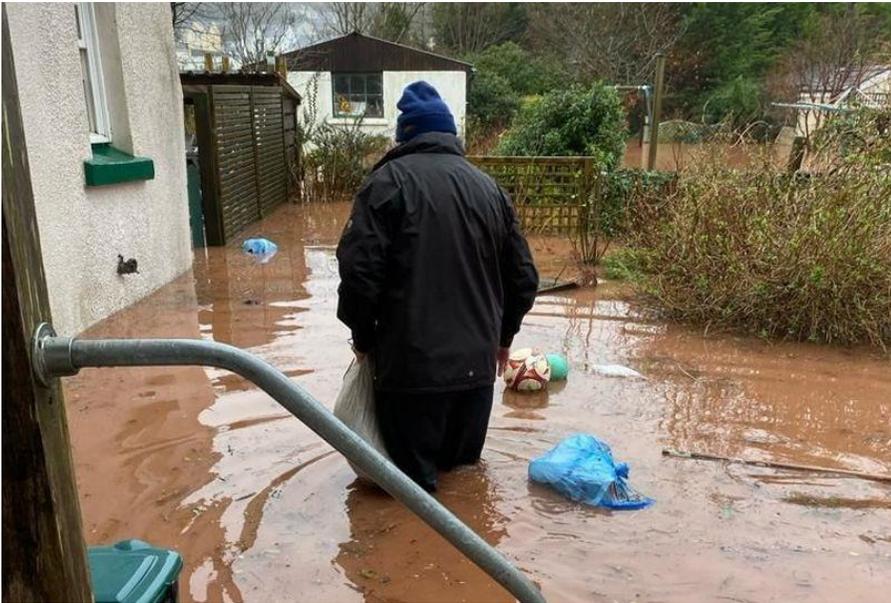
*Figure 11: Curtilage flooding at The Green. Taken during Winter 23/24 flood events (date unknown)*

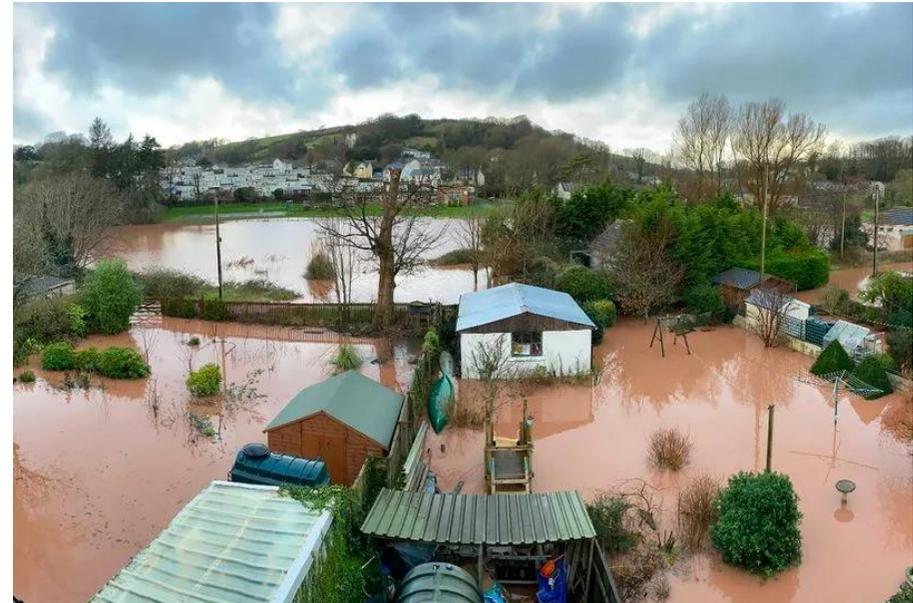
*Figure 12: Flooding at The Green. Taken during Winter 23/24 flood events (date unknown)*

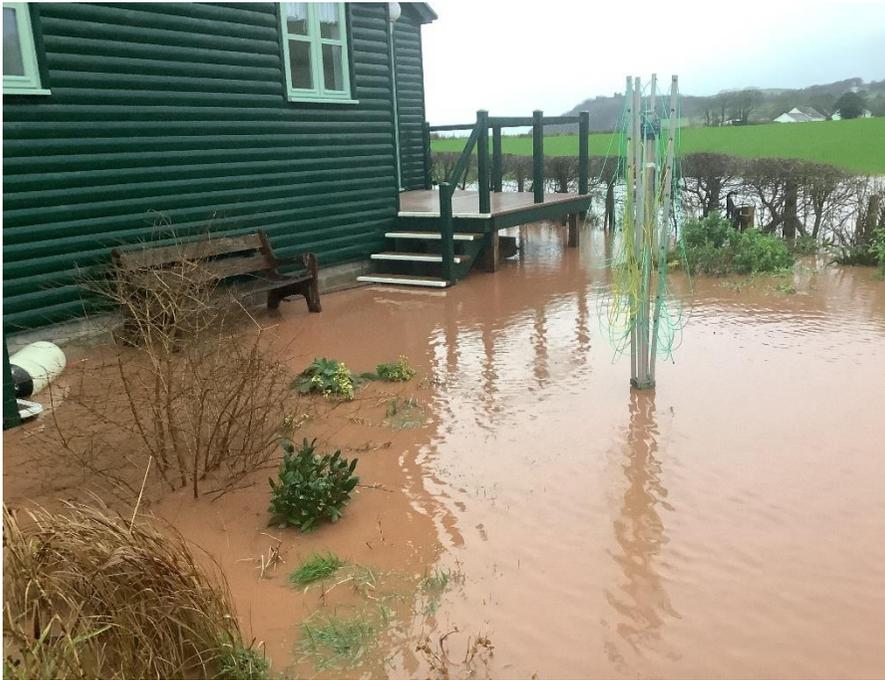
*Figure 13: Curtilage flooding at Ferry Point. Taken during Winter 23/24 flood events (date unknown)*

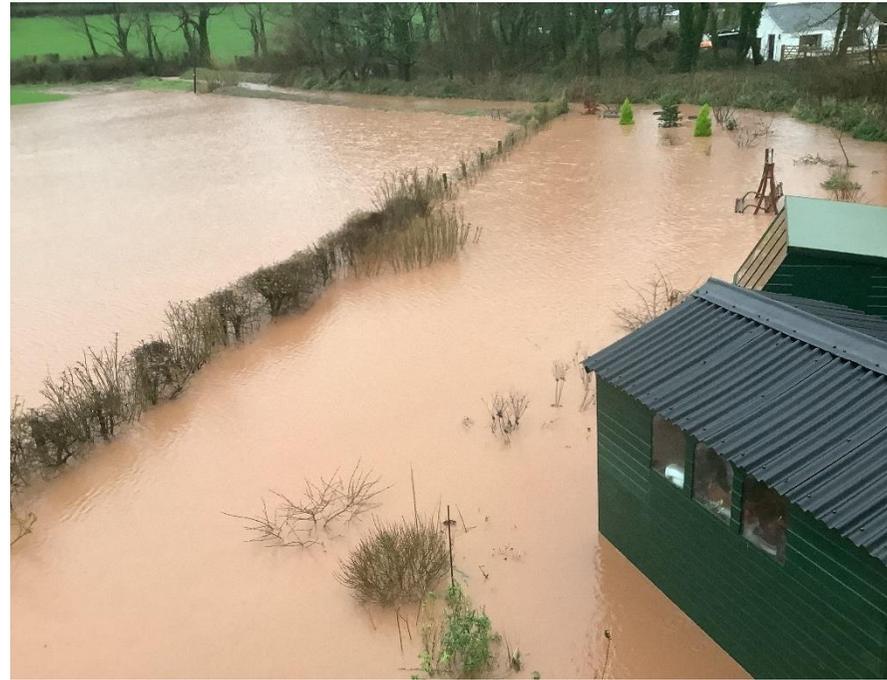
*Figure 14: Curtilage flooding at Ferry Point. Taken during Winter 23/24 flood events (date unknown)*

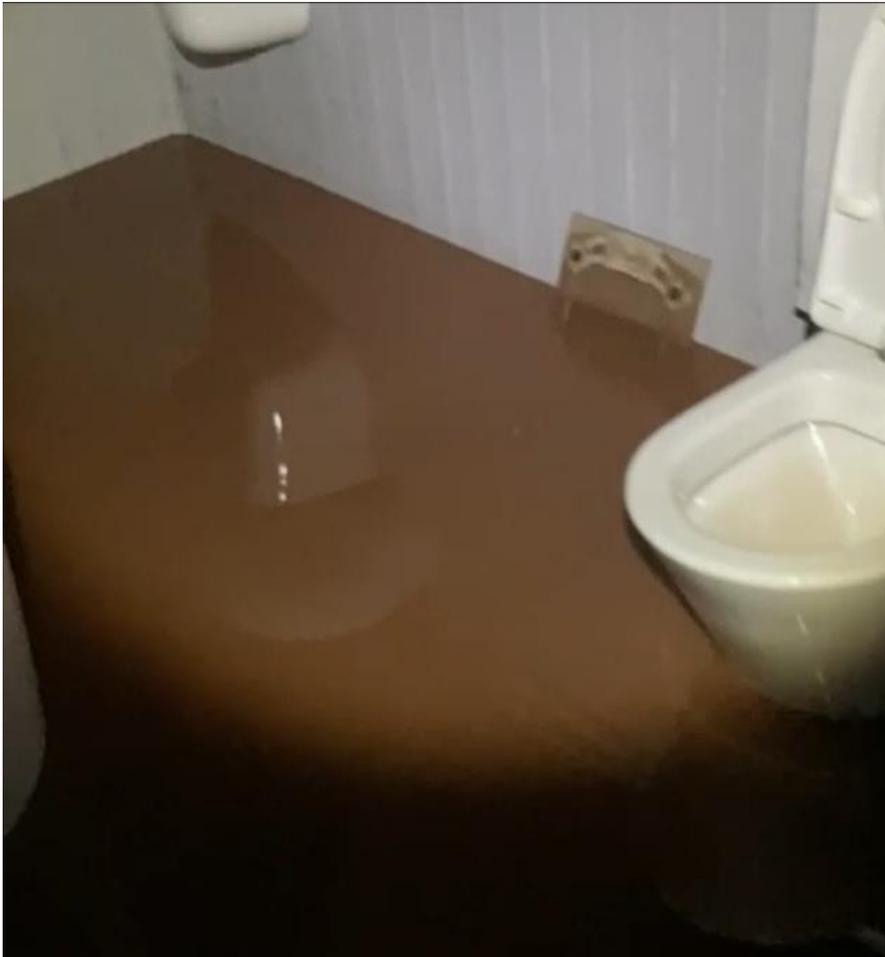
*Figure 15: Internal flooding at Ferry Point. Taken during Winter 23/24 flood events (date unknown)*

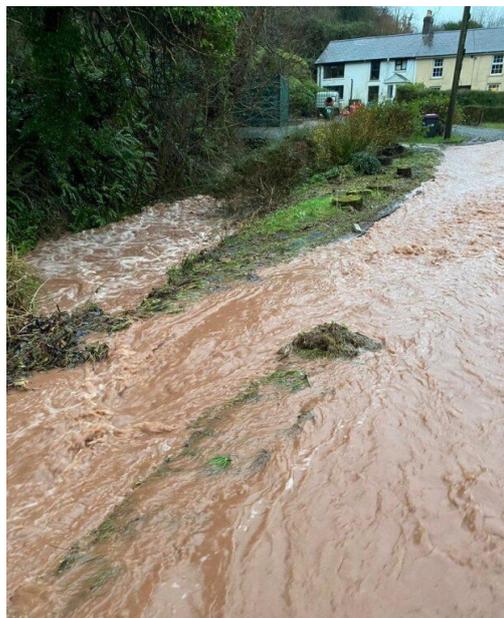
*Nant Jac overtopping the bank at Mill Pond Lane*

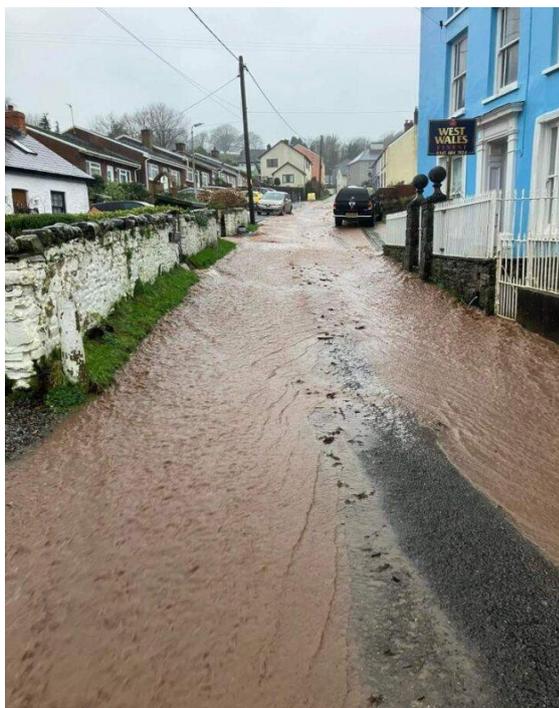
*Surface water runoff along Old Road*

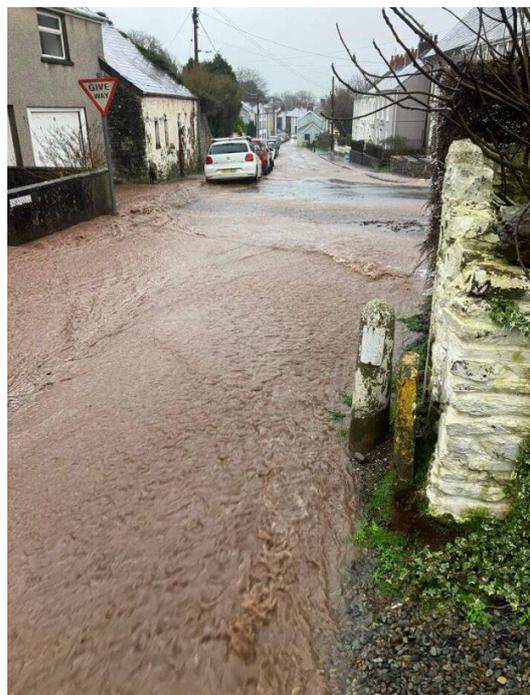
*Surface water runoff along the High Street*

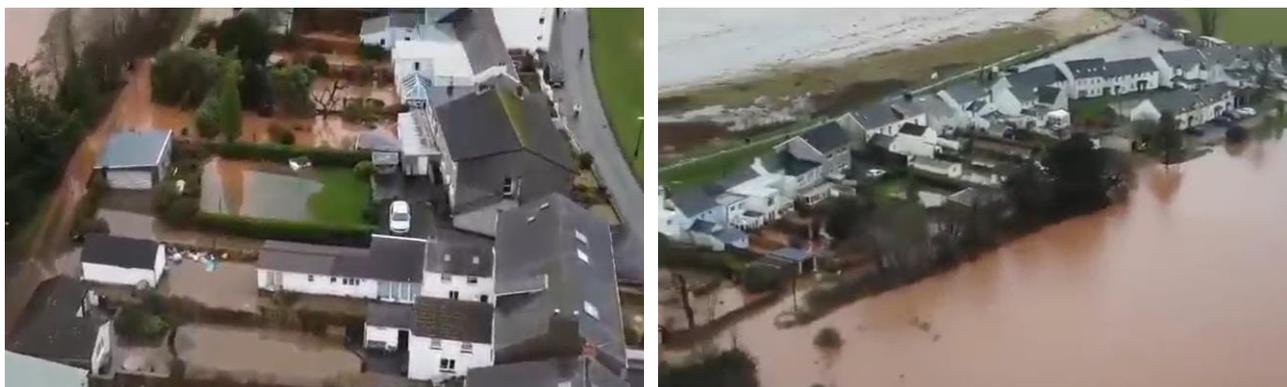
*Flooding to the back of The Green*

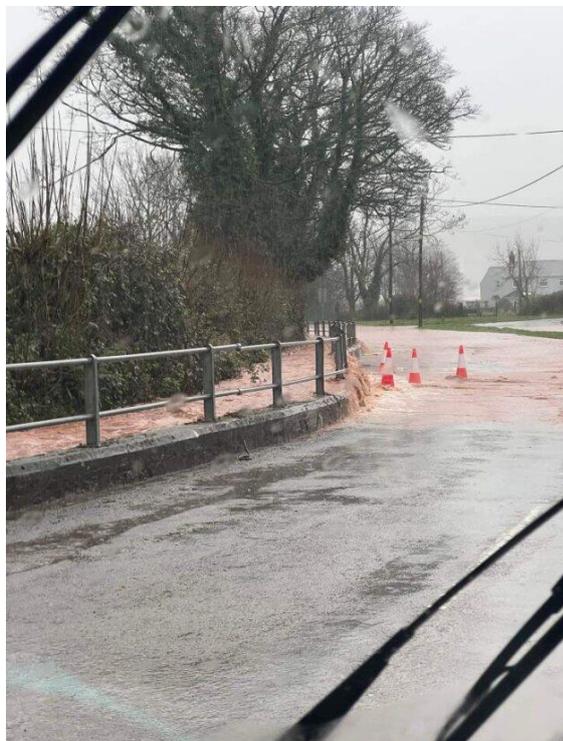
*Water ponding on the Morfa and The Green*

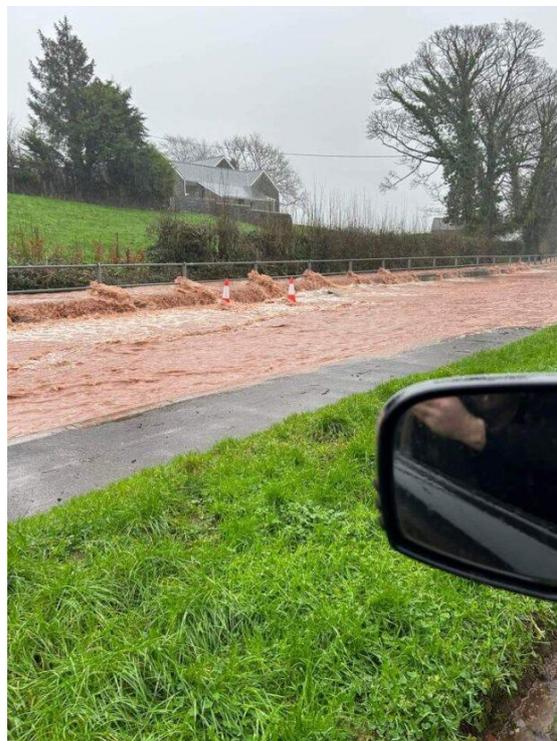
*Water overtopping the Nant Jac along Water Lane*

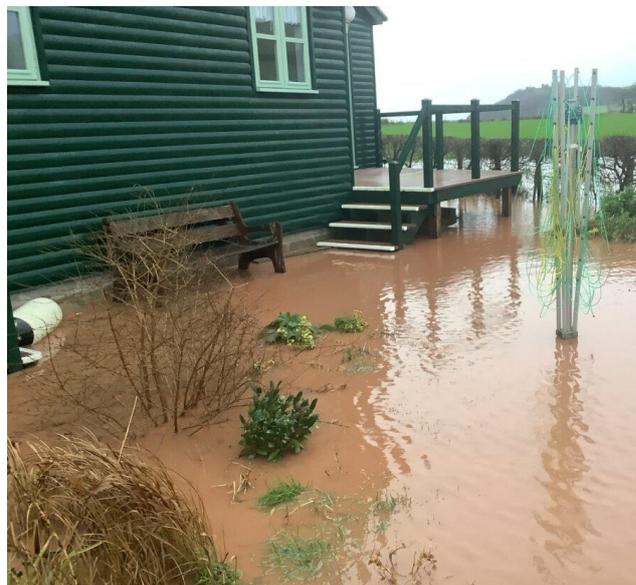
*Flooding of property curtilage at Ferry Point*
