# Kidwelly Flood Investigation Report

A report into the flooding events of the 4<sup>th</sup> and 20<sup>th</sup> October 2021 at Clos Y Helyg, Parc Pendre, Llys Gwenllian, Ferry Road, Cae Ffynnon, Ger Y Castell, Ger Y Gwendraeth and Kidwelly Industrial Estate – as required under section 19 of the Flood and Water Management Act 2010.

<b>Title of document</b>	Kidwelly Flood Investigation Report
<b>Document date</b>	September 2022
<b>Authors</b>	Carmarthenshire County Council
<b>Service responsible</b>	Flood Defence and Coastal Protection, Waste and Environmental Services
<b>Department</b>	Environment
<b>Review</b>	Cath Abbott Flood Defence and Coastal Protection Engineer Environment Department, Carmarthenshire County Council
<b>Approval</b>	Ben Kathrens Flood Defence and Coastal Protection Manager Environment Department, Carmarthenshire County Council
<b>Published</b>

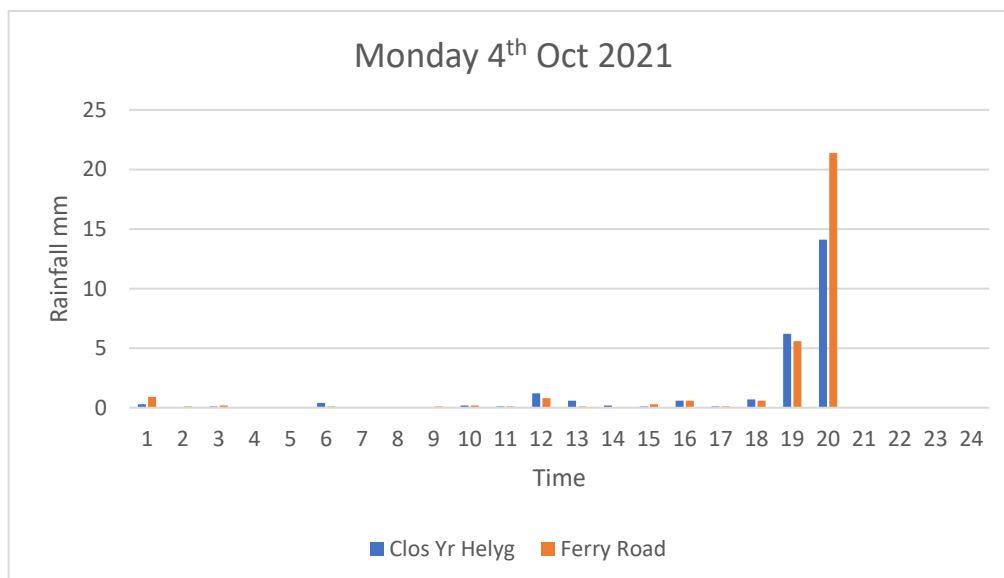
Figure 1 - Published MetDesk rainfall amounts in Kidwelly for each hour on the 4<sup>th</sup> October 2021 (mm).

- 2.4.1 Carmarthenshire County Council’s weather service provider, MetDesk, can provide rainfall amounts in millimeters (mm) for any hour throughout the day. The recorded radar rainfall amounts per hour (mm) for Clos Yr Helyg and Ferry Road are shown below in Figure 1. Between 18:00pm and 20:00pm, 20.3mm and 27mm of rain fell at Clos Yr Helyg and Ferry Road, respectively. To place the rainfall intensity in context, 30mm of rainfall in a 24-hour period is a standard trigger for action by Carmarthenshire County Council.

- 2.4.2 The MetDesk 24-hour rainfall totals for Monday 4<sup>th</sup> October 2021 were 25.1mm at Clos Yr Helyg and 31.4mm at Ferry Road. As can be seen from Figure 1 above, the vast majority of

the 24-hour rainfall total (more than 80%) fell over 2 hours from 18:00pm to 20:00pm. The cumulative radar 24-hour rainfall totals are shown below in Figure 2.

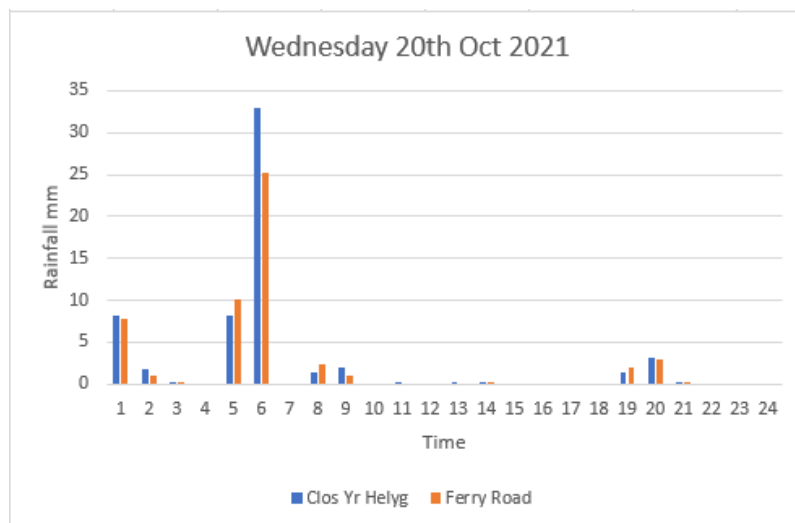
Figure 3 - Recorded rainfall amounts in Kidwelly for each hour on the 20<sup>th</sup> October 2021 (mm).

2.5.1 The recorded radar rainfall amounts for Clos Yr Helyg and Ferry Road are shown below in Figure 1. During the hour from 04:00am to 05:00am there was 8.1mm rain recorded at Clos Yr Helyg and 10.1mm at Ferry Road. Between 05:00am and 06:00am, 32.9mm and 25.2mm of rain fell at Clos Yr Helyg and Ferry Road, respectively.

2.5.2 The MetDesk 24-hour rainfall totals for Wednesday 20<sup>th</sup> October 2021 were 60.1mm at Clos Yr Helyg and 53.1mm at Ferry Road. As can be seen from

2.5.3 Figure 3 above, approximately 50% of the 24-hour rainfall total fell during one hour from 05:00am to 06:00am. The cumulative radar 24-hour rainfall totals are shown below in Figure 4.

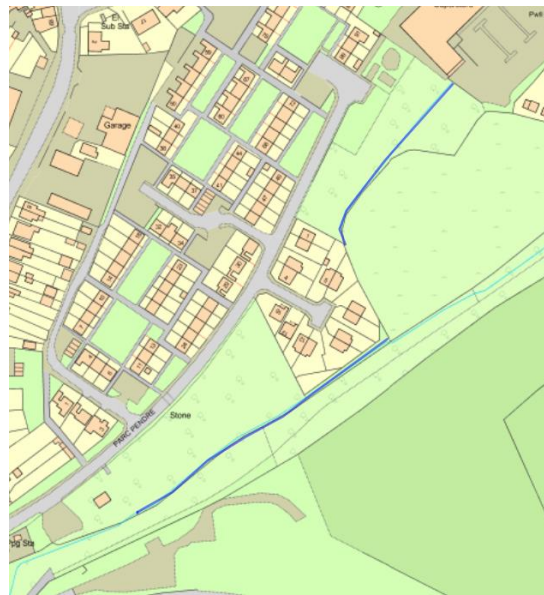
Figure 10 - Map of the Clos Yr Helyg ordinary watercourse.

- 3.5.1.3 The second ordinary watercourse is a ditch that begins at the southern edge of the Co-Op supermarket and flows south around Clos Yr Helyg (Figure 10). This is named the Clos Yr Helyg ditch on the CCC FDCP asset management system.

3.5.1.5 The Clos Yr Helyg watercourse has a significantly smaller catchment of approximately 2.6 hectares and, with the exception of a section of the Co-Op car park, is fed from surface water runoff and drainage water from surrounding fields.

3.5.2.2.2 This investigation has found no evidence of maintenance of this watercourse over the years. As such, its ability to receive and convey surface water has been compromised.

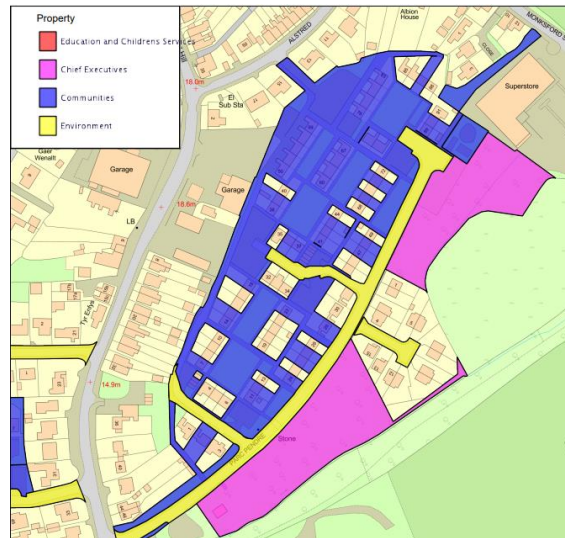
Figure 12 – Map of CCC land ownership at Clos Yr Helyg, Kidwelly.

3.5.2.2.1 Post the October 2021 flooding events, the Clos Yr Helyg watercourse has been added to the FDCP asset database. The land through which the watercourse flows is partially CCC land, as depicted in Figure 12.

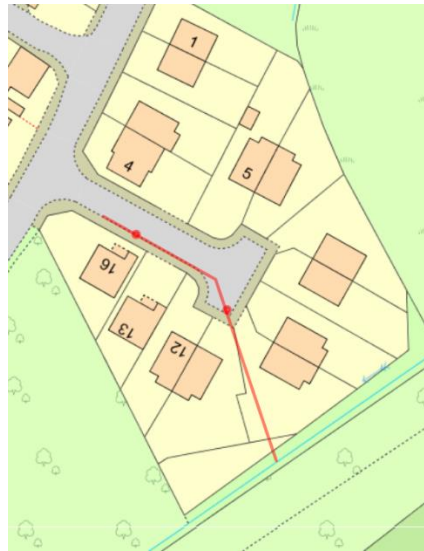
Figure 13 - Map of the highway drainage system at Clos Yr Helyg, Kidwelly.

3.5.2.5 In Clos Yr Helyg the highway has its own independent drainage system. This is served by two surface gullies that drain the carriageway and walkway. The gullies discharge to a 150mm plastic culvert which conveys surface water southeast to the ordinary watercourse as shown in Figure 13 below.

3.5.2.6 The 2019 CCTV survey did attempt to survey the Clos Yr Helyg highway drainage system. However, this investigation has discovered that the survey was not completed because of silts and water in the line. Water in the line would suggest defects in the system. This investigation has been unable to find any records that these defects were reported, recorded, or resolved.

Undertake a CCTV survey of the highway drainage system down Clos Yr Helyg in order to have a better record of CCC assets and action any defects accordingly.

**Action 6**  
**CCC Environment Department**  
Develop a more robust method of reviewing CCTV drainage surveys and recording and actioning defects between divisions and teams.

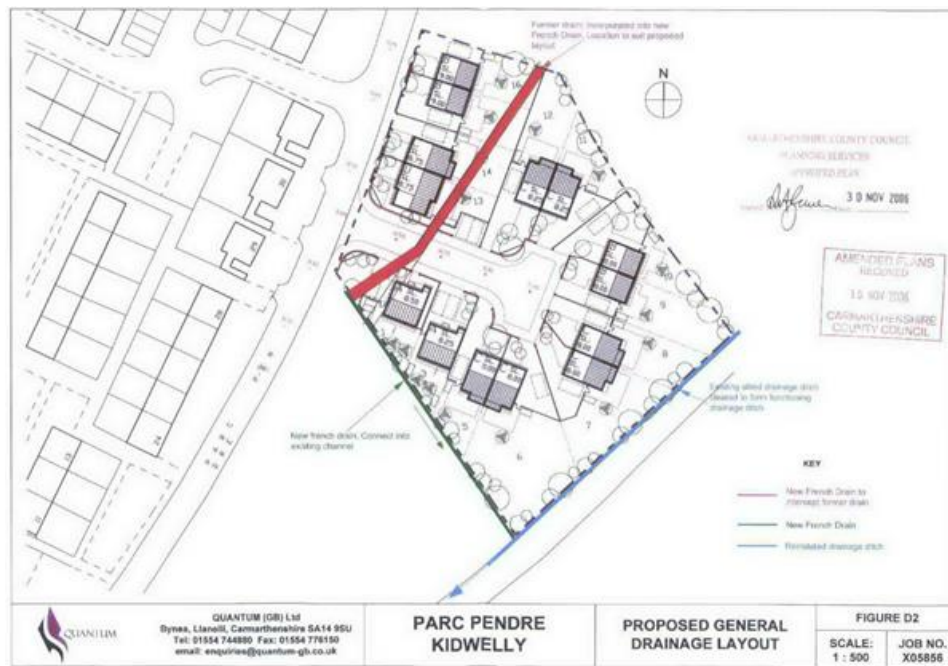
Figure 15 – Map of the approved surface water drainage design for Clos Yr Helyg (Quantum, 2006).

3.6.5 The approved surface water drainage design involved the remodelling of the former drain/watercourse into a new French drain running across the development and discharging into the reinstated drainage ditch running along the south-eastern boundary, as shown below in Figure 15.

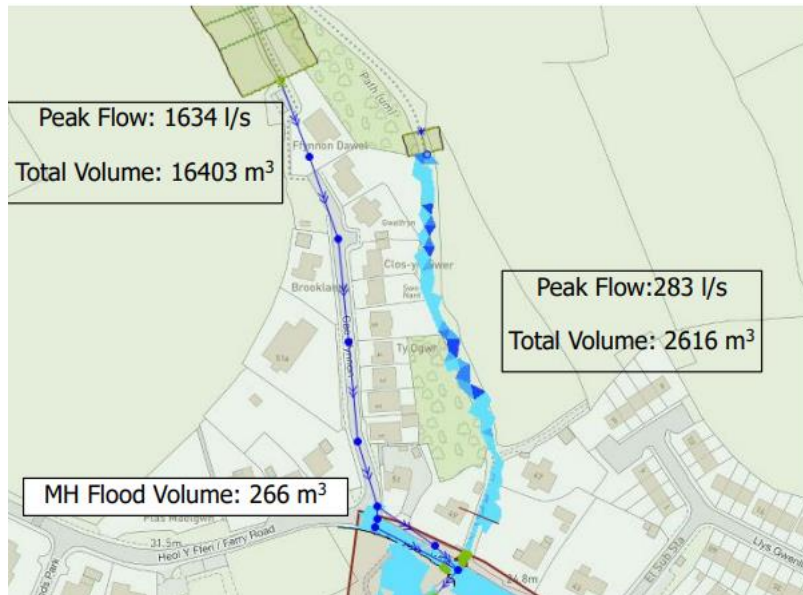
Figure 31 - Hydraulic modelling output of a 1 in 100-year (0.1% AEP) flood event - showing no surcharge at the Cae Ffynnon trash screen (Amey Consulting, March 2022).

6.6.2.1.3 An evaluation undertaken as a part of this investigation has concluded that this asset is fit for purpose, with the ability to manage flood flows up to the 1 in 100-year annual probability flood event (1% AEP). **Error! Reference source not found.** below depicts the flood modelling outputs and shows no predicted flooding during the modelling of this storm event.

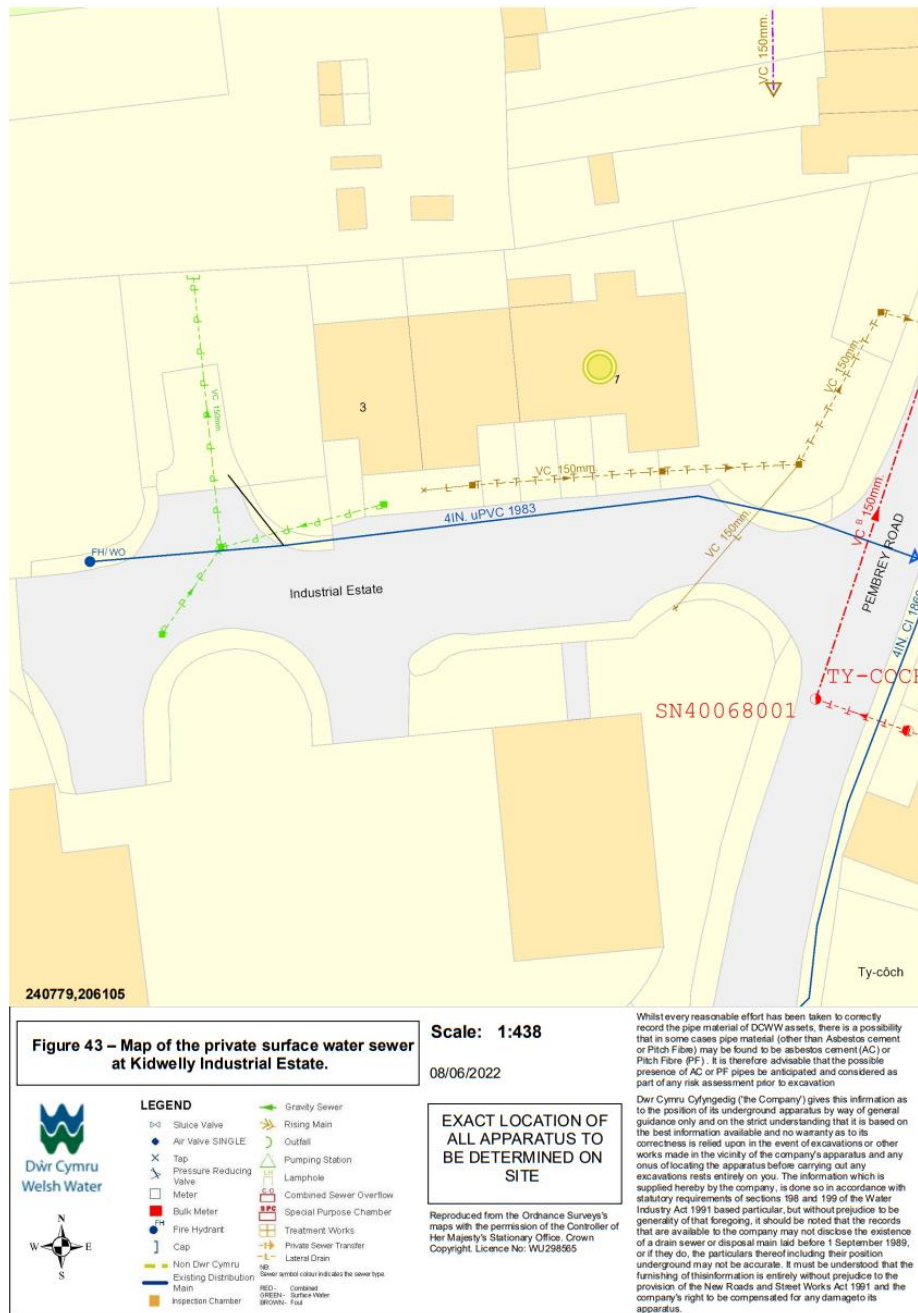
Figure 43 – Maps of the private surface water sewer at Kidwelly Industrial Estate.

8.6.3.1 The industrial estate is served by a DCWW foul sewer and a private surface water sewer as shown in Figure 43.

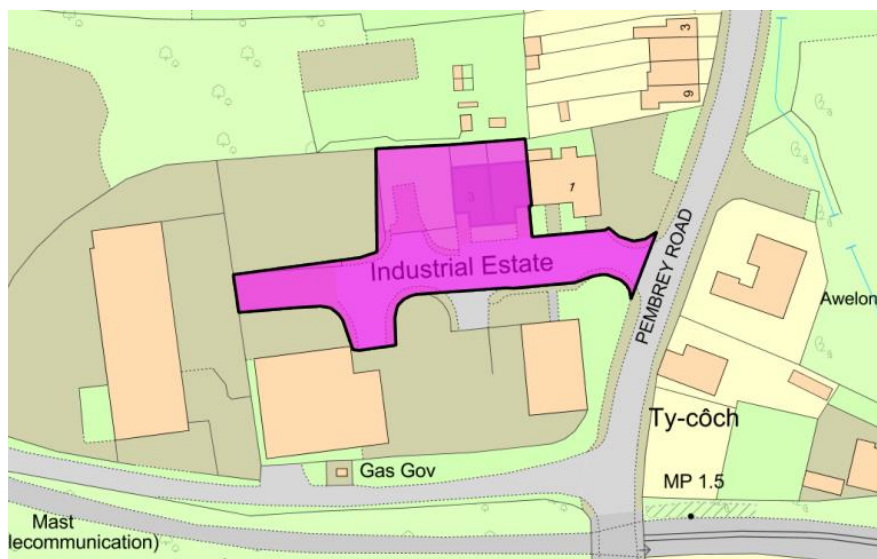
Figure 44 - Kidwelly Industrial Estate and the area managed by CCC's Property Services (highlighted in pink).

8.5.4.1 CCC's Property Services - who manage units 2 and 3, and the highway in the Industrial Park (Figure 44), have records of flooding that occurred in March 2021. After this event, a drainage contractor provided advice on resolution of the issues but to date that advice has not been followed up.

8.6.4.1 The CCC Estates Team manage units 2 and 3 and the industrial estate road, as shown in Figure 44.

- 8.6.4.4 The maintenance of all CCC's industrial or business estates is delivered on a reactive basis. Assets are inspected and repaired as and when issues are highlighted.
