# Section 19 Flood Investigation Report

Llansteffan, Carmarthenshire

JUNE 2024

FINAL REPORT

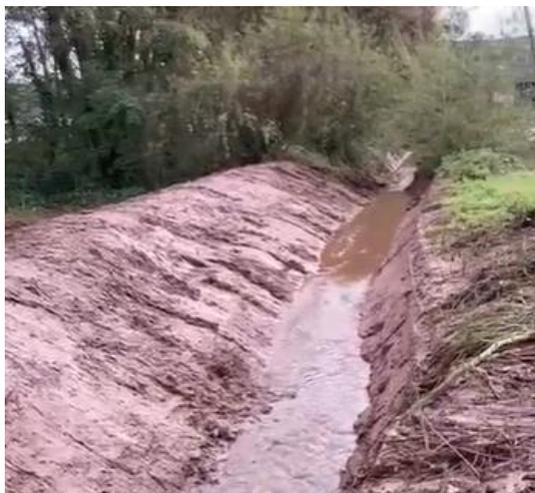
*Looking downstream towards the Towy Estuary during Winter 23/24 storms*

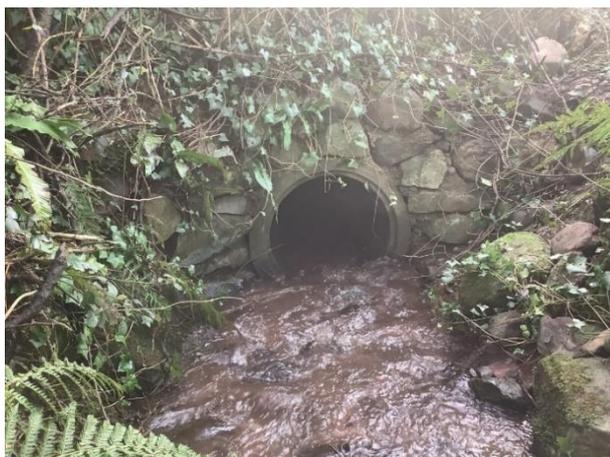
*Looking downstream at the unnamed watercourse culvert under the access track*

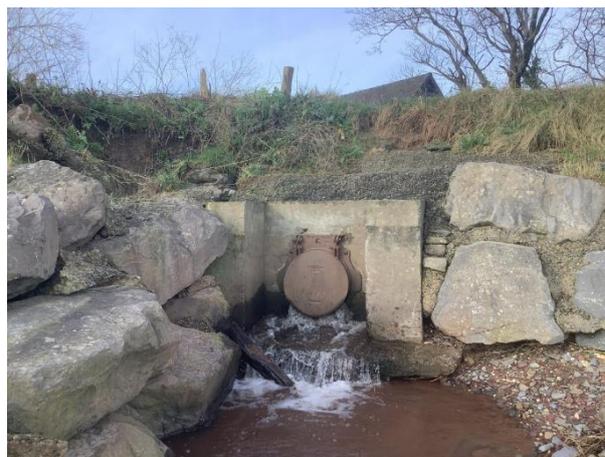
*Unnamed watercourse outfall into the Towy Estuary*

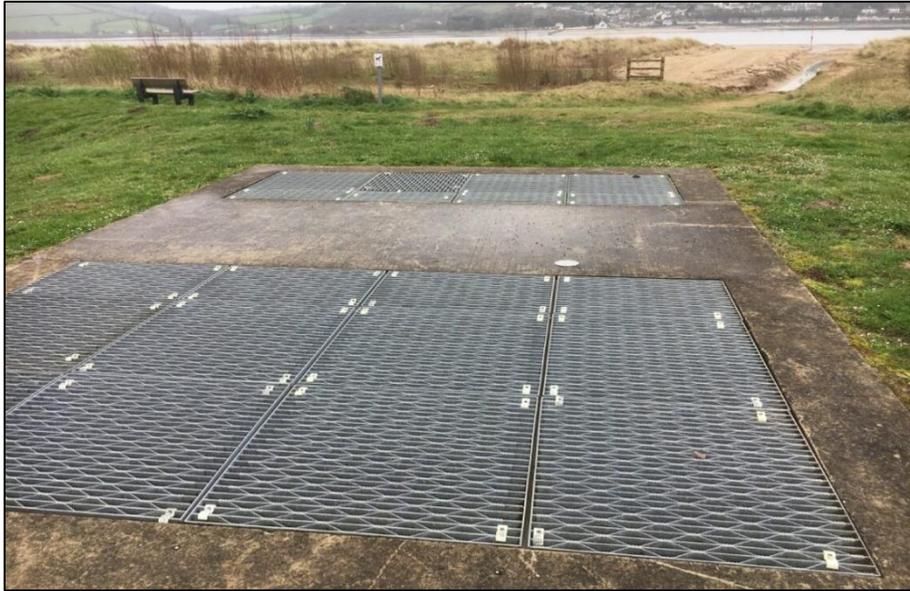
Figure 2-10: Surface Water Chambers located on The Green

The landward chamber is twice the size of the seaward chamber. In the landward chamber there is one large inflow on the back wall; it is assumed that this is where all the water from the drainage system enters from the village. This drainage water then exits via the duckbill valve into the seaward chamber which has an invert level of 3.325 mAOD.

Towards the bottom of the seaward chamber there is a duckbill valve with inflow from the landward chamber which prevents seawater ingress. The water level telemetry is located in the seaward chamber and shows a tidal pattern of rising and falling water levels. This is a key data source to correlate rainfall and tidal states for normal periods and flood events. The seaward chamber is gravity fed to three visible outflow pipes to the sea – these are the Middle Outfall, Short Outfall and Long Outfall. The outfalls which serve the storage tanks are outfalls labelled 1-3 in the Beach Outfall section and are marked accordingly on Figure 2-11.

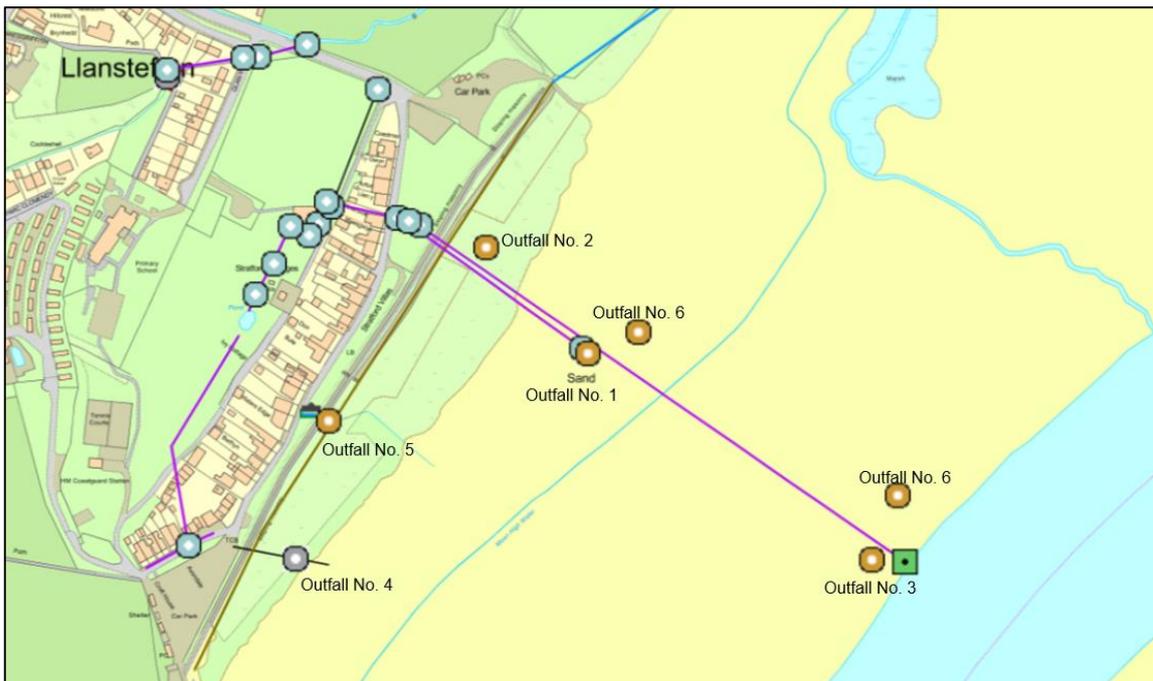
Figure 2-11: Outfall Locations. Contains OS data © Crown Copyright and database right 2020

There are six outfalls on Llansteffan beach, outfalls 1 to 3 serve the underground surface water drainage chambers and a further three outfalls, labelled 4 to 6 drain discrete areas within Llansteffan (see Figure 2-11):

The majority of the outfall invert levels are located within the highly dynamic and influential intertidal zone, below the Mean High Water tide level.

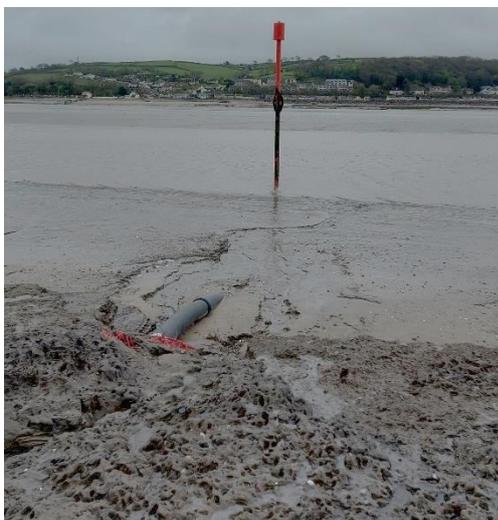
4. Car park drainage outfall

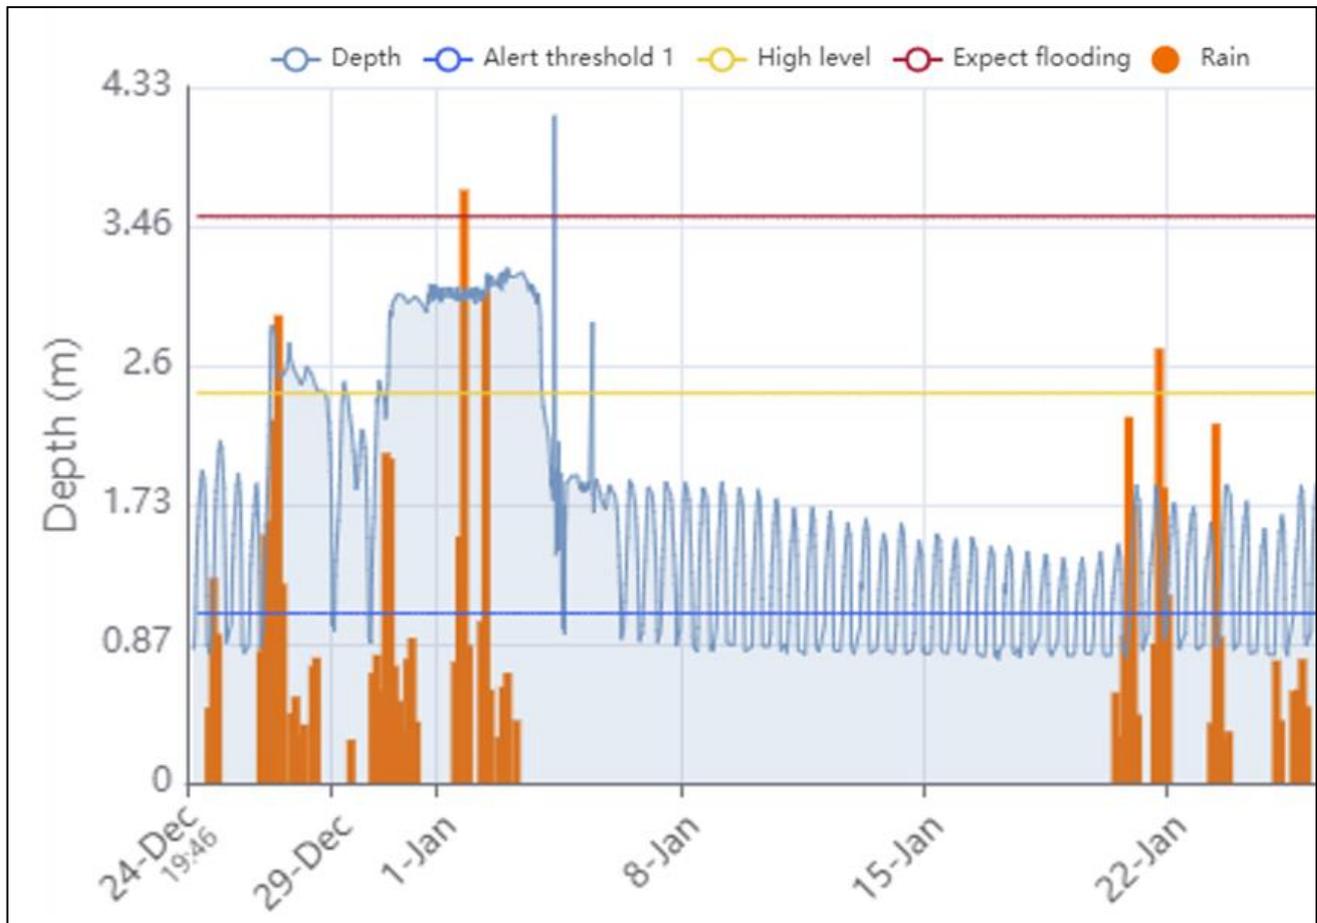
Figure 4-8: Extract from Chamber Telemetry Data Long Term View

Telemetry data is available for the seaward chamber of the surface water drainage system. Over a 10 day period, from the 27 December to 6 of January, the telemetry data in the seaward chamber did not exhibit the longer term pattern of rising and falling water levels in the chamber level associated with the tidal cycle (Figure 4-8 and Figure 4-9). During the period preceding and following the events on 30 December and 2 January the levels in the chamber were on average 1.28 m higher than a period where the longer-term pattern is resumed from 6 to 16 January.

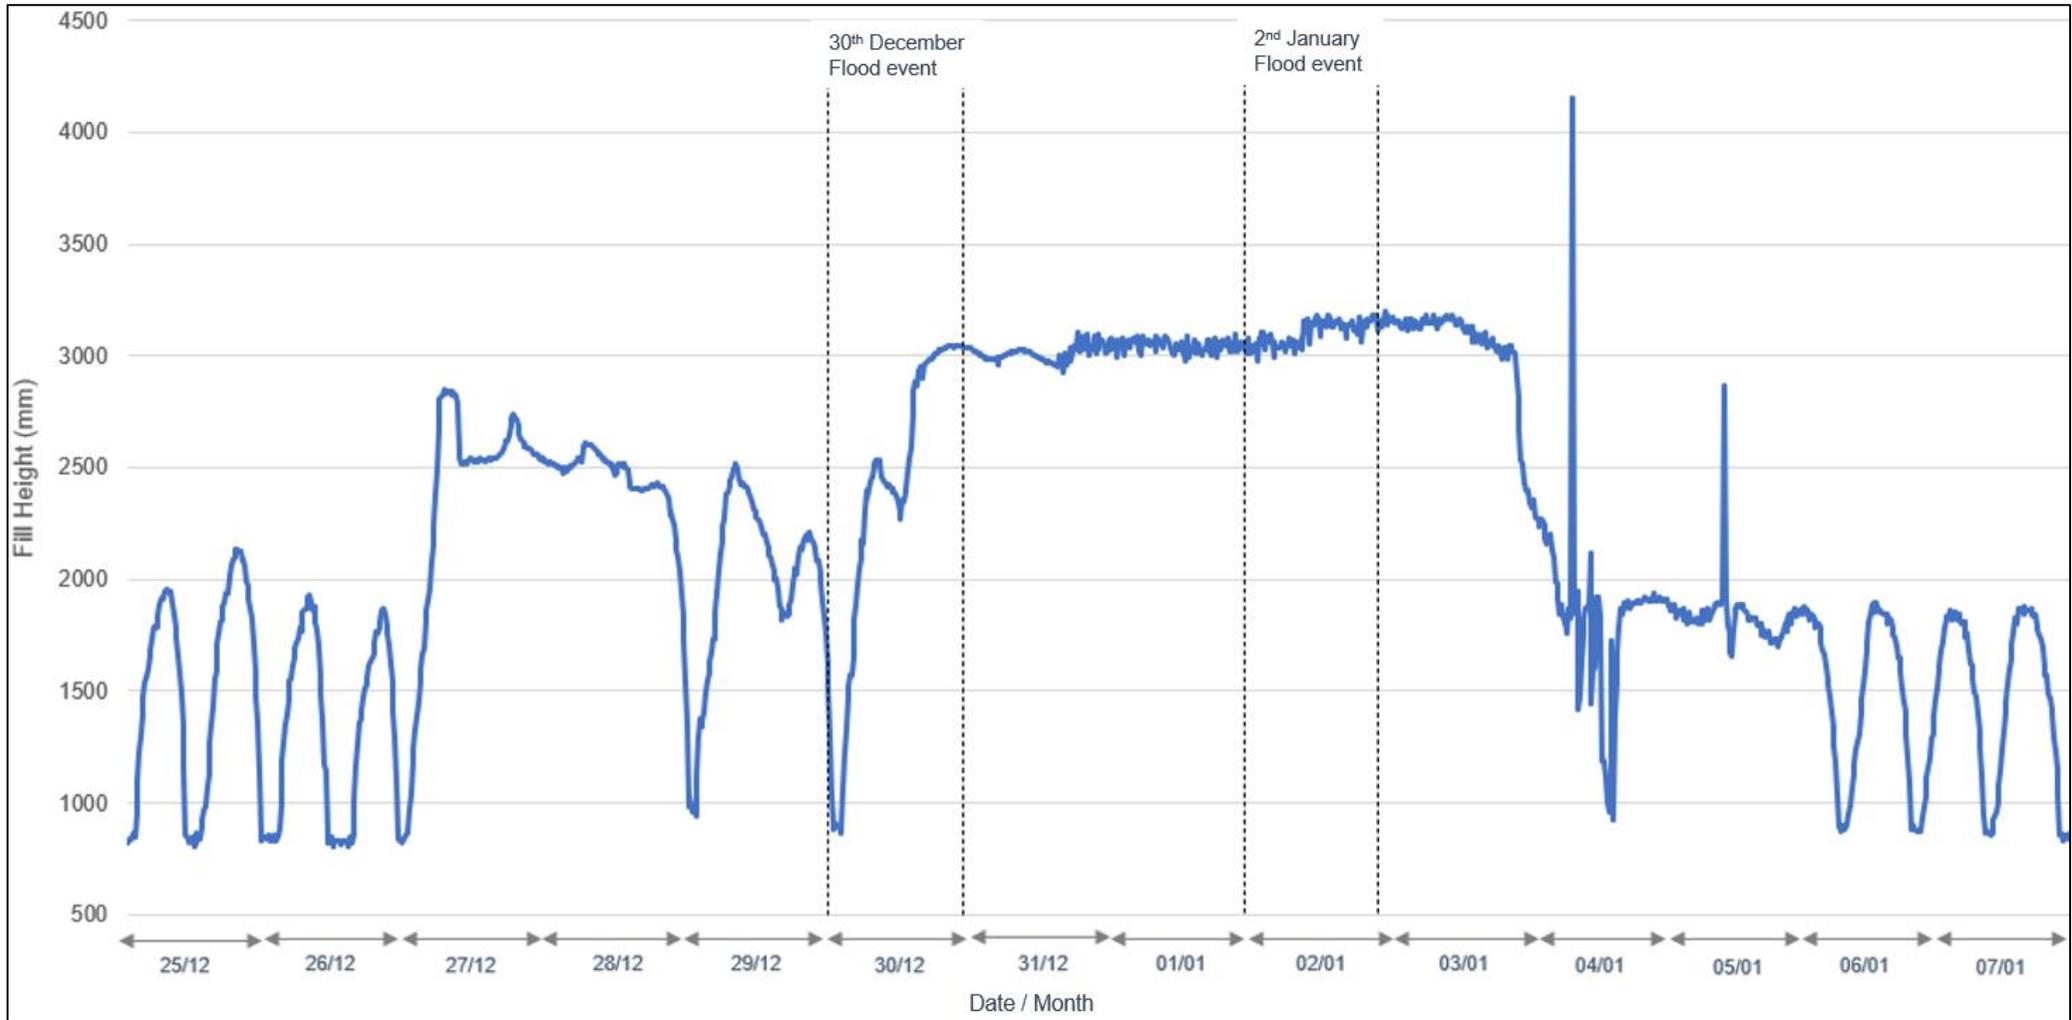
Figure 4-9: Chamber Telemetry Data

The telemetry is recorded in 15-minute intervals. Short term peaks in water depths were recorded in the chamber on 4 January at 09:30 and 5 January at 11:45 for a 15-minute period only and as such this is likely to be due to a temporary fault in the telemetry system.

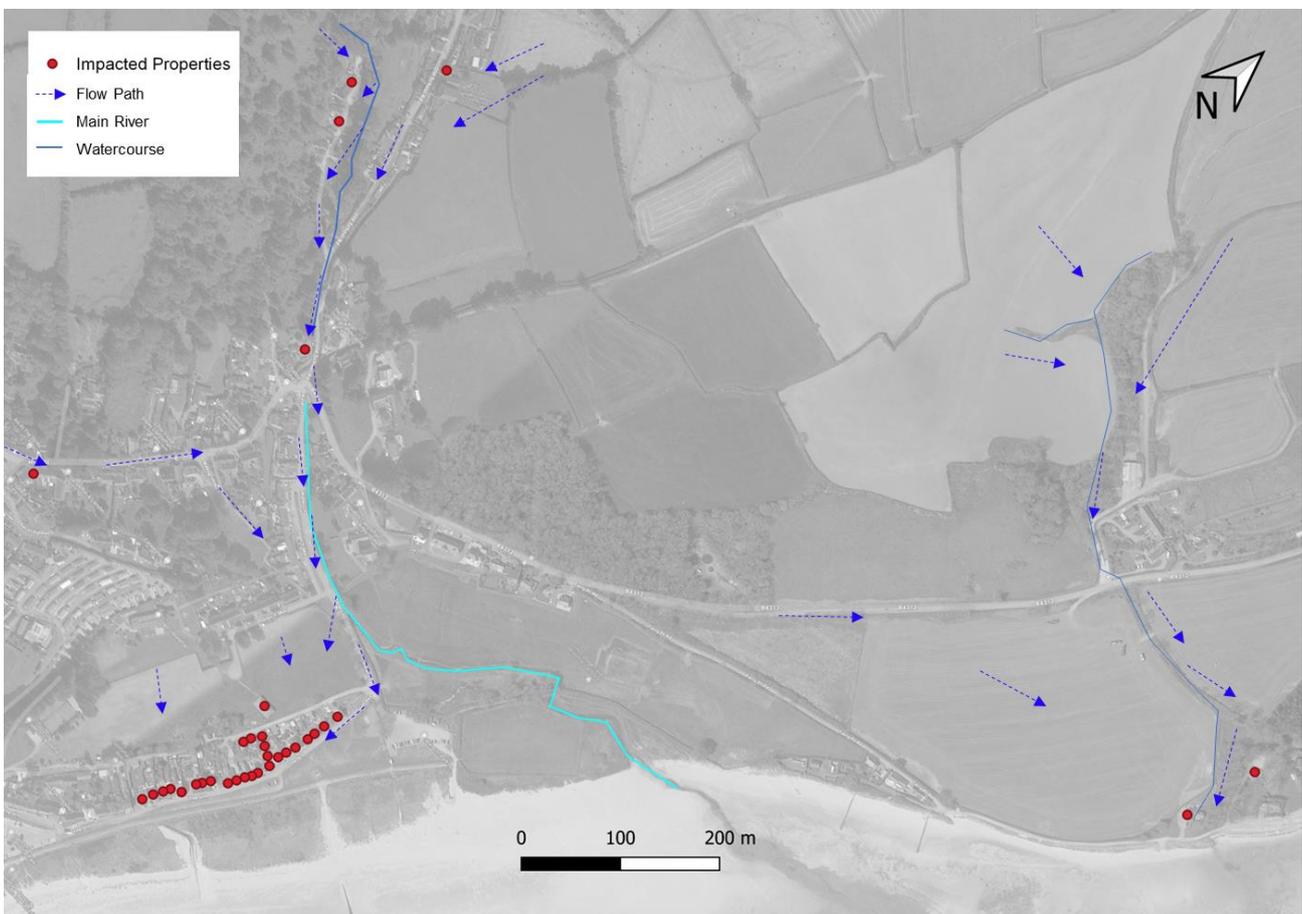
Figure 4-12: Impacted Properties Winter 23/24

The properties which experienced internal flooding as a result of the Winter 23/24 events are shown in the figures below. The area which experienced the highest number of internal property flooding was The Green owing to the topographical location in a natural low-lying area. There is evidence that there was more extensive flooding to gardens, outbuildings, sheds and garages but there is limited available data available to confirm the wider extent of the potential damage. There is also anecdotal evidence that at Ferry Point additional properties could have been flooded internally but were not reported as such to CCC.

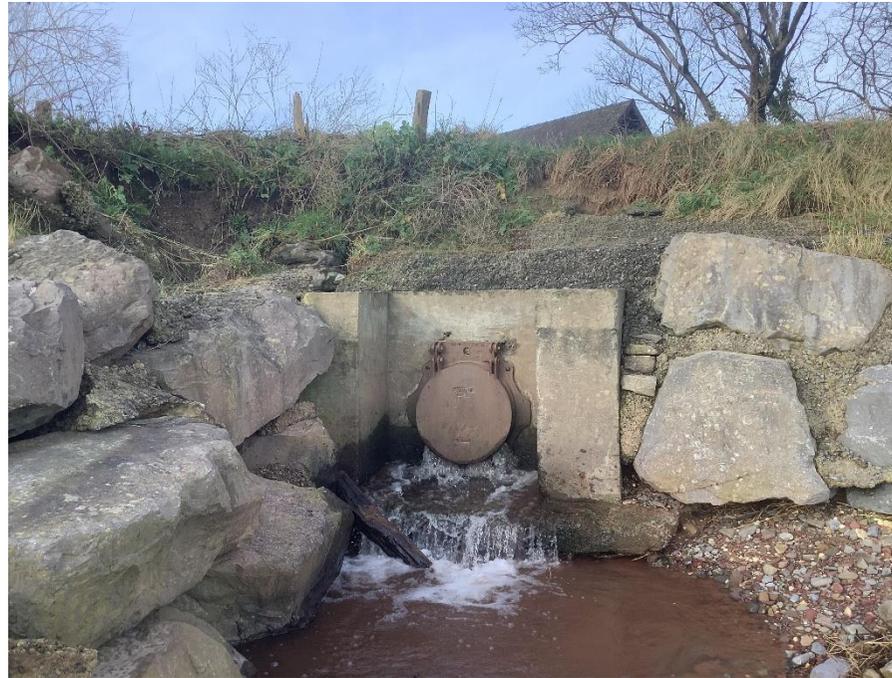
*Figure 16: Outfall at Ferry Point (date unknown)*

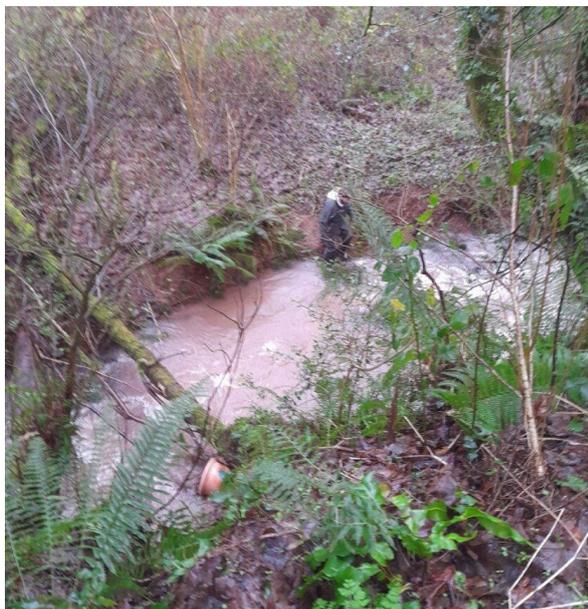
On both 30 December 2023 and 2 January 2024, residents at Glan-Y-Mor noted that water was flowing down Glan-Y-Mor and Water Lane where they run parallel to the Nant Jac during the flooding. This came close to flooding certain properties through their front doors, and residents noted concerns about the air bricks.

*Nant Jac upstream of Mill Pond Lane*

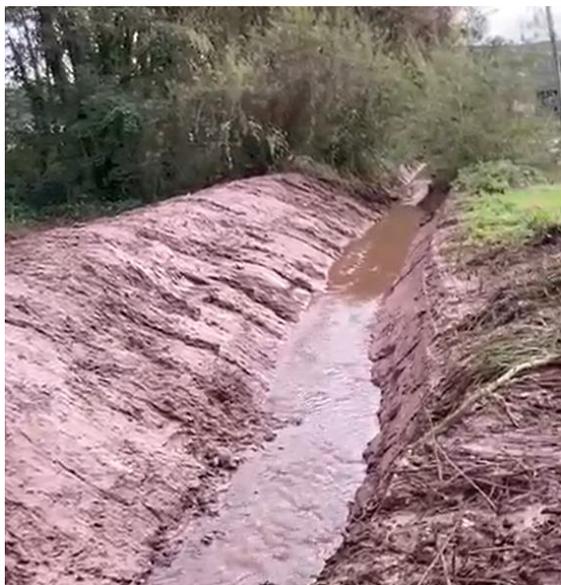
Following the October 2023 event, modifications were made by the landowner to the unnamed watercourse to increase the capacity and clear vegetation. However, due to the saturated ground conditions in conjunction with high intensity and heavily localised rainfall the channel of the watercourse did not have the capacity to convey the flow to the outfall at the beach without overtopping, resulting in flooding to properties in the area. Videos during the event show seepage of flood water through the informal embankment of the unnamed watercourse.

*Recently re-profiled watercourse channel*
