52 St Ishmaels Ward, Ferryside South Policy Unit

52.1 Area Description

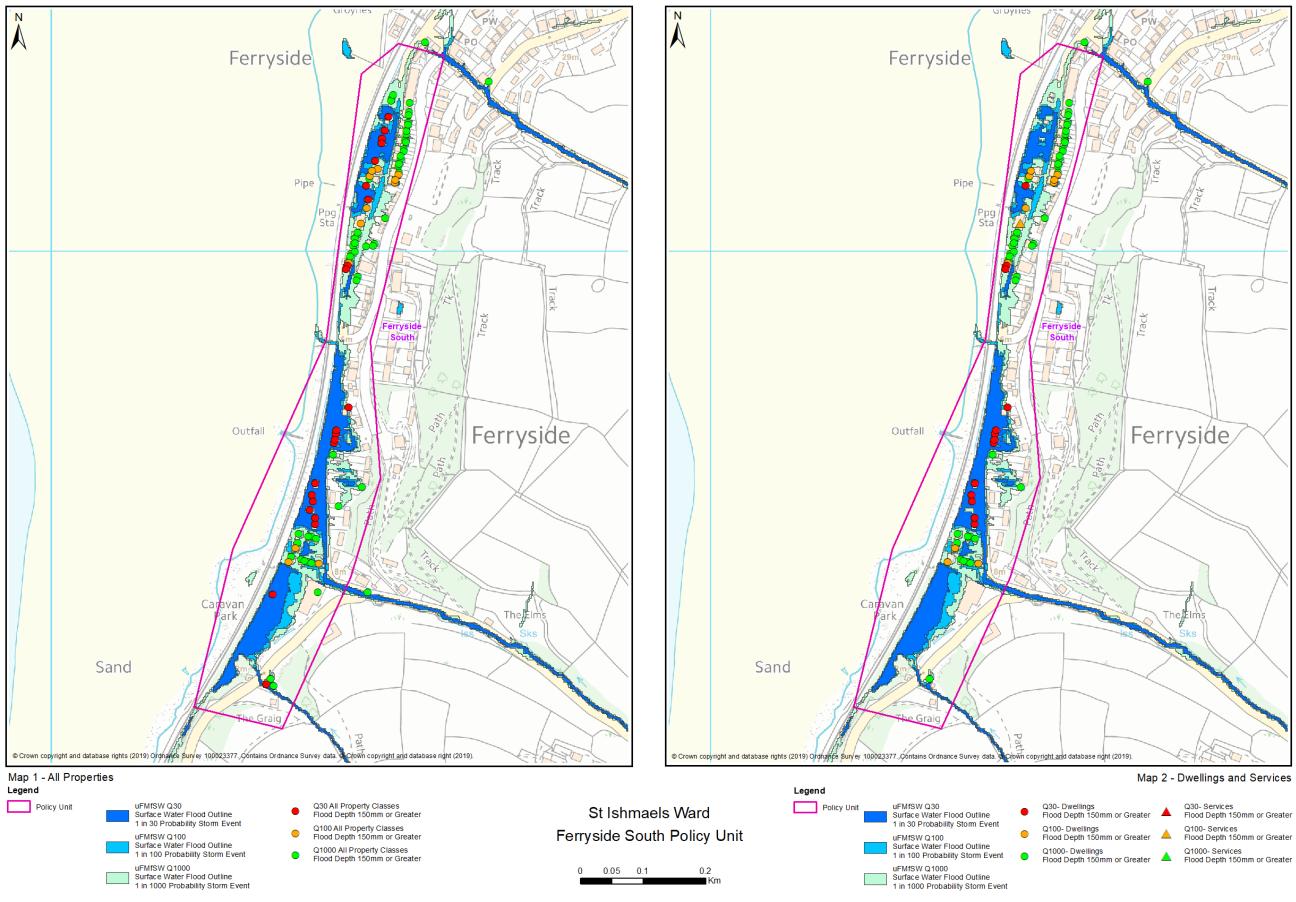
This is the most recent flood mapping from Welsh Government. This dataset depicts all properties at risk of pluvial (surface water) flooding in a storm event with a 1 in 100 probability.

Number of specified units at risk of flooding			
	1 in 30 probability storm event	1 in 100 probability storm event	1 in 1000 probability storm event	
Map 1 Total Properties	23	35	86	
Map 2 Dwellings and Services	14	25	68	
Map 3 CaRR	n/a	13	n/a
