Carmarthenshire County Council Flood Risk Management Plan May 2019

Carmarthenshire County Council Flood Risk Management Plan

Part 2 - Policy Unit Level Summaries

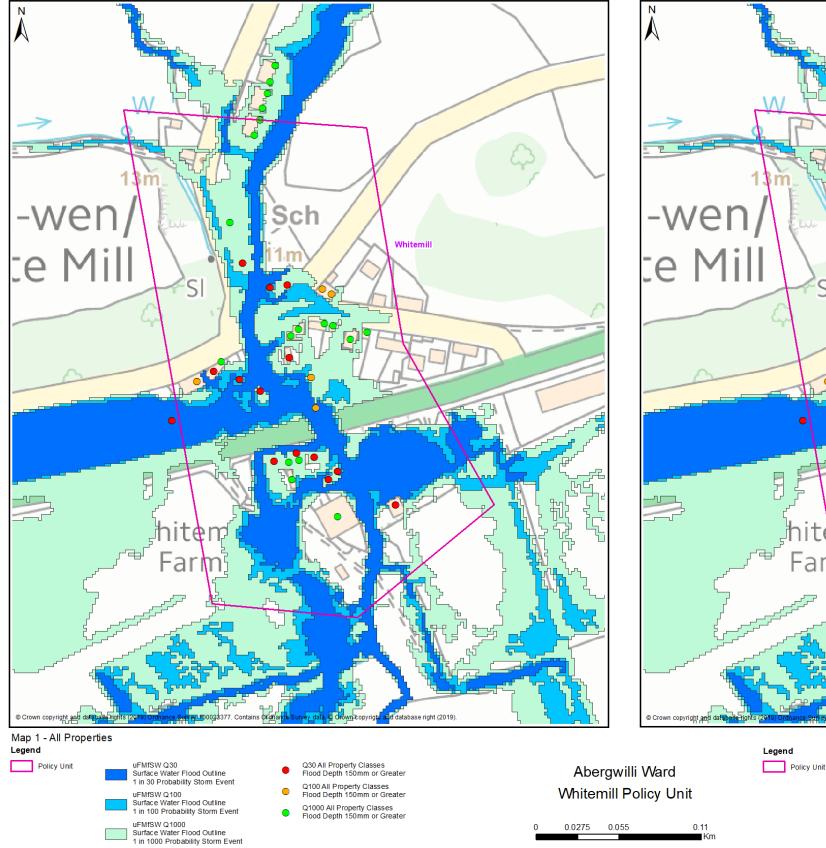
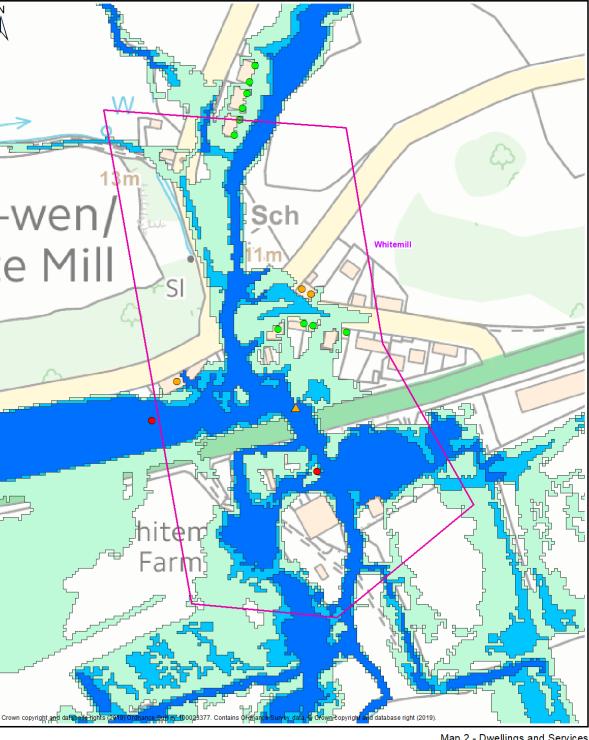
4.8.3 Map 3: Community at Risk Register (CaRR)

Number of specified units at risk of flooding		
	1 in 30 probability storm event	1 in 100 probability storm event	1 in 1000 probability storm event
Map 1 Total Properties	13	18	32
Map 2 Dwellings and Services	1	5	11
Map 3 CaRR	n/a	3	n/a

uFMfSW Q30 Surface Water Flood Outline 1 in 30 Probability Storm Event

uFMfSW Q100 Surface Water Flood Outline 1 in 100 Probability Storm Event

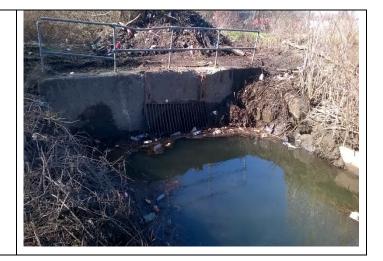
Afon Dafen (Main River) Trash Screen

Area	Works Undertaken	When
Afon Dafen Trash Screen	Formal T98 Inspection	Annually
	Debris management	Weekly in the winter
		Monthly in the summer

Natural Resources Wales are working with Network Rail to develop a scheme to resolve the restriction on flow caused by the existing culverts. This is currently a medium-term project over 5-10-years.

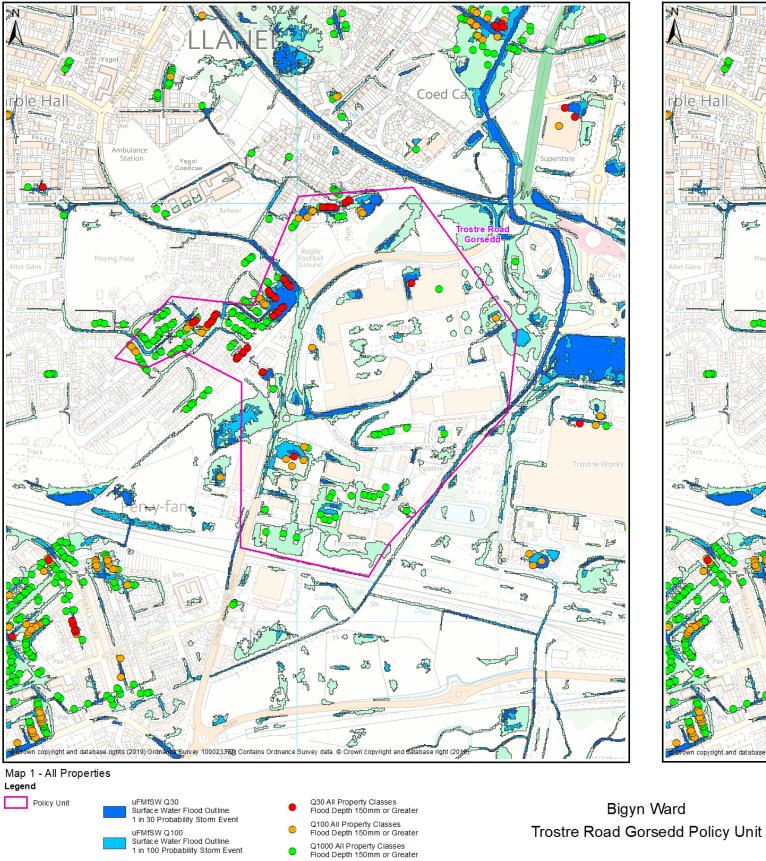
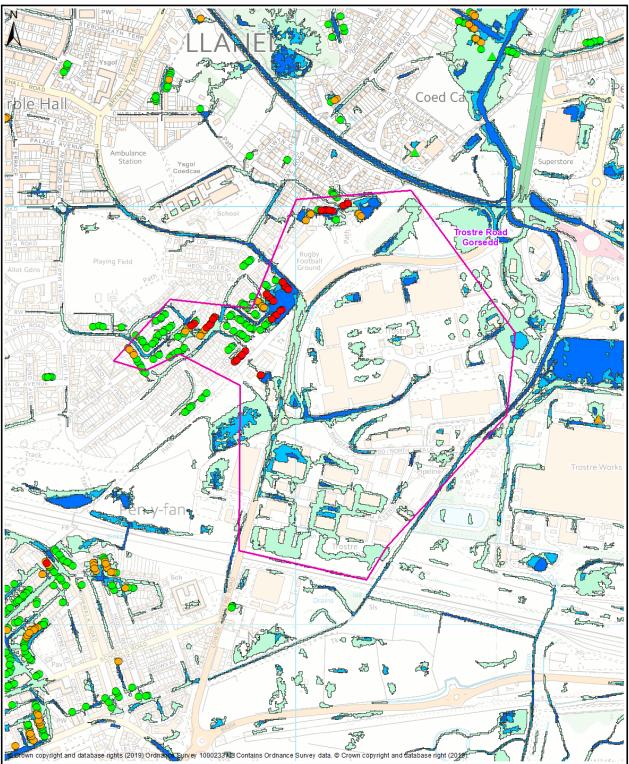
7.9.3 Map 3: Community at Risk Register (CaRR)

Number of specified units at risk of flooding		
	1 in 30 probability storm1 in 100 probability storm1 in 1000 probability stormeventeventevent		1 in 1000 probability storm event
Map 1 Total Properties	37	60	153
Map 2 Dwellings and Services	35	50	111
Map 3 CaRR	n/a	34	n/a

uFMfSW Q30 Surface Water Flood Outline 1 in 30 Probability Storm Event

uFMfSW Q100 Surface Water Flood Outline 1 in 100 Probability Storm Event

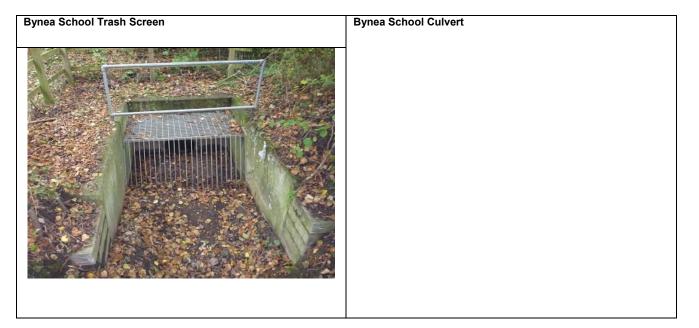
11.5 Flood Defence Assets

Area	Works Undertaken	When
Bynea School Trash Screen	Formal T98 Inspection	Annually
	Debris management	Weekly in the winter
		Monthly in the summer
Bynea School Culvert	CCTV camera survey	2018, 2020
Watercourse rear of Cwmfelin Road	Dredging	5 Year Cycle

- 2010 Bynea Primary School screen upgraded.
- 2011 Watercourse dredged rear of Cwmfelin Road
- 2012 Culvert Relined underneath 35 Cwmfelin Road

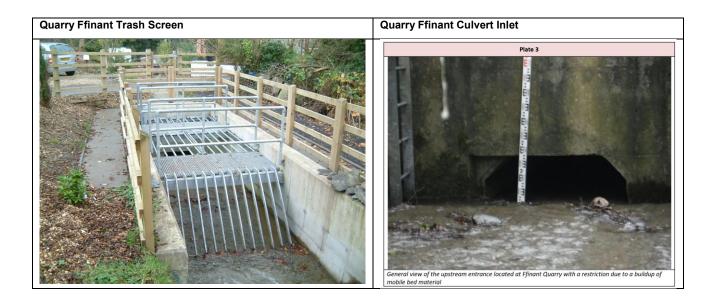
14.5 Flood Defence Assets

Area	Works Undertaken	When
Quarry Ffinant Trash Screen	Formal T98 Inspection	Annually
	Debris management	Weekly in the winter
		Monthly in the summer
Quarry Ffinant Culvert	CCTV camera survey	2018

The current inlet trash screen at Quarry Ffinant was constructed in 2005.

Funding for the renewal of the culvert between Quarry Ffinant and Ebenezer Street has been sought from Welsh Government. Initial investigations have highlighted that the culvert is at risk of failure.

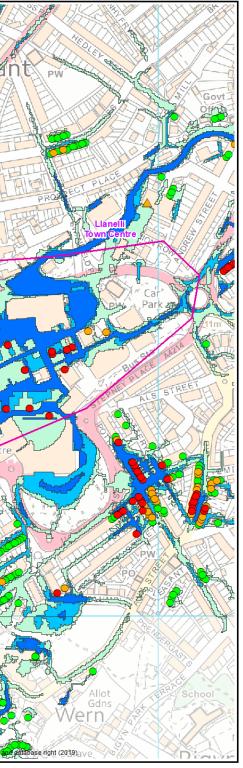
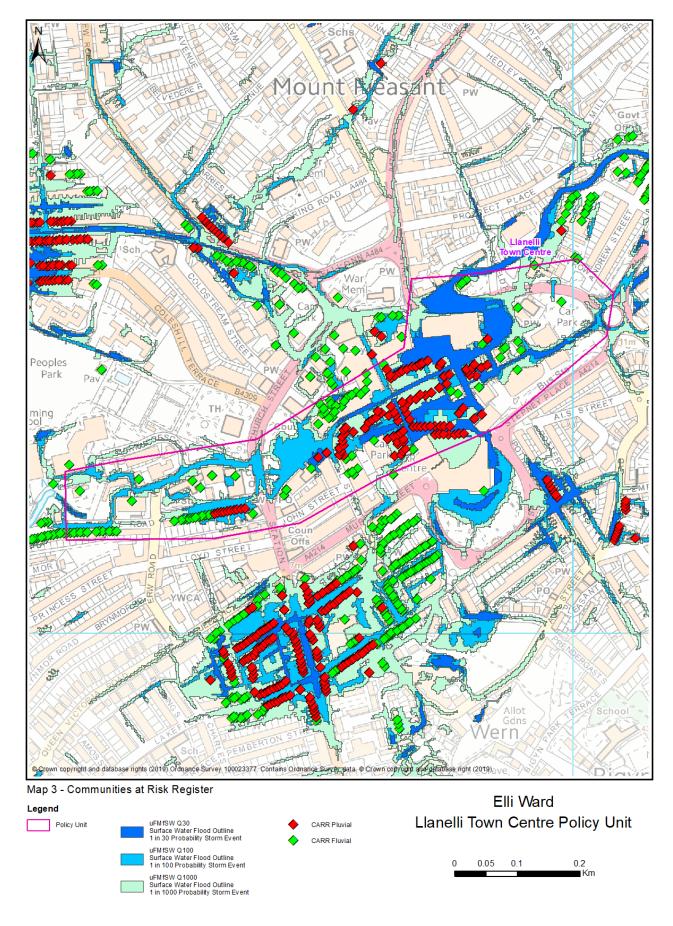
Map 2 - Dwellings and Services

Q100- Dwellings Flood Depth 150mm or Greater

Q30- Services Flood Depth 150mm or Greater Q100- Services Flood Depth 150mm or Greater

Q1000- Dwellings Flood Depth 150mm or Greater

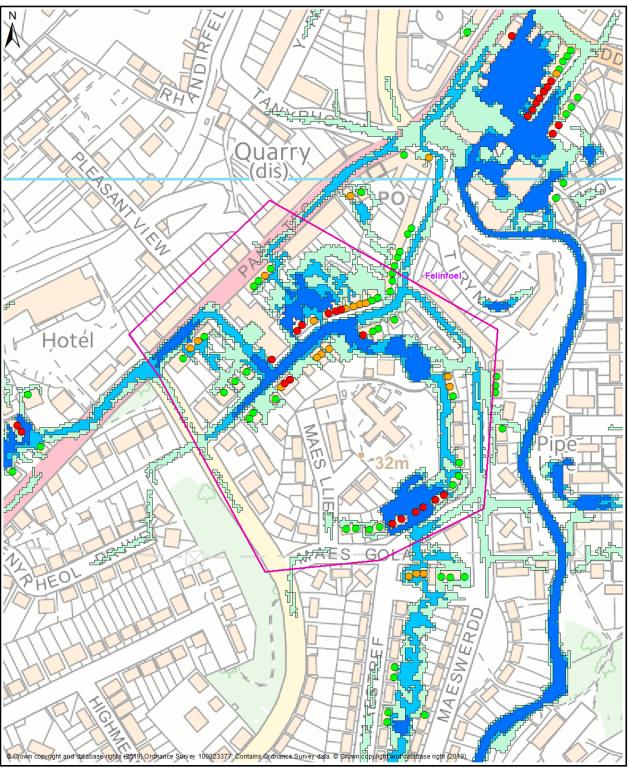
uFMfSW Q30 Surface Water Flood Outline 1 in 30 Probability Storm Event

uFMfSW Q100 Surface Water Flood Outline 1 in 100 Probability Storm Event

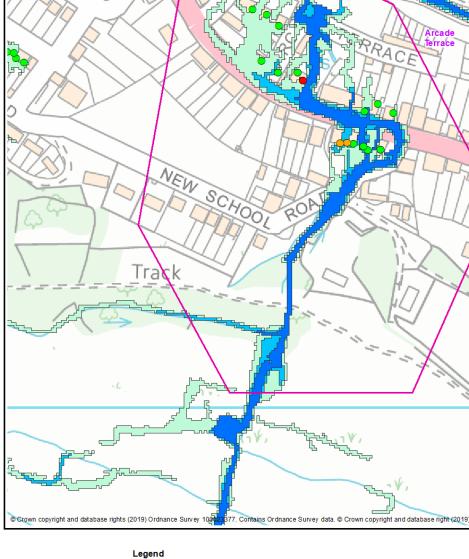
uFMfSW Q30 Surface Water Flood Outline 1 in 30 Probability Storm Event

uFMfSW Q1000 Surface Water Flood Outline 1 in 1000 Probability Storm Event

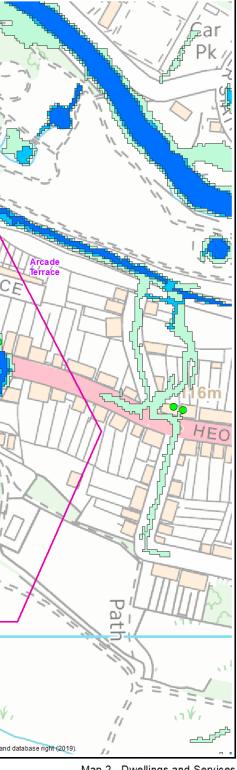
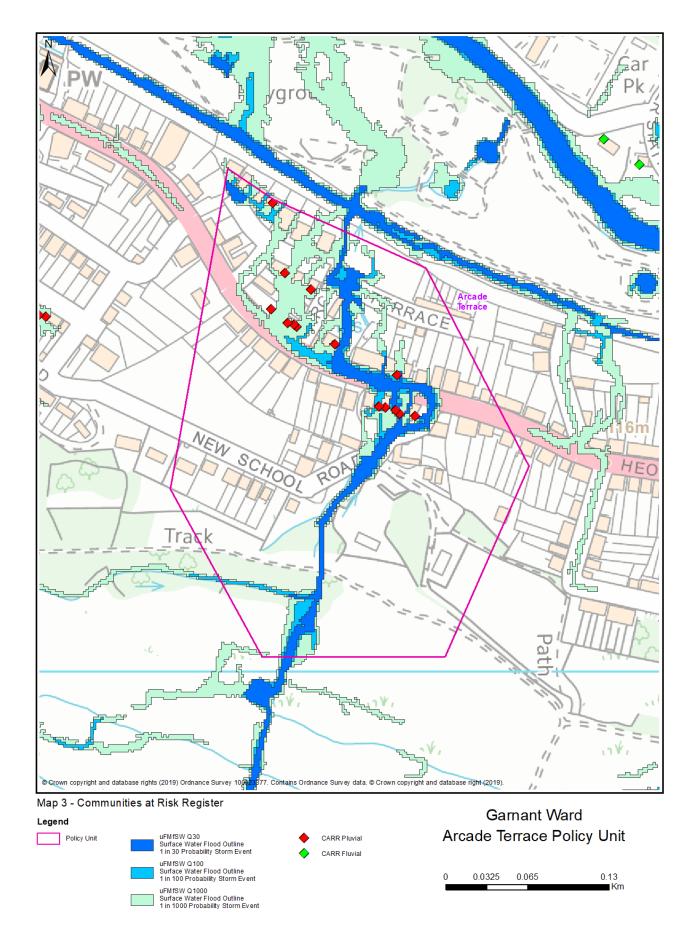
Map 2 - Dwellings and Services

- Q30- Dwellings Flood Depth 150mm or Greater Q100- Dwellings Flood Depth 150mm or Greater
- Q1000- Dwellings Flood Depth 150mm or Greater

Q30- Services Flood Depth 150mm or Greater Q100- Services Flood Depth 150mm or Greater Q1000- Services Flood Depth 150mm or Greater

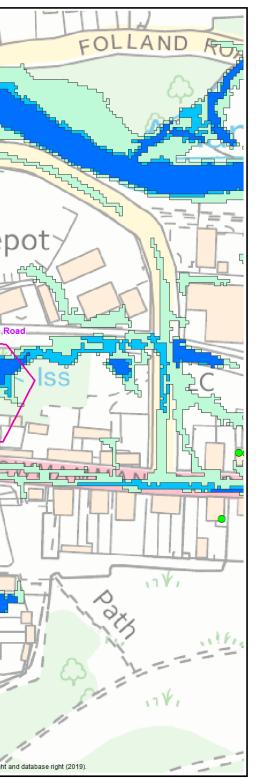
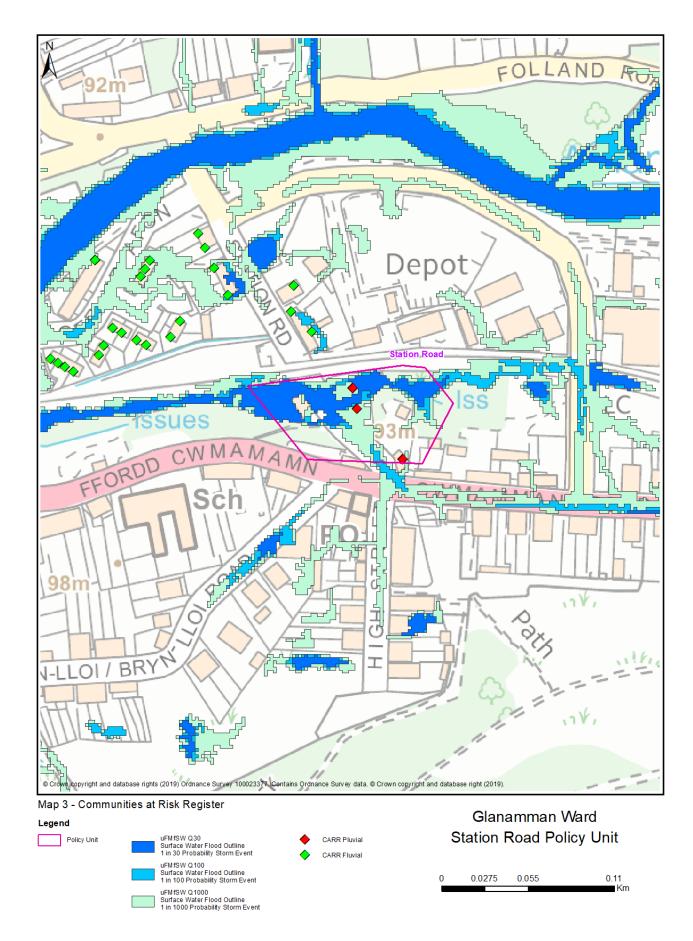
Map 2 - Dwellings and Services

Q30- Dwellings Flood Depth 150mm or Greater Q100- Dwellings Flood Depth 150mm or Greater

- Q30- Services Flood Depth 150mm or Greater Q100- Services Flood Depth 150mm or Greater Q1000- Dwellings Flood Depth 150mm or Greater A Flood Depth 150mm or Greater

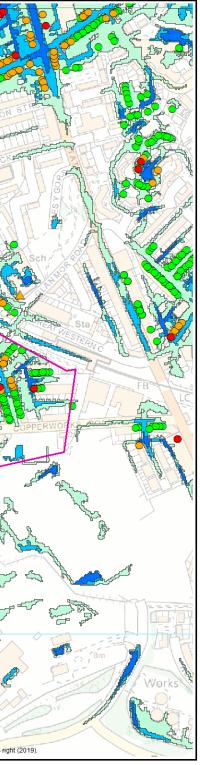
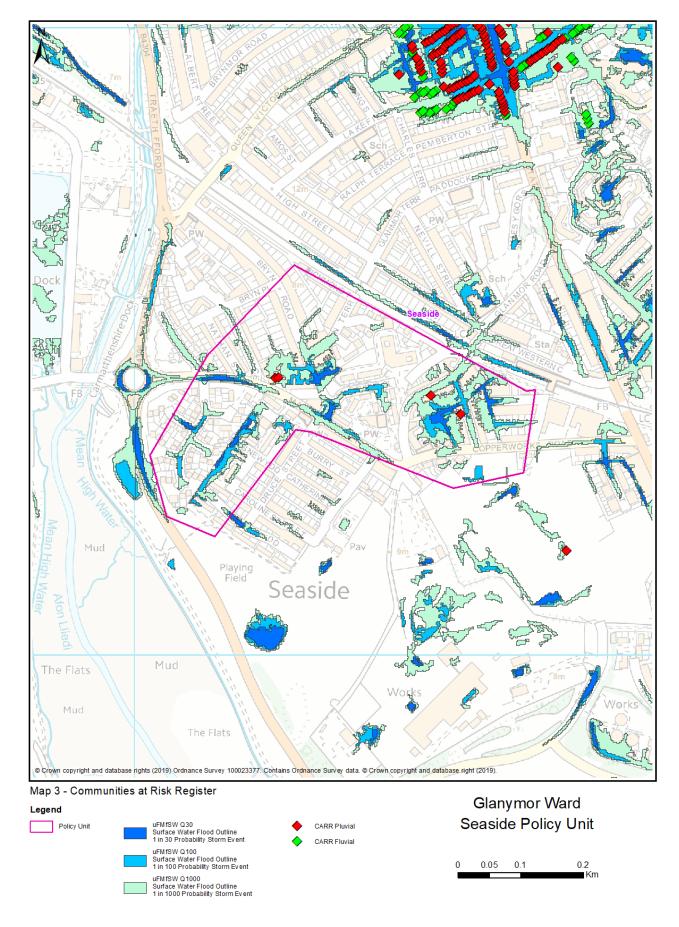
Map 2 - Dwellings and Services

Q30- Dwellings Flood Depth 150mm or Greater Q100- Dwellings Flood Depth 150mm or Greater

Q1000- Dwellings Flood Depth 150mm or Greater

Q30- Services Flood Depth 150mm or Greater Q100- Services Flood Depth 150mm or Greater Q1000- Services Flood Depth 150mm or Greater

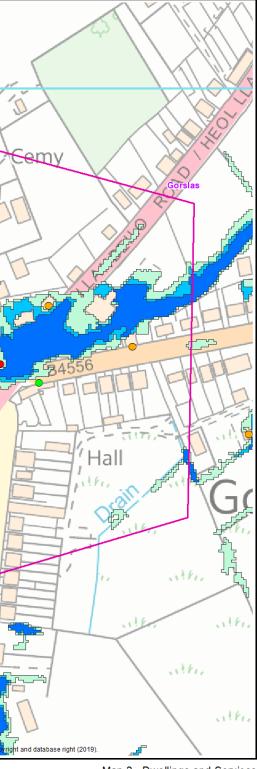
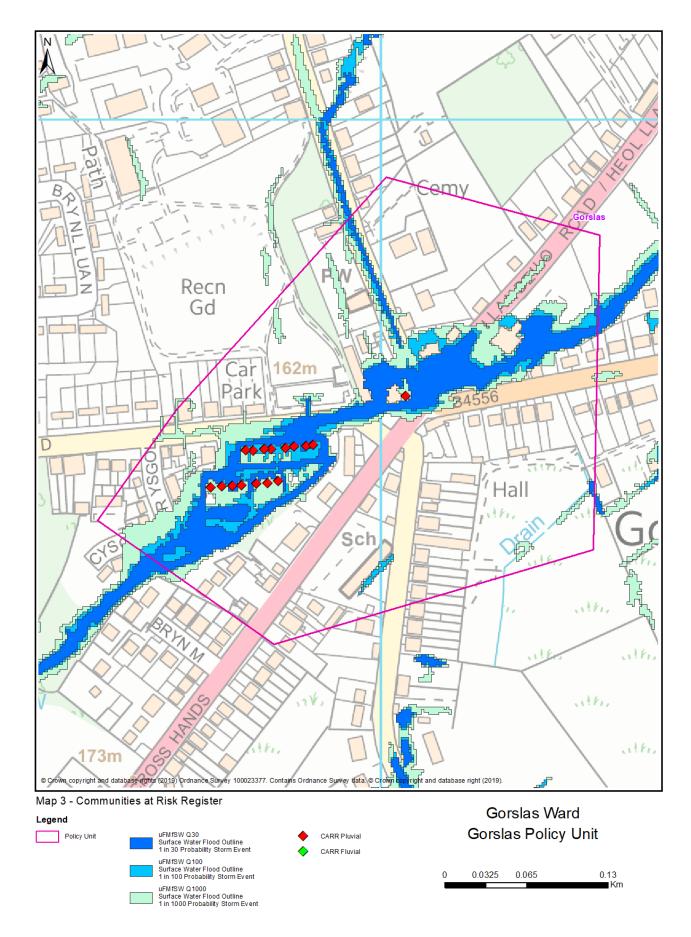
Map 2 - Dwellings and Services

Q30- Services Flood Depth 150mm or Greater Q100- Services Flood Depth 150mm or Greater Q1000- Services Flood Depth 150mm or Greater

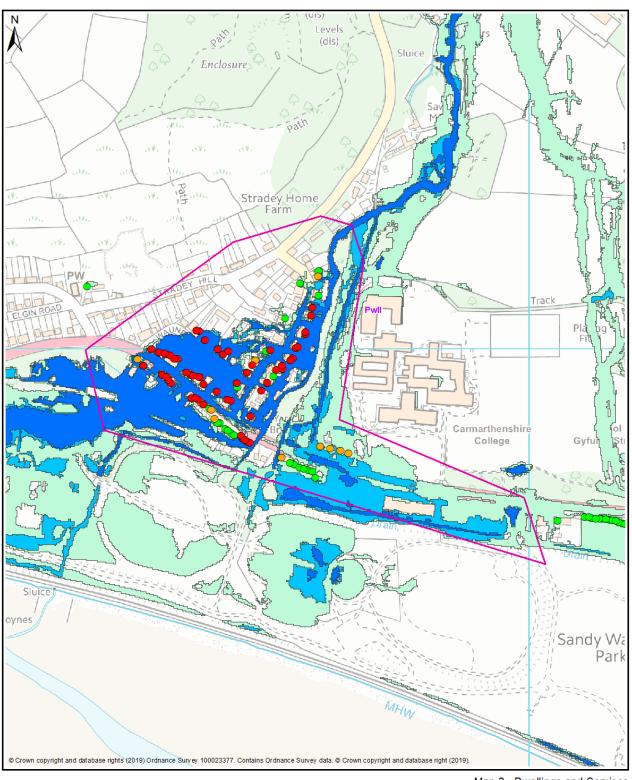
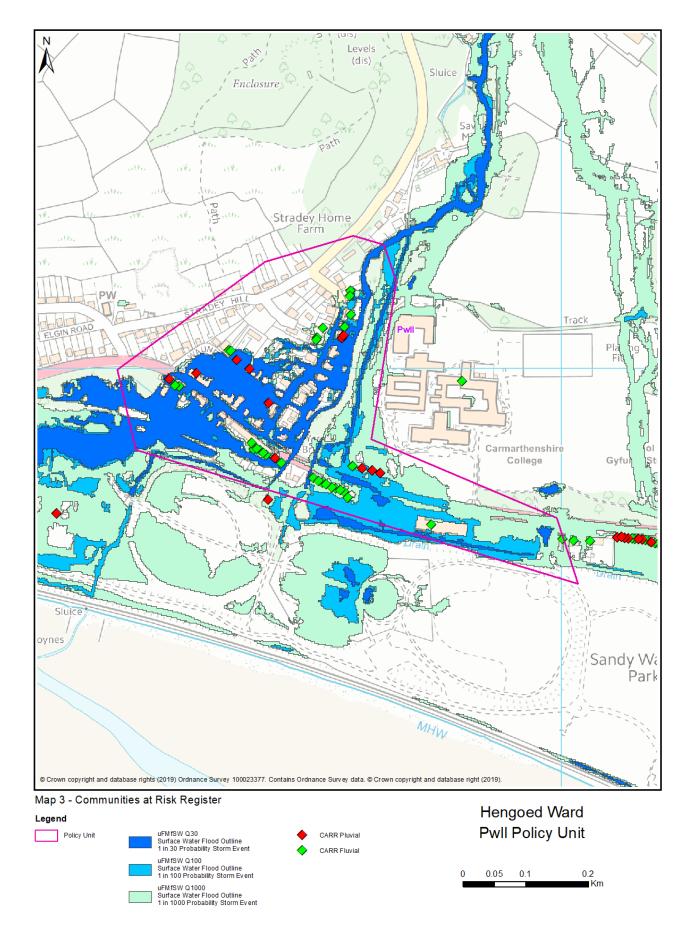
Map 2 - Dwellings and Services

Q30- Dwellings Flood Depth 150mm or Greater Q100- Dwellings Flood Depth 150mm or Greater

Q30- Services Flood Depth 150mm or Greater Q100- Services Flood Depth 150mm or Greater Q1000- Services Flood Depth 150mm or Greater

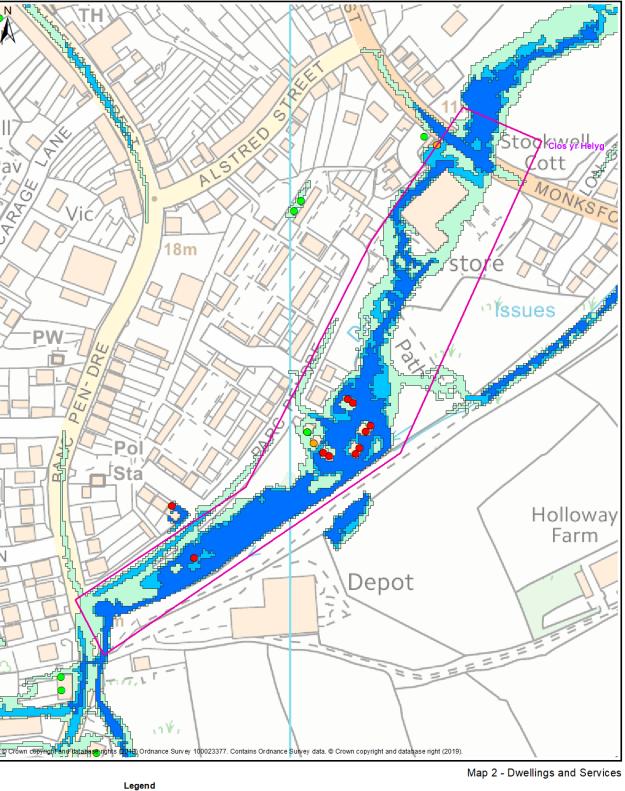
uFMfSW Q30 Surface Water Flood Outline 1 in 30 Probability Storm Event

uFMfSW Q100 Surface Water Flood Outline 1 in 100 Probability Storm Event

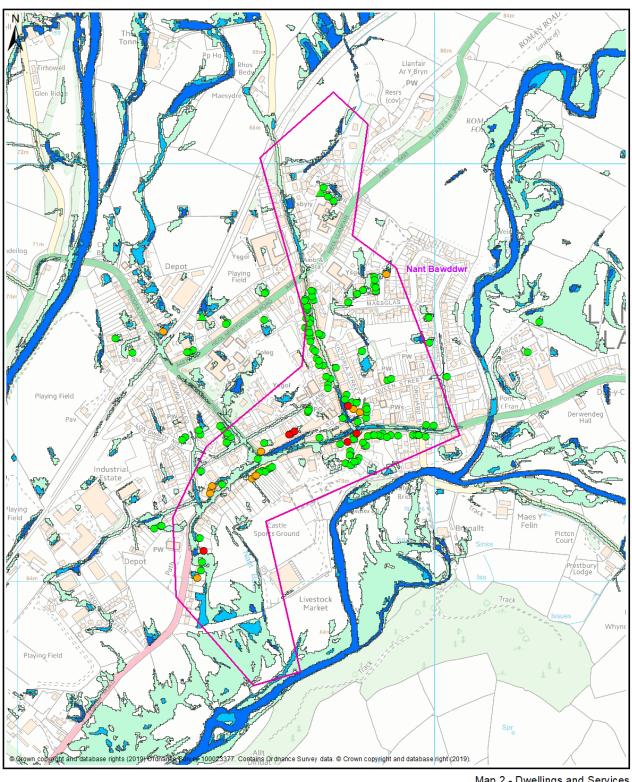
uFMfSW Q30 Surface Water Flood Outline 1 in 30 Probability Storm Event

uFMfSW Q100 Surface Water Flood Outline 1 in 100 Probability Storm Event

uFMfSW Q1000 Surface Water Flood Outline 1 in 1000 Probability Storm Event

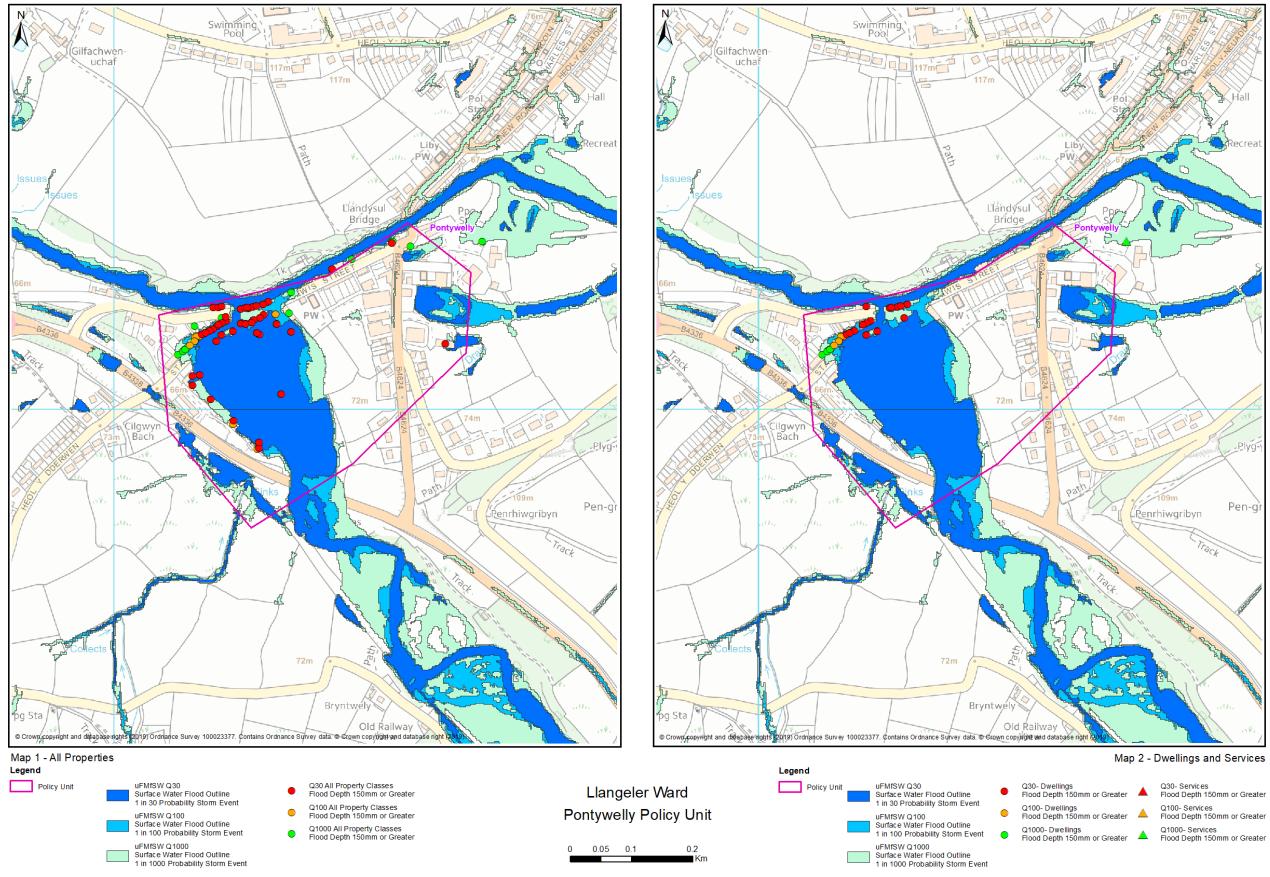
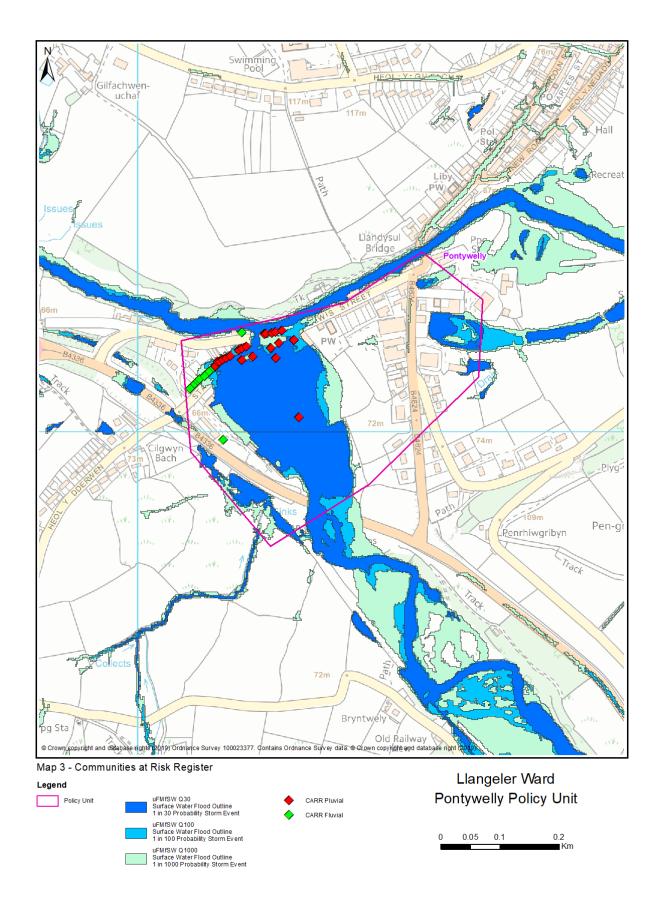
35.8.3 Map 3: Community at Risk Register (CaRR)

Number of specified units at risk of flooding		
	1 in 30 probability storm event	1 in 100 probability storm event	1 in 1000 probability storm event
Map 1 Total Properties	44	60	71
Map 2 Dwellings and Services	16	25	29
Map 3 CaRR	n/a	30 Pluvial 19 Fluvial	n/a

Although CaRR maps indicate 30 properties are at risk of pluvial flooding it is difficult to differentiate these from those affected by the Main River.

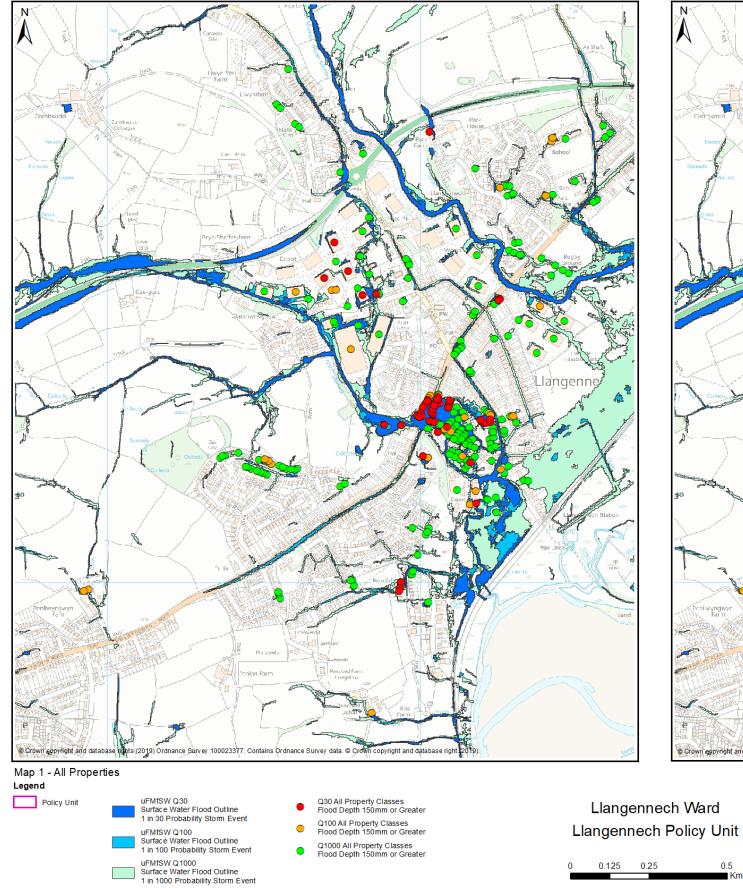
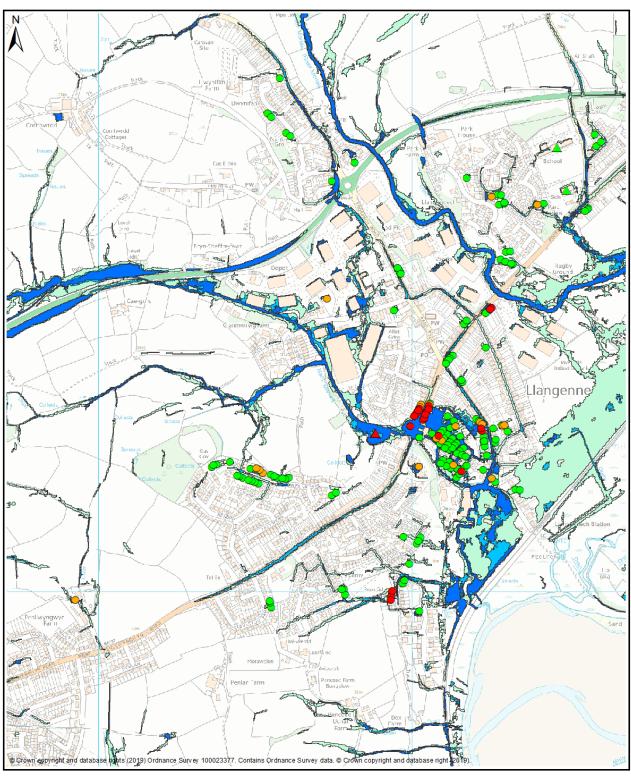
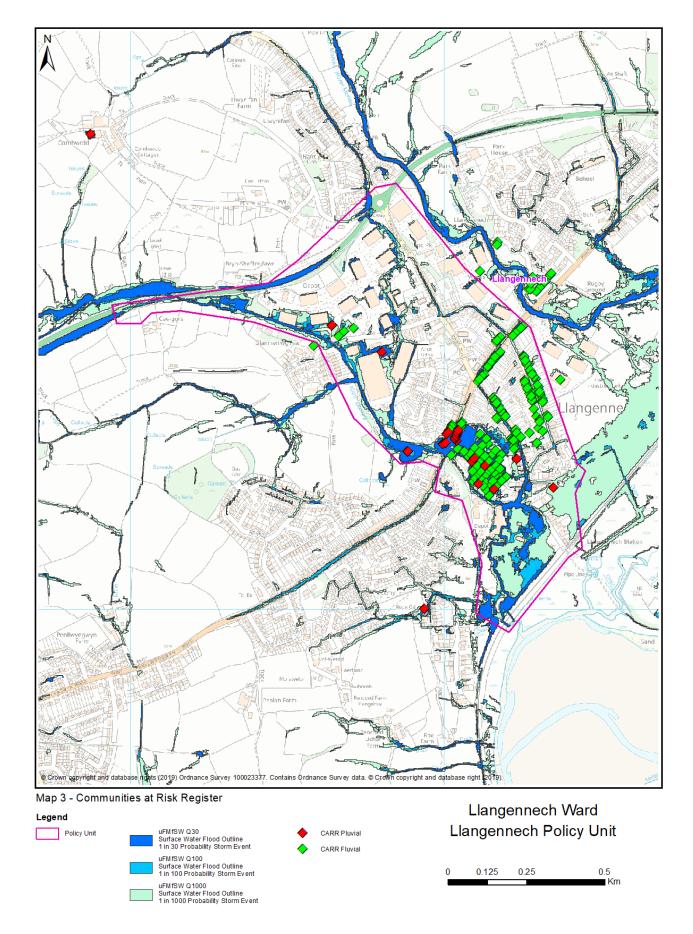
Map 2 - Dwellings and Services

Number of specified units at risk of flooding		
	1 in 30 probability storm event	1 in 100 probability storm event	1 in 1000 probability storm event
Map 1 Total Properties	48	100	201
Map 2 Dwellings and Services	23	70	142
Map 3 CaRR	n/a	23 Pluvial 183 Fluvial 60 Tidal	n/a

Q30- Services Flood Depth 150mm or Greater Q100- Services Flood Depth 150mm or Greater Q1000- Dwellings Flood Depth 150mm or Greater A Flood Depth 150mm or Greater

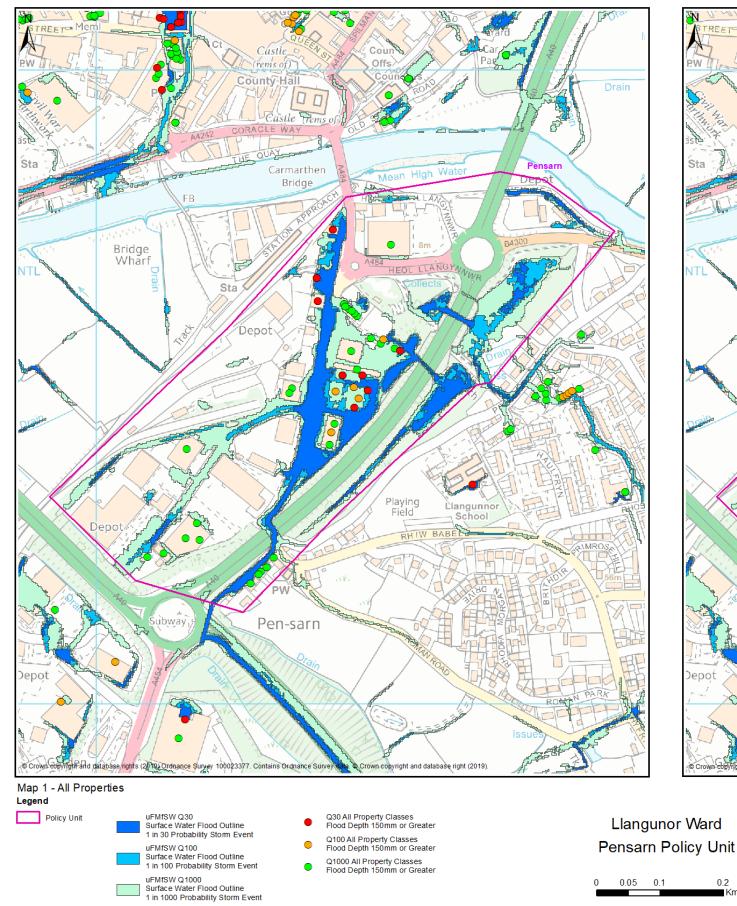
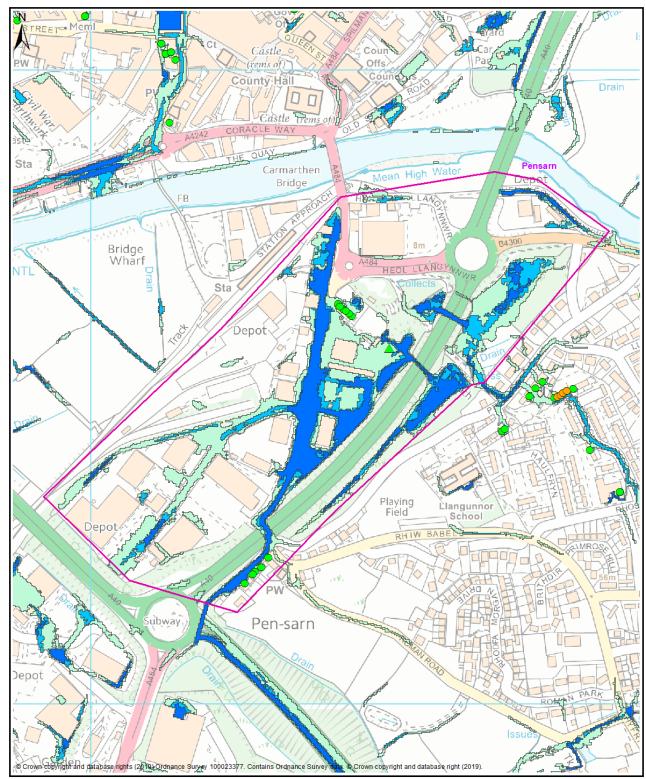
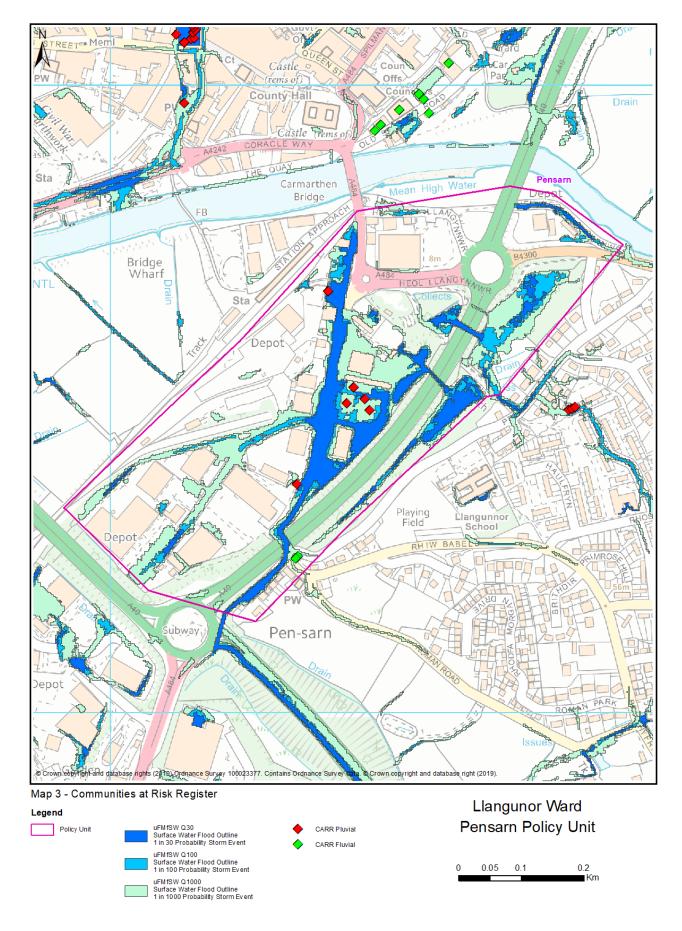
37.8.3 Map 3: Community at Risk Register (CaRR)

Number of specified units at risk of flooding			
	1 in 30 probability storm event	1 in 100 probability storm event	1 in 1000 probability storm event	
Map 1 Total Properties	10	15	42	
Map 2 Dwellings and Services	0	0	12	
Map 3 CaRR	n/a	8 Pluvial 2 Fluvial	n/a

Q30- Dwellings Flood Depth 150mm or Greater	
Q100- Dwellings Flood Depth 150mm or Greater	
Q1000- Dwellings Flood Depth 150mm or Greater	(

Q30- Services Flood Depth 150mm or Greater Q100- Services Flood Depth 150mm or Greater Q1000- Services Flood Depth 150mm or Greater

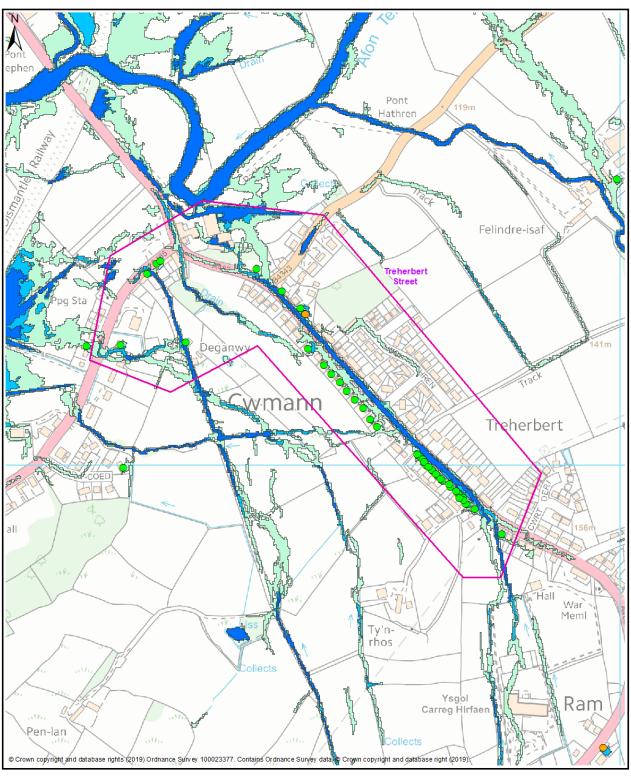
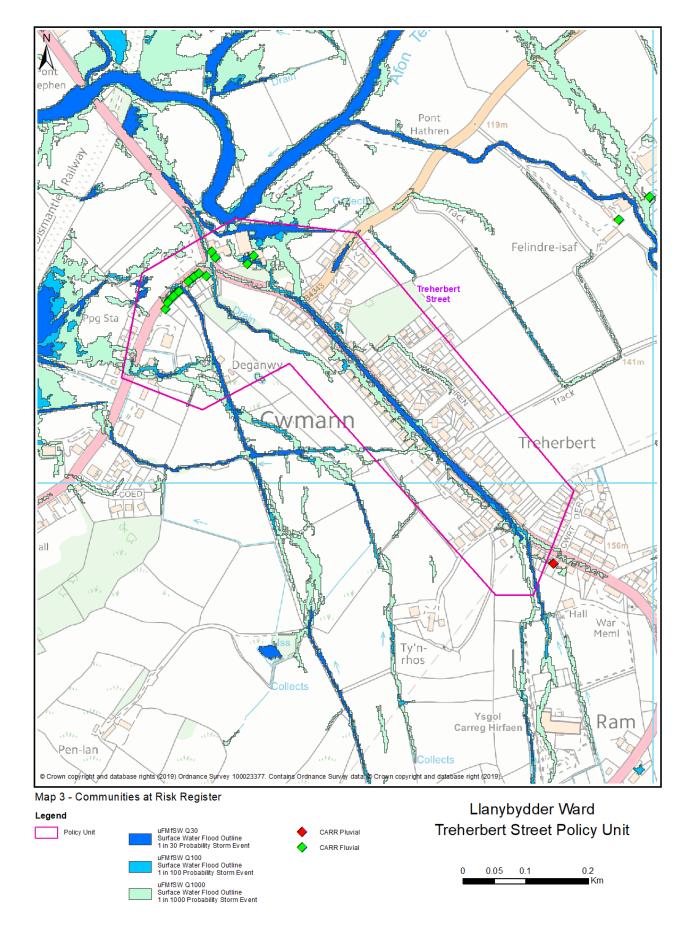
uFMfSW Q30 Surface Water Flood Outline 1 in 30 Probability Storm Event

uFMfSW Q100 Surface Water Flood Outline 1 in 100 Probability Storm Event

Q1000- Dwellings
 Flood Depth 150mm or Greater

Q30- Services Flood Depth 150mm or Greater Q100- Services Flood Depth 150mm or Greater Q1000- Services Flood Depth 150mm or Greater

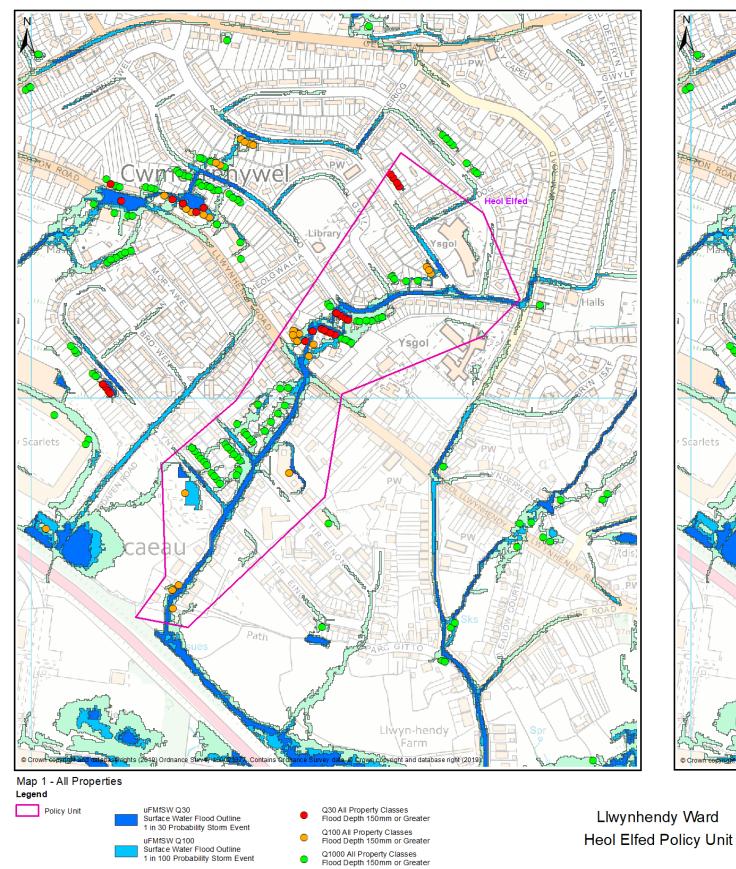
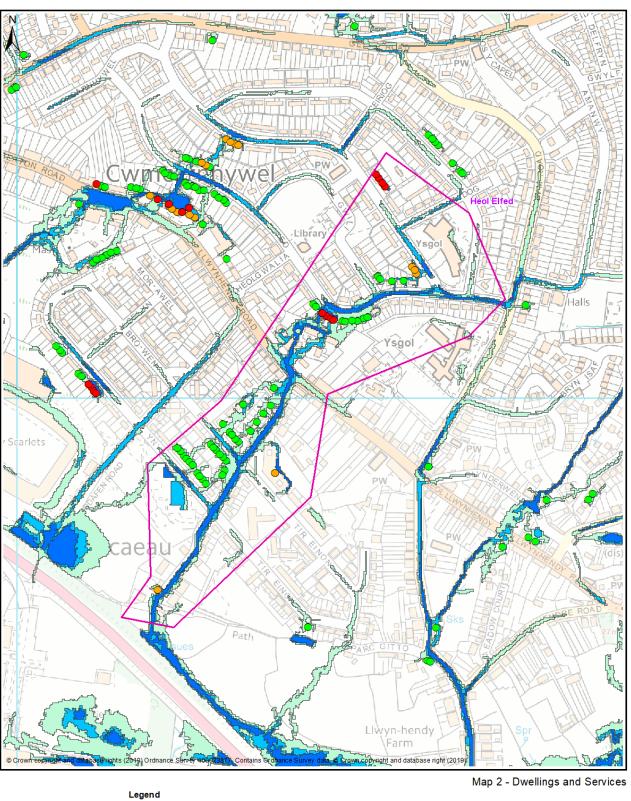
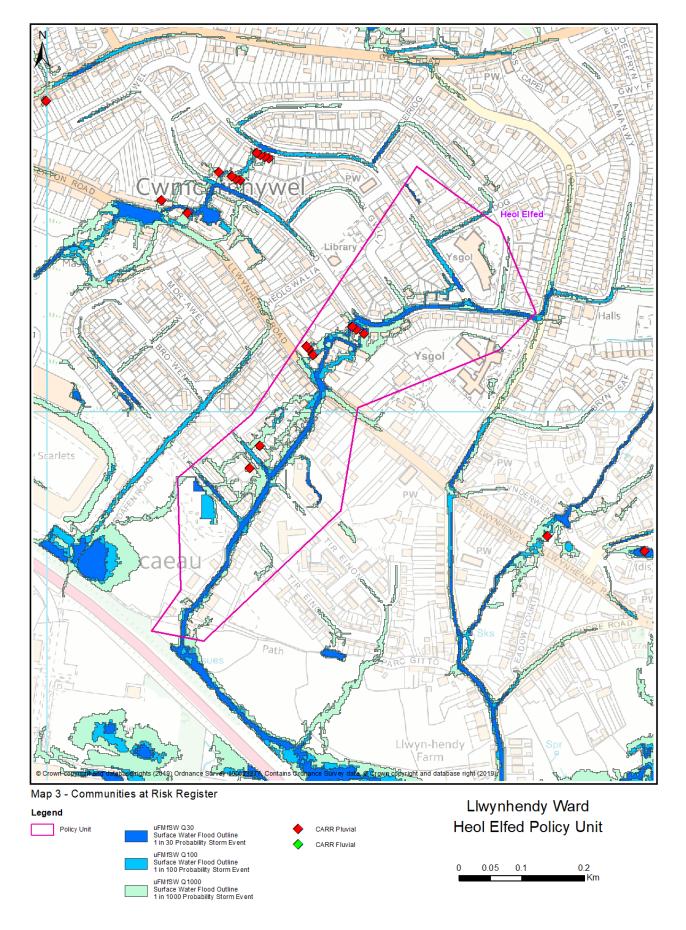
45.8.3 Map 3: Community at Risk Register (CaRR)

Number of specified units at risk of flooding		
	1 in 30 probability storm1 in 100 probability storm1 in 1000 probability stormeventeventevent		
Map 1 Total Properties	15	58	104
Map 2 Dwellings and Services	8	41	82
Map 3 CaRR	n/a	9	n/a

uFMfSW Q1000 Surface Water Flood Outline 1 in 1000 Probability Storm Event

- Q30- Dwellings Flood Depth 150mm or Greater Q100- Dwellings Flood Depth 150mm or Greater
- Q1000- Dwellings Flood Depth 150mm or Greater

Q30- Services Flood Depth 150mm or Greater Q100- Services Flood Depth 150mm or Greater Q1000- Services Flood Depth 150mm or Greater

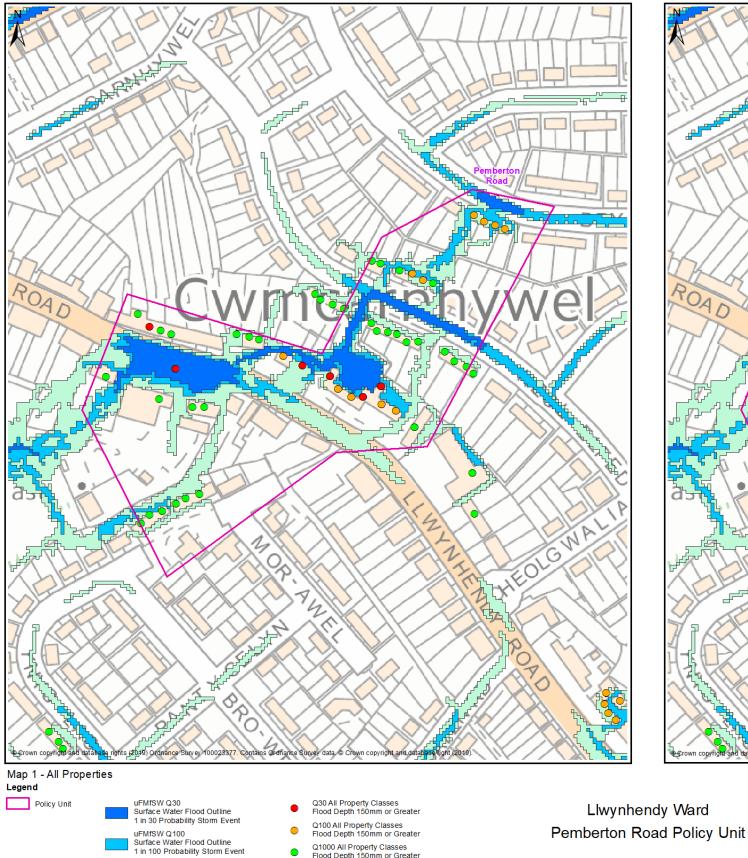
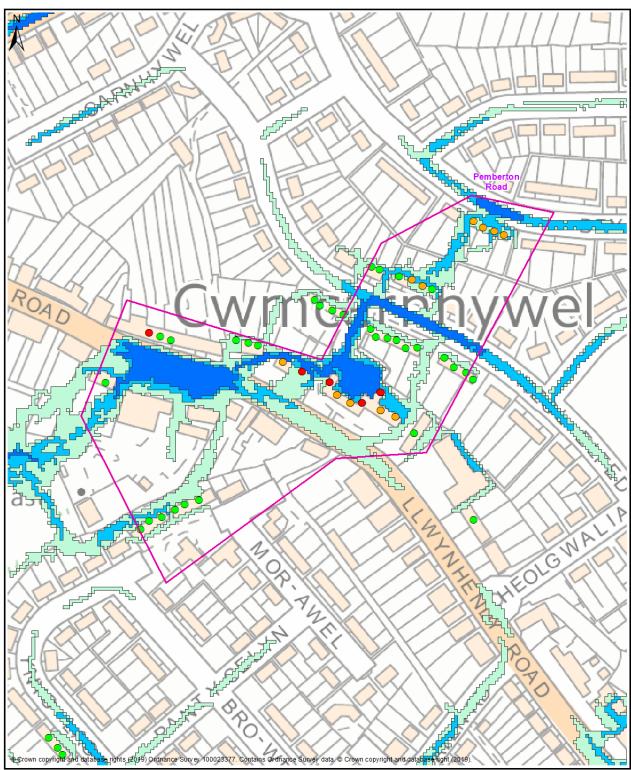
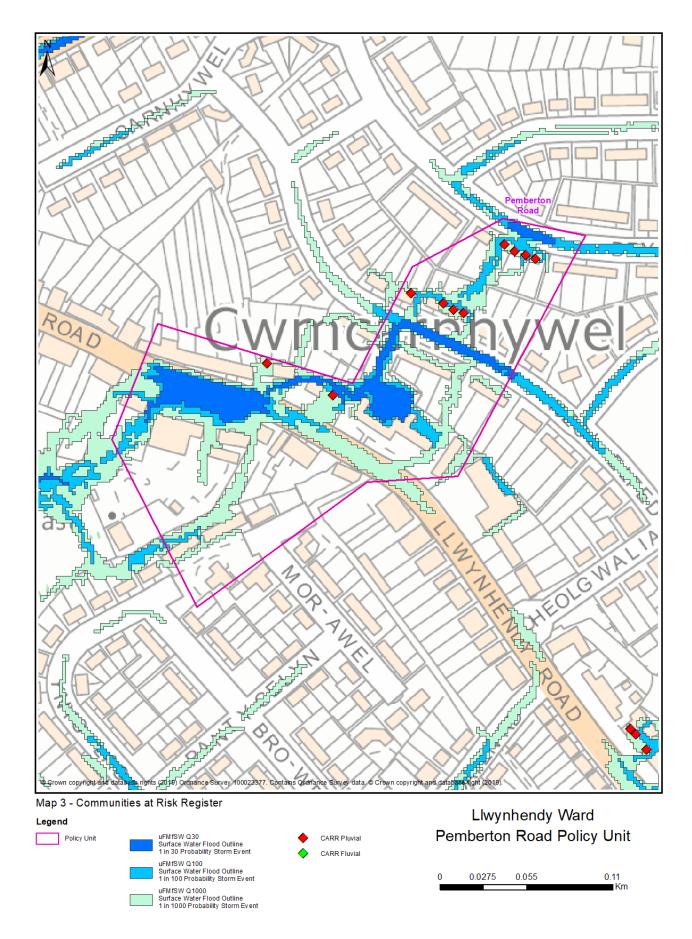
46.8.3 Map 3: Community at Risk Register (CaRR)

Number of specified units at risk of flooding		
	1 in 30 probability storm1 in 100 probability storm1 in 1000 probability stoeventeventevent		
Map 1 Total Properties	9	24	55
Map 2 Dwellings and Services	8	23	50
Map 3 CaRR	n/a	10	n/a

Q1000 All Property Classes
 Flood Depth 150mm or Greater

uFMfSW Q30 Surface Water Flood Outline 1 in 30 Probability Storm Event

uFMfSW Q100 Surface Water Flood Outline 1 in 100 Probability Storm Event

Q30- Services Flood Depth 150mm or Greater Q100- Services Flood Depth 150mm or Greater

Q1000- Dwellings Flood Depth 150mm or Greater A Flood Depth 150mm or Greater

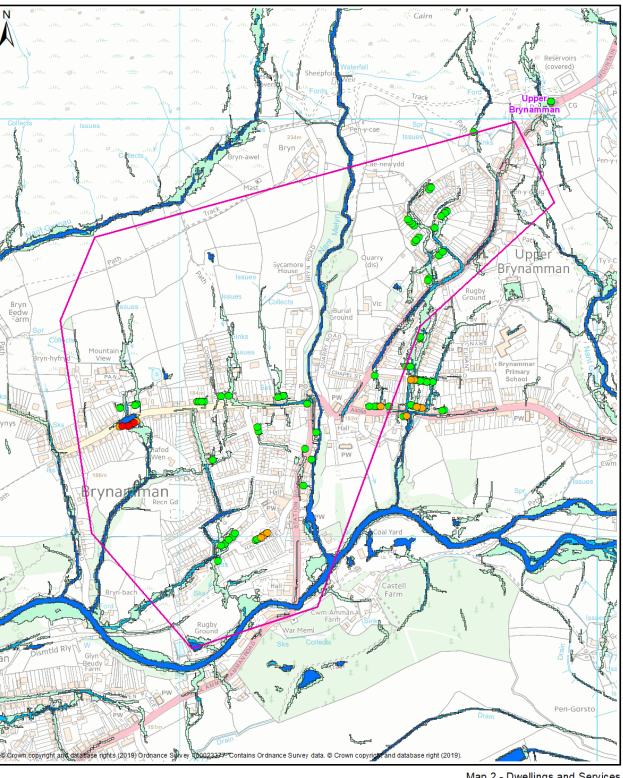
uFMfSW Q30 Surface Water Flood Outline 1 in 30 Probability Storm Event

uFMfSW Q100 Surface Water Flood Outline 1 in 100 Probability Storm Event

Number of specified units at risk of flooding		
	1 in 30 probability storm event	1 in 100 probability storm event	1 in 1000 probability storm event
Map 1 Total Properties	8	17	85
Map 2 Dwellings and Services	4	11	71
Map 3 CaRR	n/a	12	n/a
