Carmarthenshire County Council Flood Risk Management Plan May 2019

Carmarthenshire County Council Flood Risk Management Plan

Part 2 - Policy Unit Level Summaries

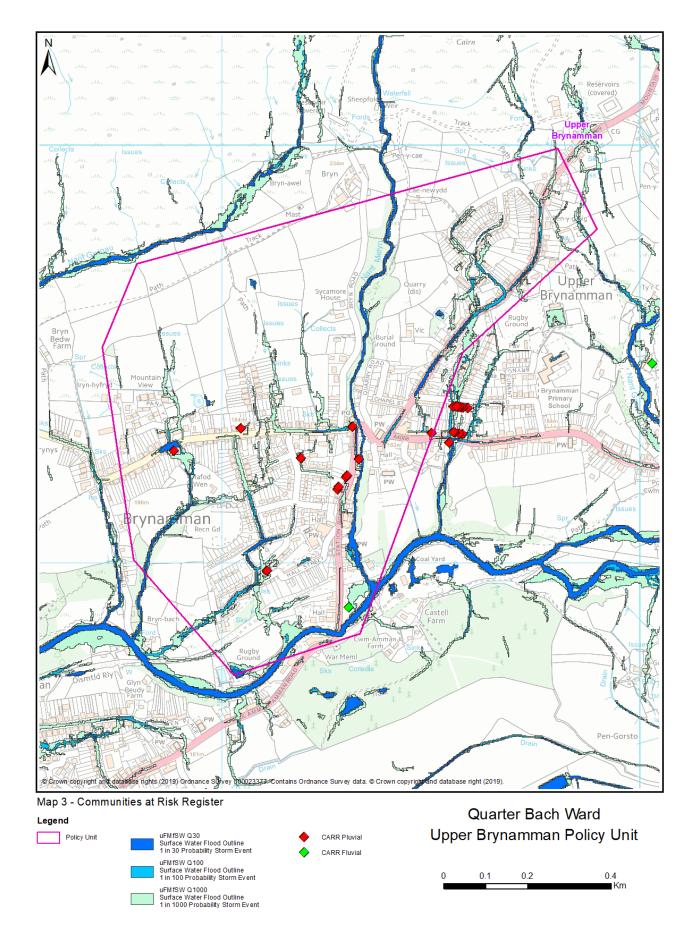
- Q30- Dwellings Flood Depth 150mm or Greater Q100- Dwellings Flood Depth 150mm or Greater
- Q1000- Dwellings Flood Depth 150mm or Greater

Q30- Services Flood Depth 150mm or Greater Q100- Services Flood Depth 150mm or Greater Q1000- Services Flood Depth 150mm or Greater

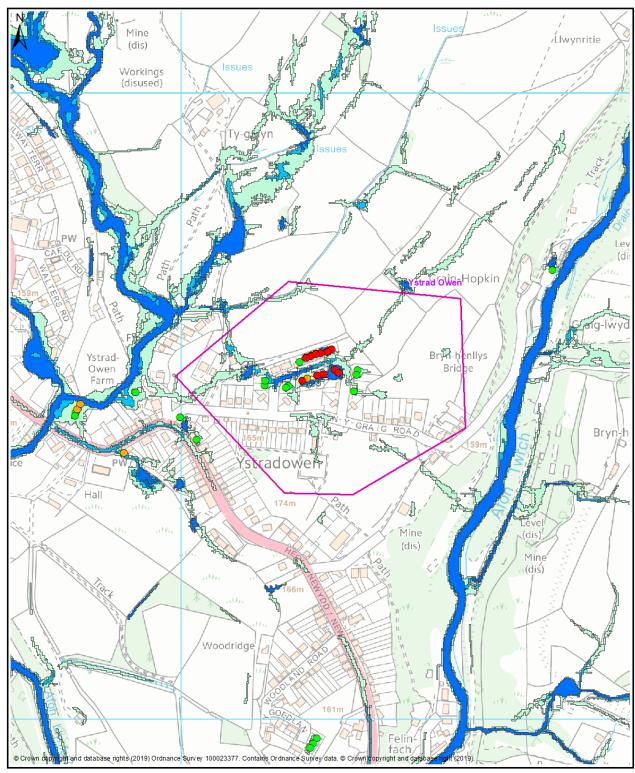
uFMfSW Q30 Surface Water Flood Outline 1 in 30 Probability Storm Event

uFMfSW Q100 Surface Water Flood Outline 1 in 100 Probability Storm Event

Number of specified units at risk of flooding			
	1 in 30 probability storm event	1 in 100 probability storm event	1 in 1000 probability storm event	
Map 1 Total Properties	11	12	22	
Map 2 Dwellings and Services	11	12	20	
Map 3 CaRR	n/a	0	n/a

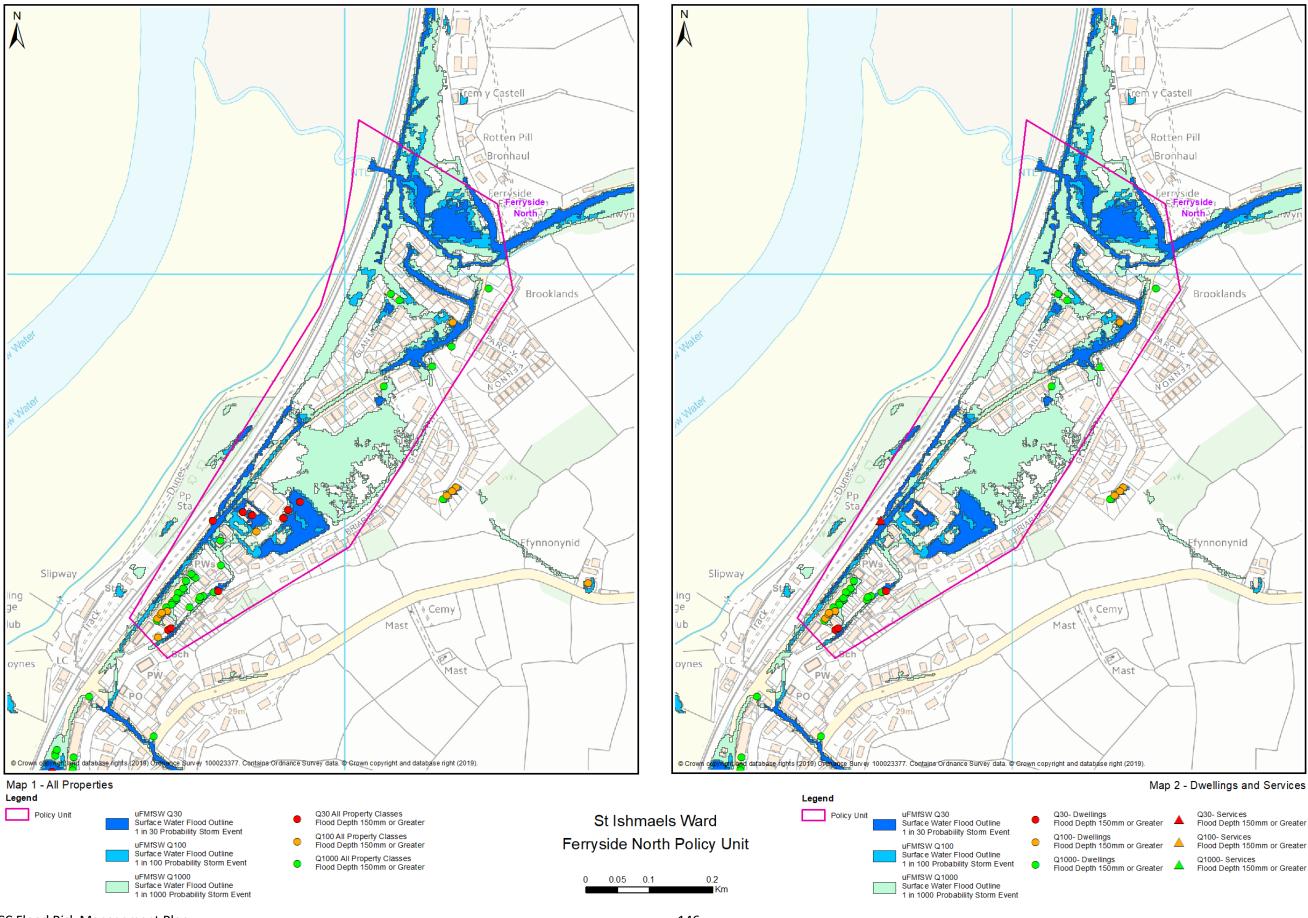
This is the most recent flood mapping from Welsh Government. This dataset depicts all properties at risk of pluvial (surface water) flooding in a storm event with a 1 in 100 probability.

Number of specified units at risk of flooding			
	1 in 30 probability storm event	1 in 100 probability storm event	1 in 1000 probability storm event	
Map 1 Total Properties	9	17	44	
Map 2 Dwellings and Services	4	10	31	
Map 3 CaRR	n/a	3 Pluvial O Fluvial 98 Tidal	n/a

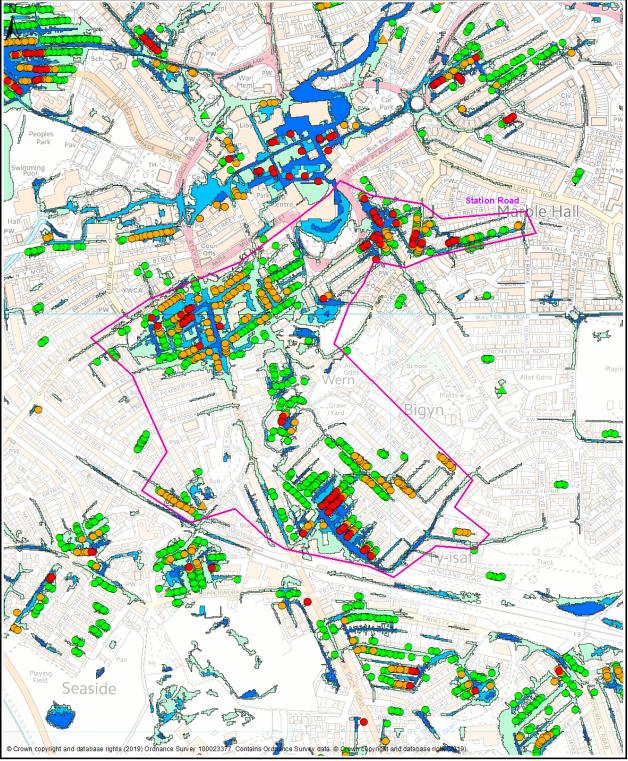
uFMfSW Q30 Surface Water Flood Outline 1 in 30 Probability Storm Event

uFMfSW Q100 Surface Water Flood Outline 1 in 100 Probability Storm Event

Number of specified units at risk of flooding			
	1 in 30 probability storm event	1 in 100 probability storm event	1 in 1000 probability storm event	
Map 1 Total Properties	116	421	848	
Map 2 Dwellings and Services	82	311	673	
Map 3 CaRR	n/a	232 Pluvial 321 Fluvial	n/a
