Investigation Report into Flooding- Storm Callum 12th-14th October 2018

Title of document	Storm Callum Section 19 Flood Investigation Report			
Document date	March 2019			
Authors	Carmarthenshire County Council			
Service responsible	Flood Defence and Coastal Protection, Waste and Environmental Services.			
Department	Environment			
Review	March 2019 (Multi agency)			
Approval	29 July 2019 (CCC Executive Board)			
Published	September 2019

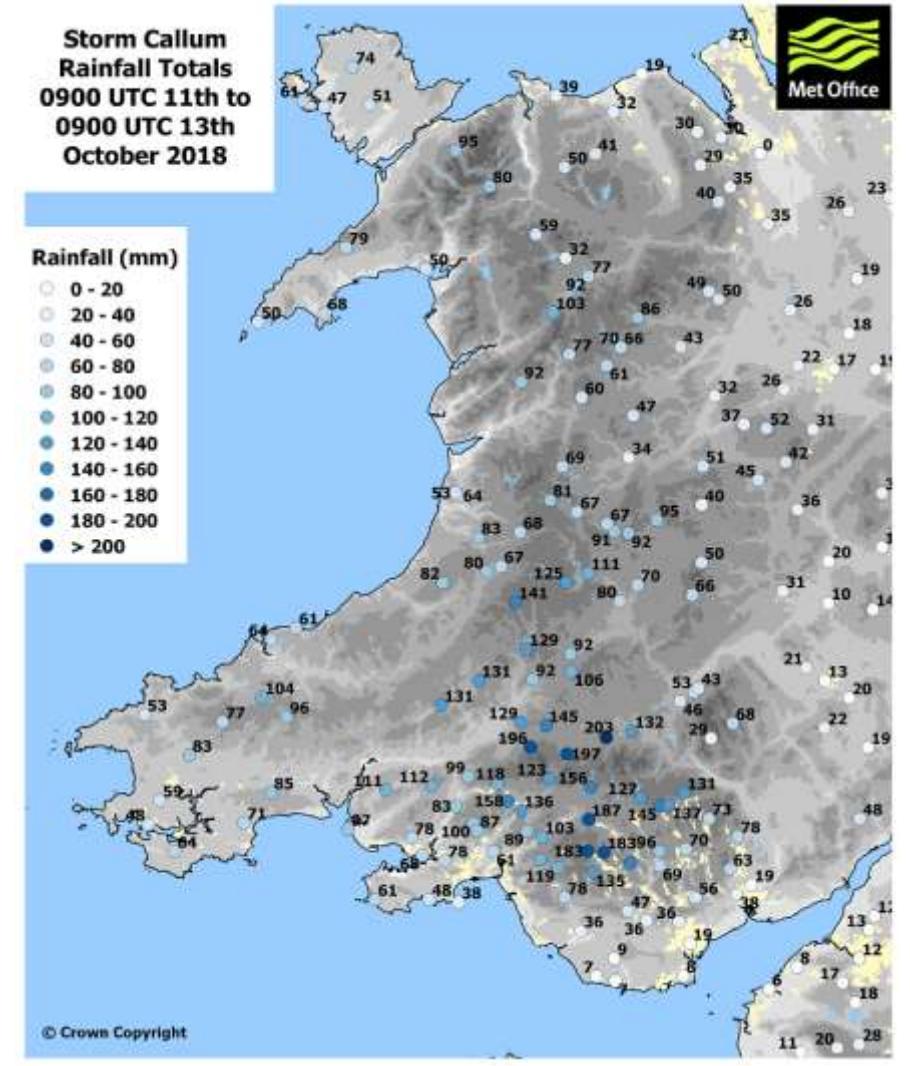
Figure 1 below shows the rainfall totals across Wales from 09:00 on Thursday 11th October to 09:00 on Saturday 13th October 2018.

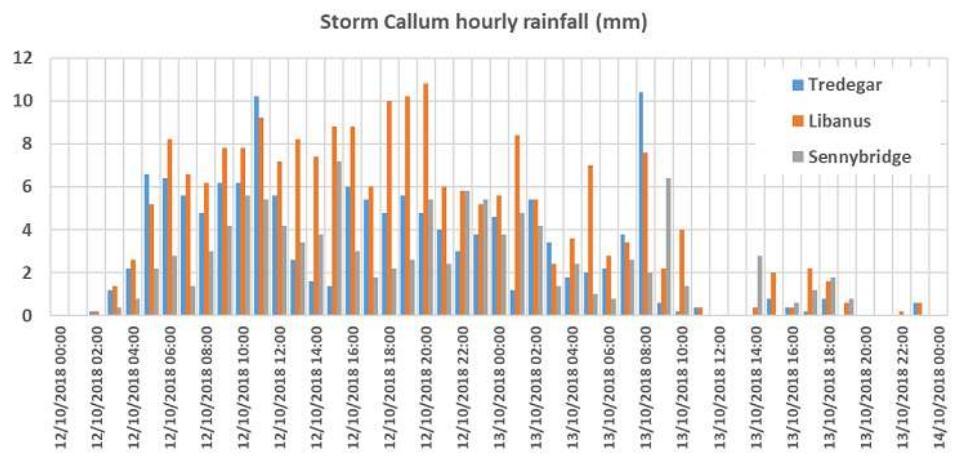
Figure 2 – Storm Callum Hourly Rainfall at Tredagar, Libanus and Sennybridge.

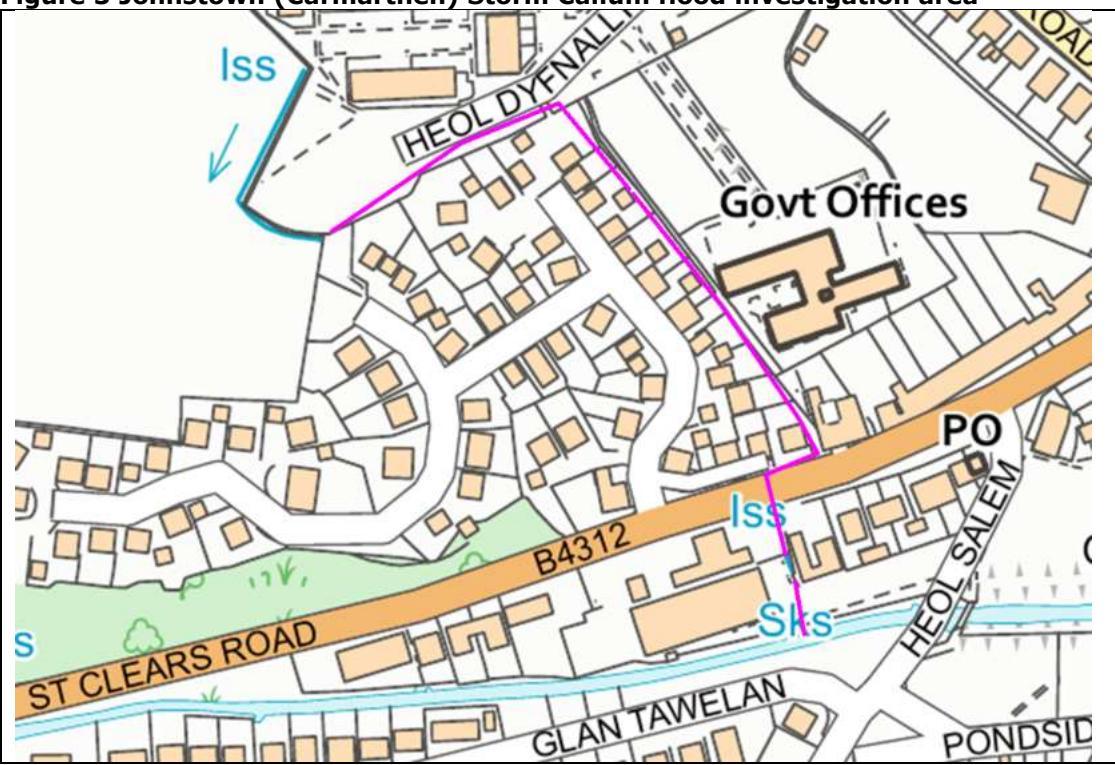
Figure 3 Johnstown (Carmarthen) Storm Callum flood investigation area

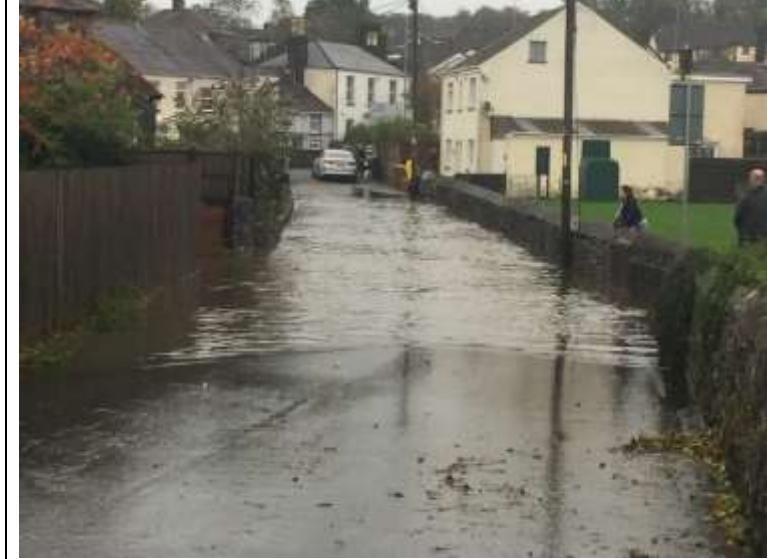
The highway network is drained via highway gullies. The Highway Authority have the gullies mapped on their asset management system WDM; these are cleaned annually. There is no information available on where the gullies drain to or the standards and conditions of these carrier drains. It is assumed that this discharges into the DCWW surface water system.

Plate 1: Highway flooding on Heol Salem, Johnstown (© Cllr Gareth John)

Action 2: CCC Highways Authority to work with DCWW to evaluate the standard of service and the condition of the highway drainage in Johnstown.

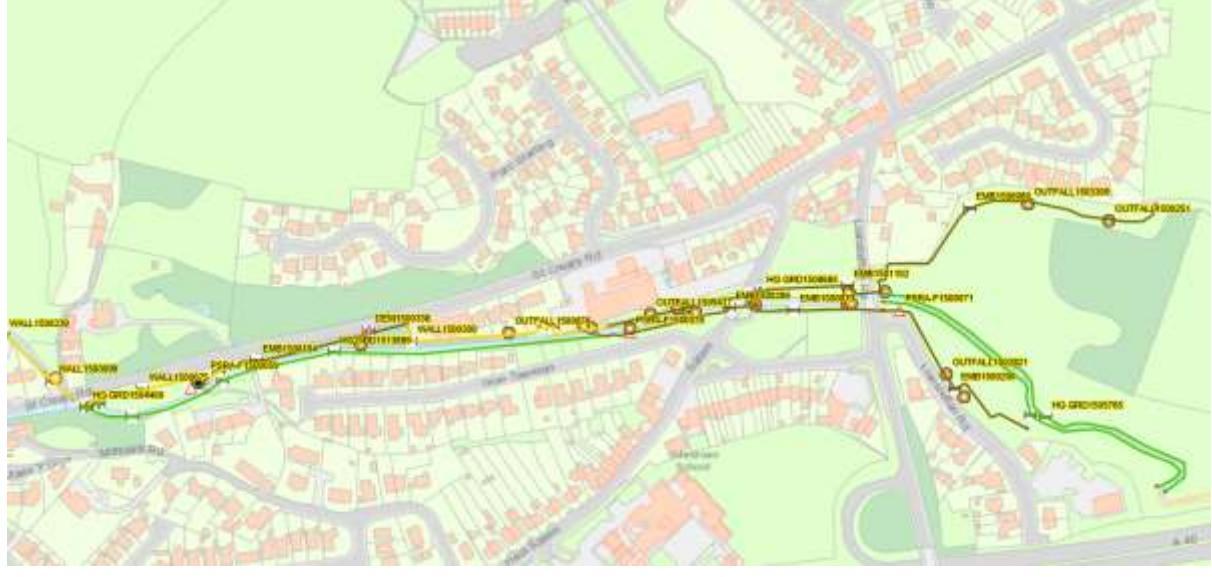
NRW have 49 flood risk assets in the Johnstown area. These include areas of high ground, embankments and walls that serve as flood defence structures.

Figure 5 NRW flood risk management assets in Johnstown (Carmarthen)

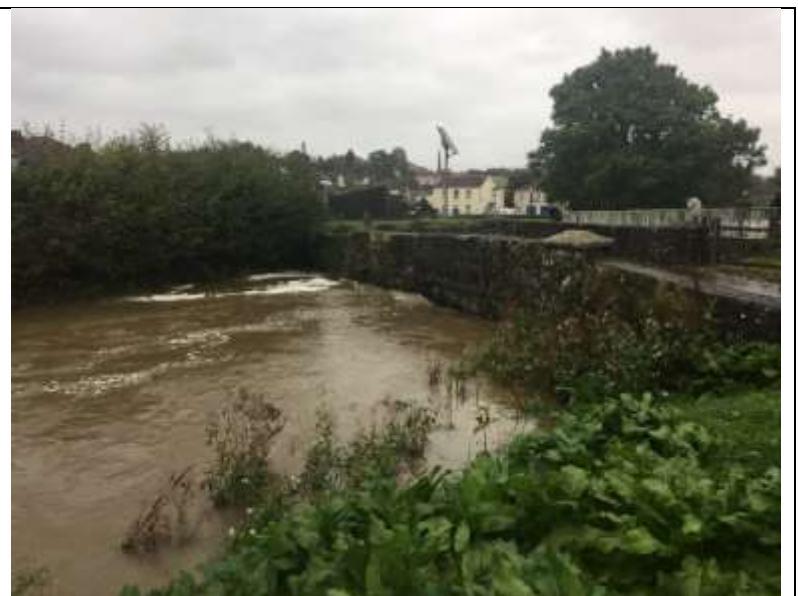
Plate 2: Flood waters at Heol Salem Bridge and Llansteffan Road Bridge (© Cllr Gareth John)

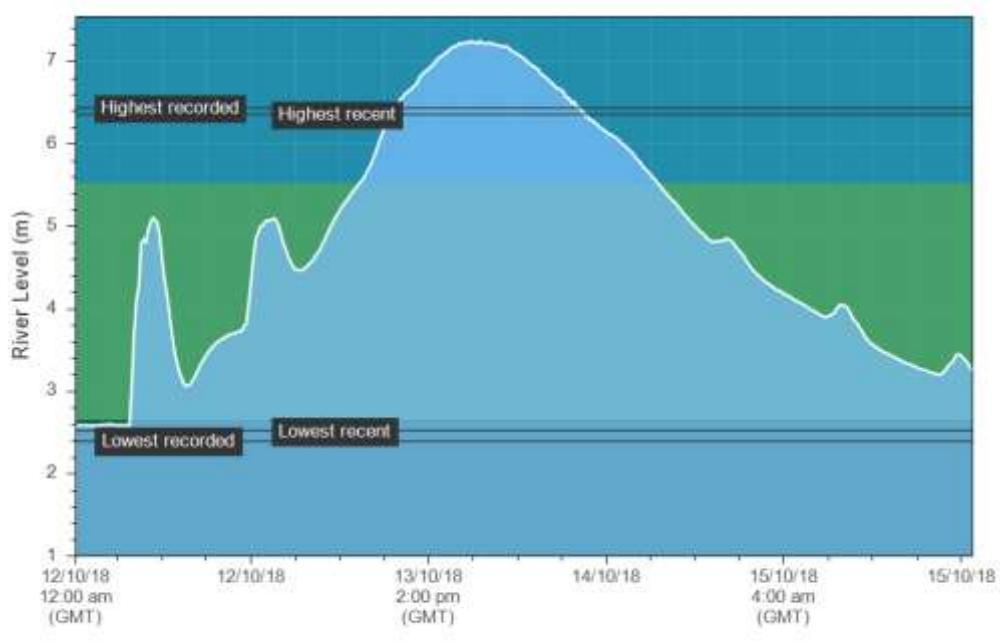
NRW have no telemetry on the Tawelan Brook. The nearest gauge is at Pothouse Wharf in Carmarthen. The flood water peaked at this location at a height of 7.25 metres on the 13th October at 18:15.

Figure 8: River Towy at Pothouse Wharf.

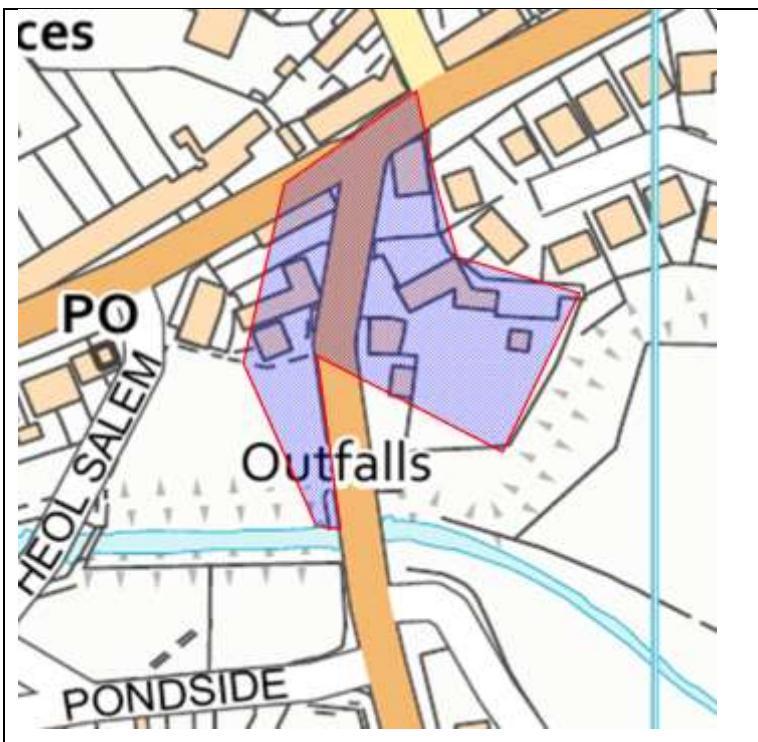
Figure 9 – Map of the Johnstown recreation ground and Llansteffan Road Investigation area

It has also been reported that flooding in this area was from manholes in the highway which lifted under the force of the water inside. This flood water inundated the highway before spreading to affect local residential and commercial property.

Investigations have also concluded that contractors working on behalf of CCC removed a section of the NRW flood defence embankment while undertaking improvements to the adjacent walkway along Llansteffan Road. The actions were undertaken of the contractors own volition without the knowledge of CCC. This breach in the flood defence allowed flood flows to escape the Tawelan Brook. The breach was repaired by the contractor in liaison with CCC and NRW.

Action 3: Repair flood bank – COMPLETE.

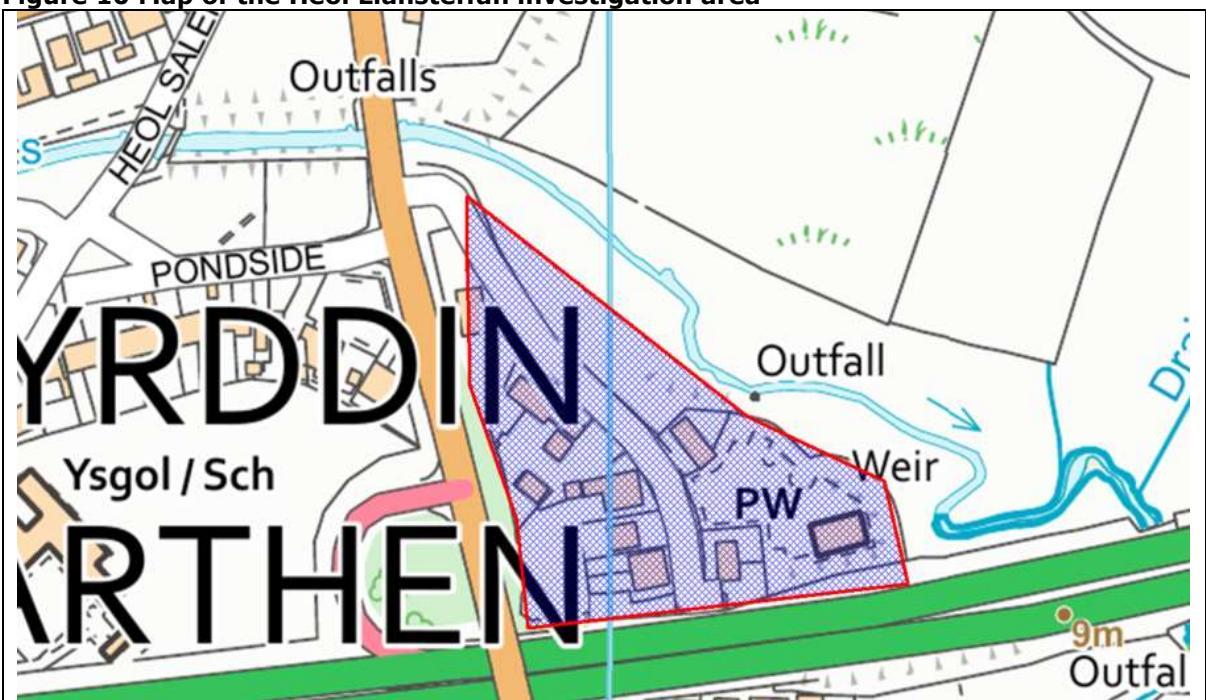
Surface water initially pooled on the highway and then spread to neighbouring residential property as the rain continued. The water appeared not to drain away. There were also unsubstantiated reports that there was ground water flooding.

Figure 10 Map of the Heol Llansteffan investigation area

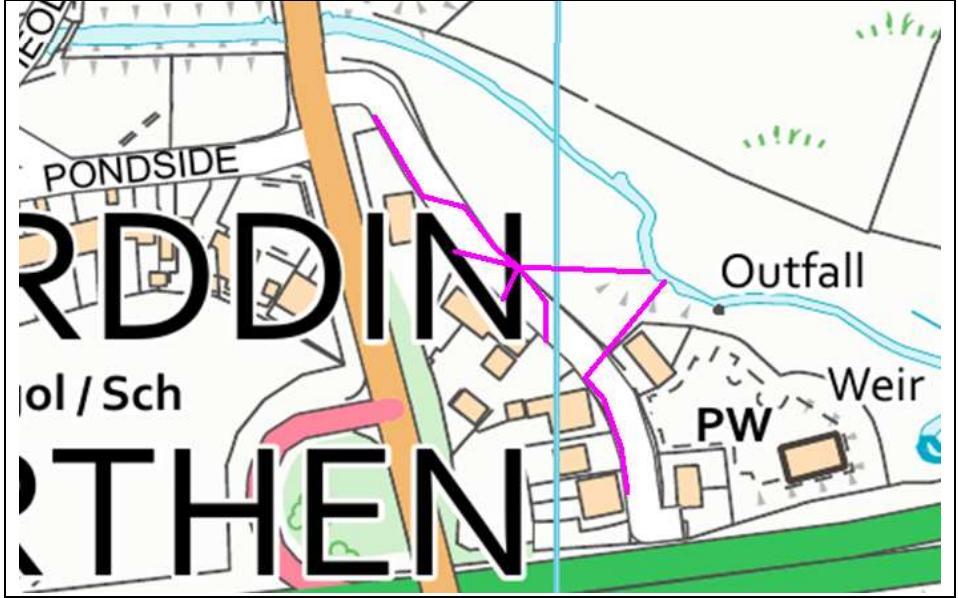
Figure 6: Map of the highway drainage at Llansteffan Road, Johnstown

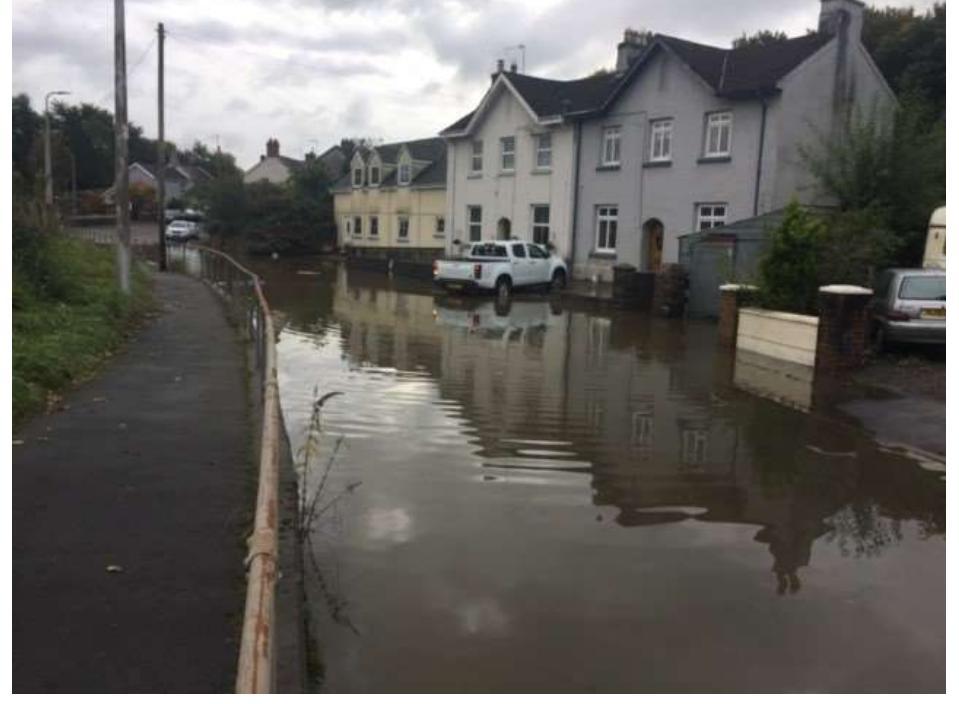
Plate 3: Flooding at Heol Llansteffan on Sunday October 14th 2018 (© Cllr Gareth John)

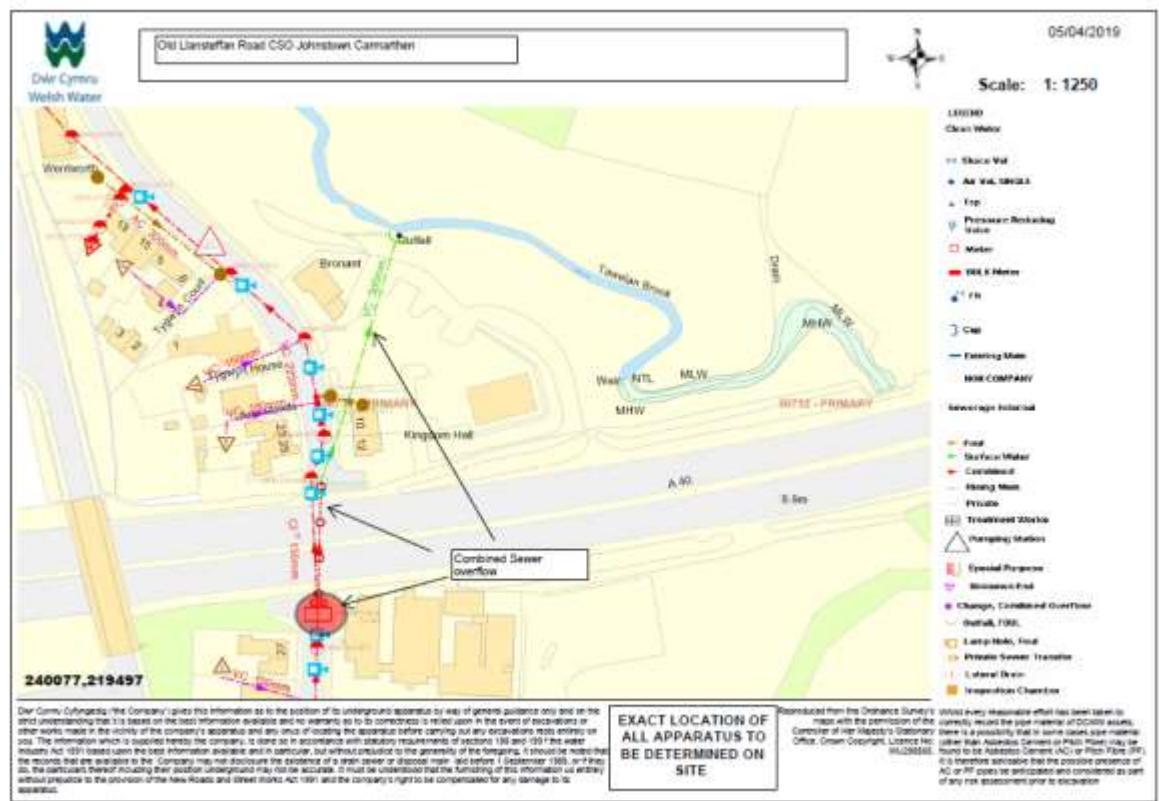
Figure 7 DCWW system at Heol Llansteffan, Johnstown

Action 8: Jet/clean the drainage system and action repairs accordingly (Heol Llansteffan, Johnstown) COMPLETE

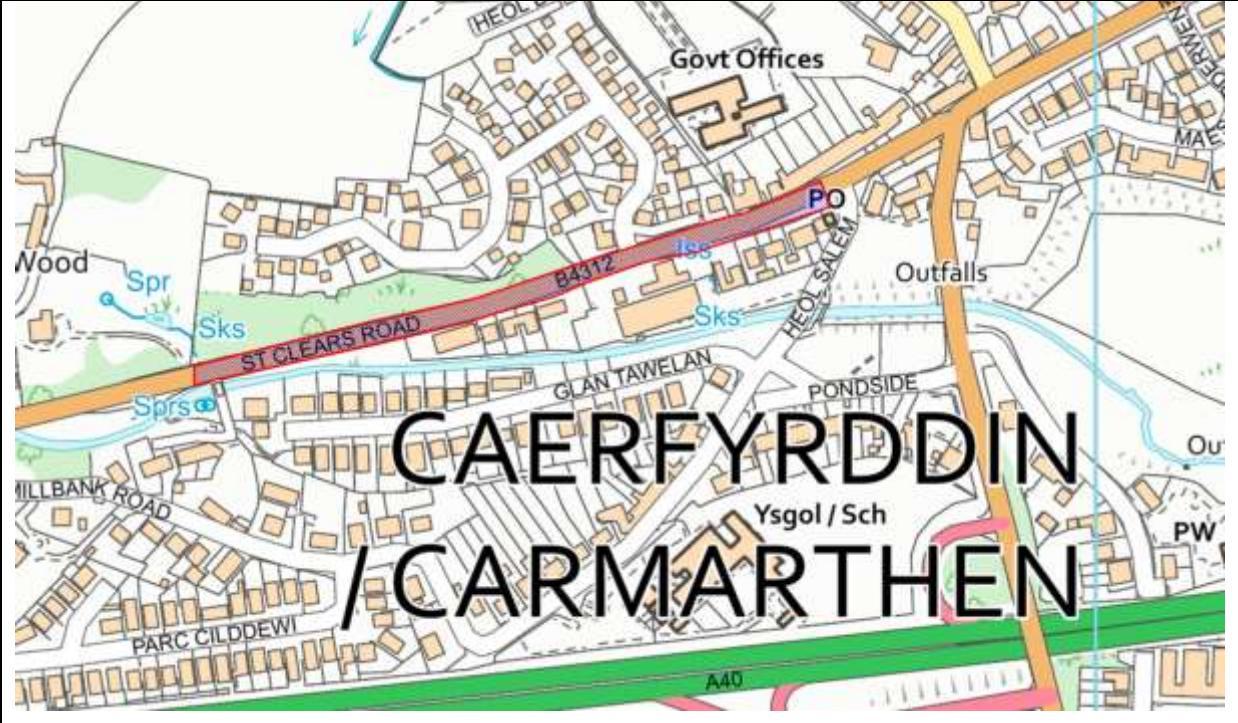
It has also been reported that ground water flooding was evident in this area. Some properties had no surface inundation but water rose up through the floor. Comments were also made that flooding was very random with some properties along St Clears Road escaping internal flooding.

Figure 8 Map of the St Clears Road investigation area.

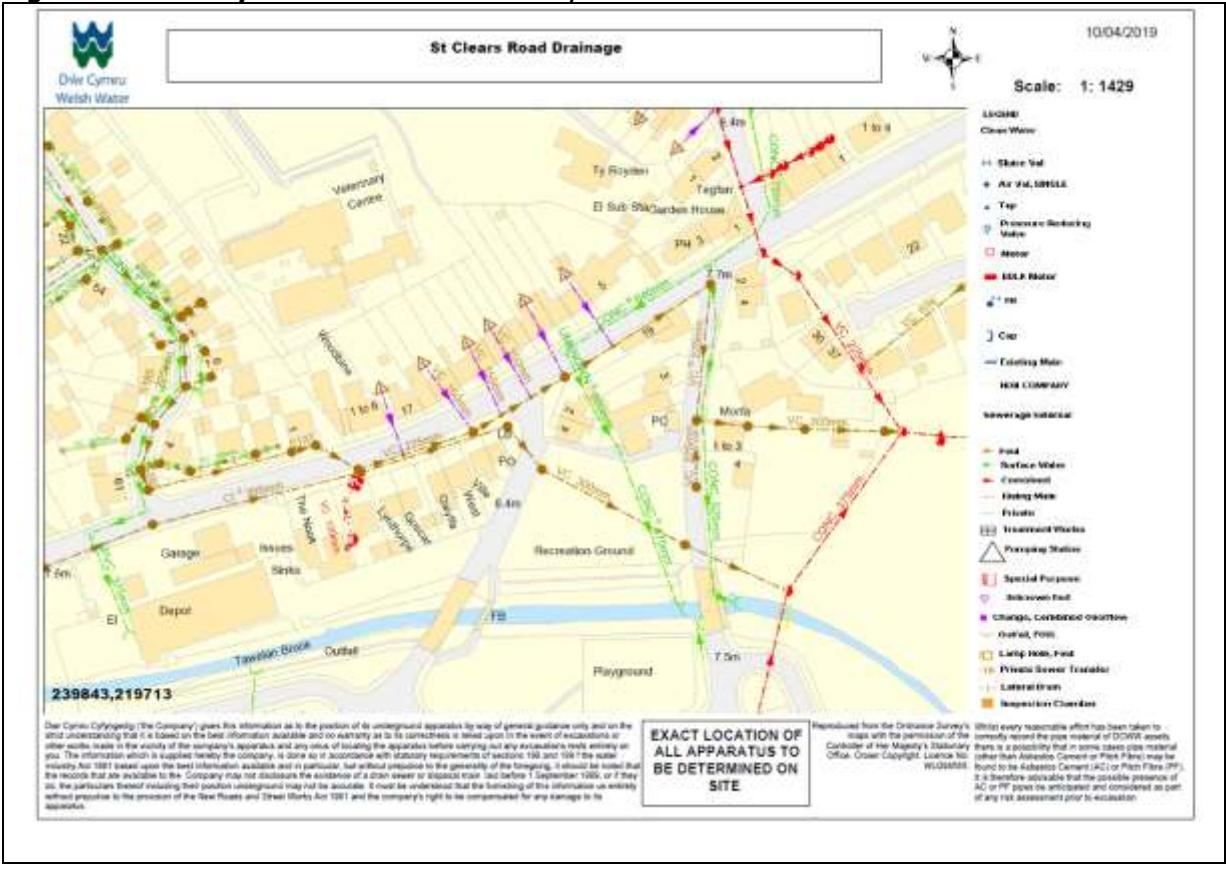
Figure 9 DCWW systems in St Clears Road, Johnstown

Action 13: DCWW and the Highways Authority to evaluate management options for exceedance in St Clears Road, Johnstown.

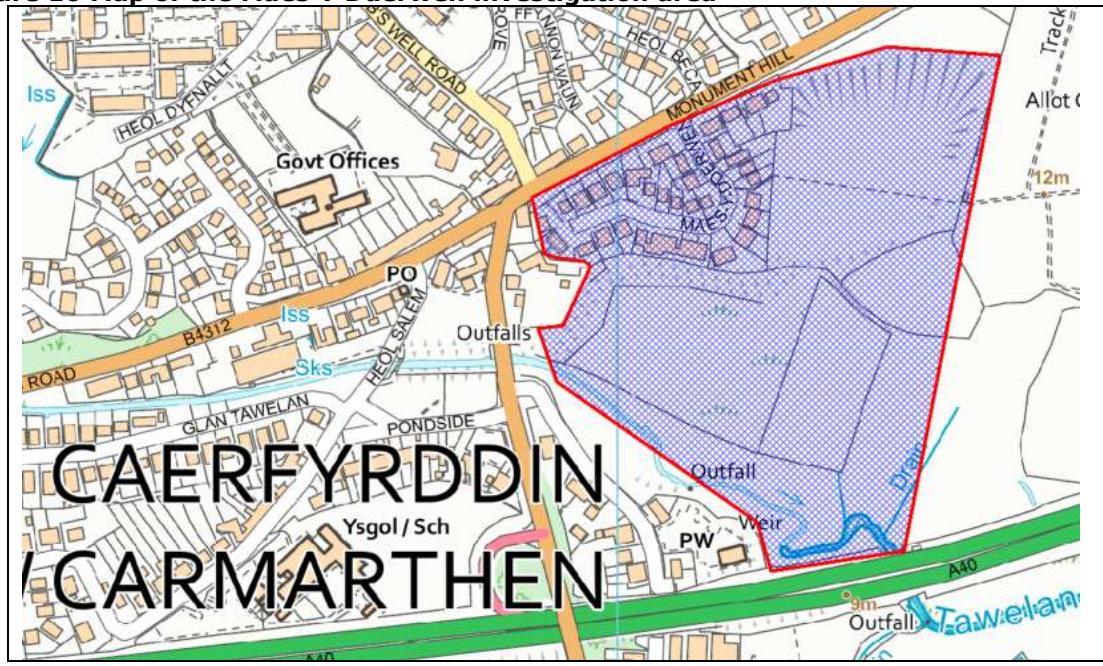
Surface water flowing downhill from the land to the north, could become trapped on the landward side of the embankment. Ground water flooding was reported throughout Johnstown. The was due to the weight and volume of water in the Tawelan Brook forcing water through the local geology and out of the ground neighbouring the watercourse.

Figure 10 Map of the Maes Y Dderwen investigation area

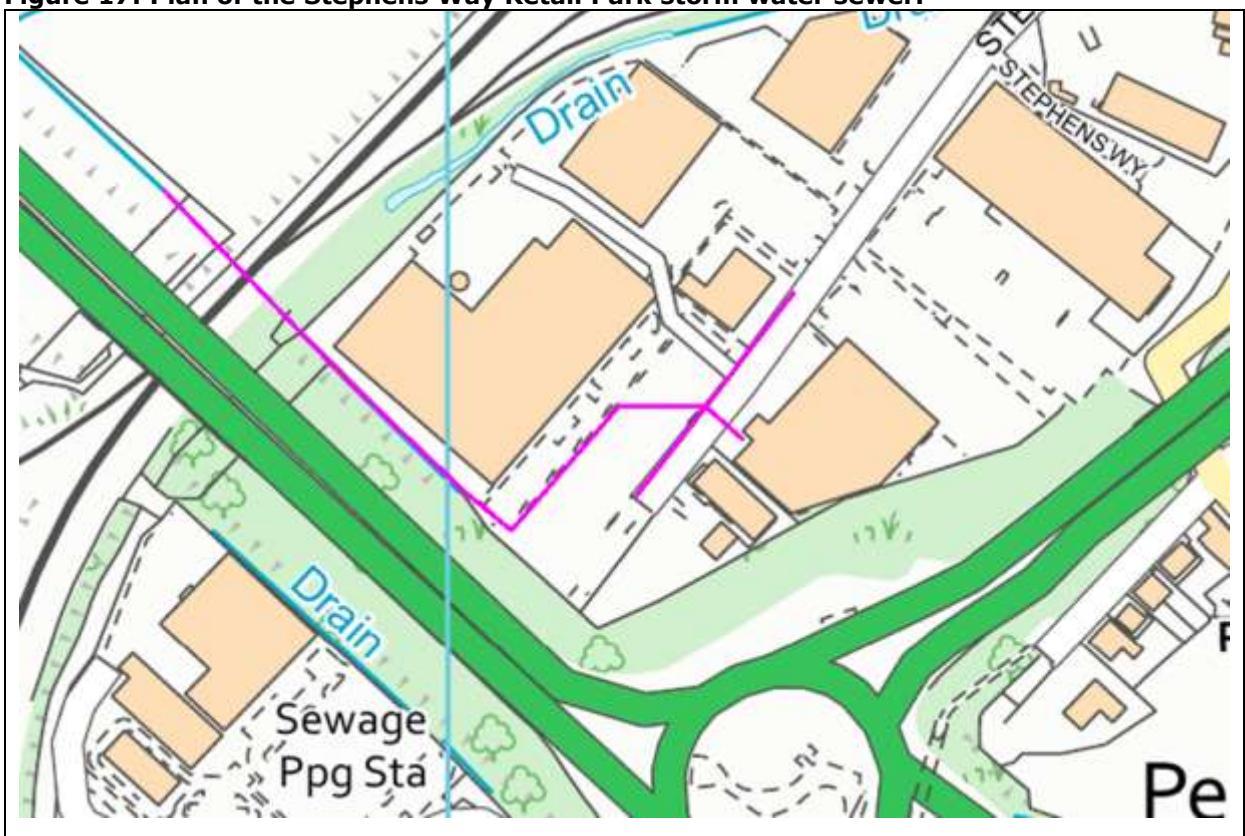
In light of the information above and the results of a 2018 CCTV drainage survey, this report has concluded that the drainage system has sufficient capacity to manage all of the above storm events.

Figure 17: Plan of the Stephens Way Retail Park storm water sewer.

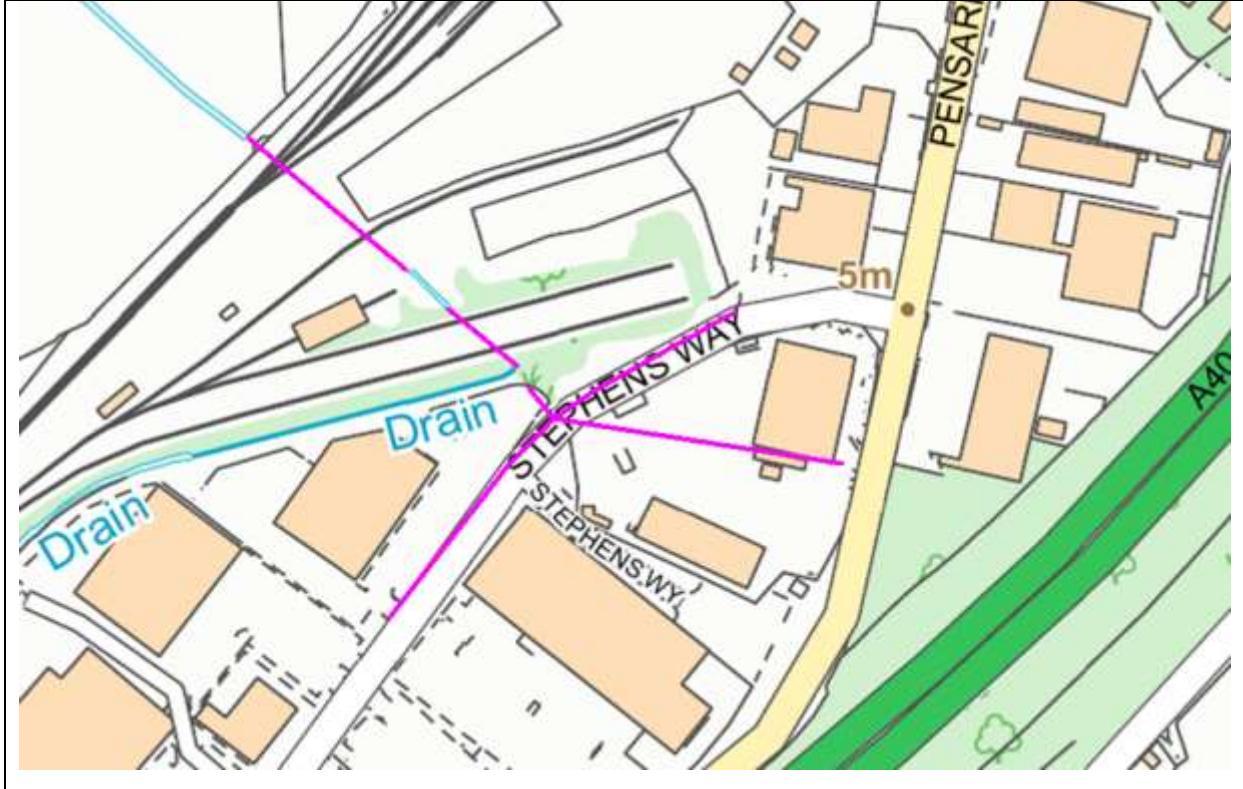
In light of the information above and the results of a 2018 CCTV drainage survey, this report has concluded that the drainage system has sufficient capacity to manage all of the above storm events.

Figure 18: Plan of the Stephens Ways Storm Water Sewer

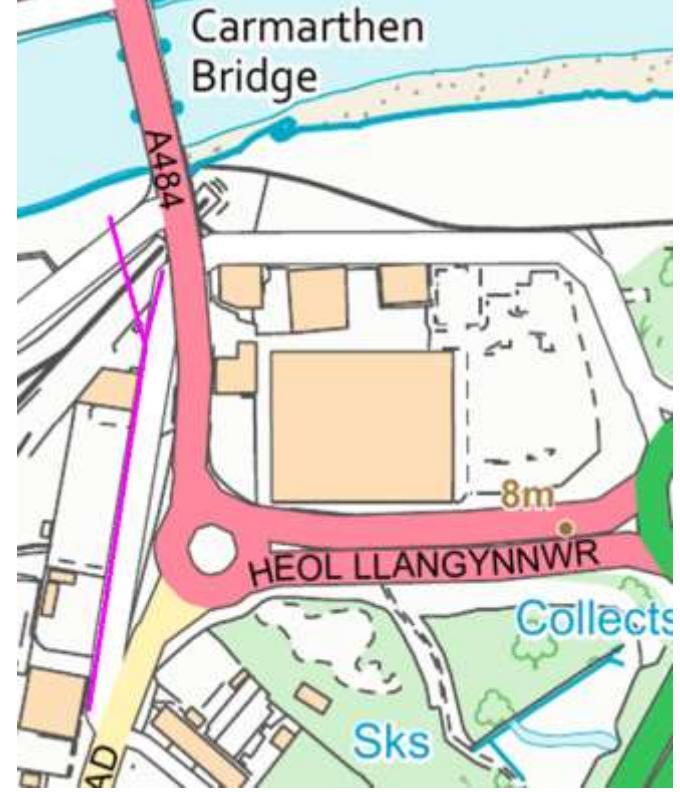
Figure 19 Old Llangunnor Road Surface Water System

In light of the information above and the results of a CCTV drainage survey, this report has concluded that the drainage system has sufficient capacity to manage all of the above storm events.

Action 18: Undertake a CCTV survey of Old Llangunnor Road and the Currys PC World car park to ascertain its network, structural and service conditional and its future maintenance liability COMPLETE

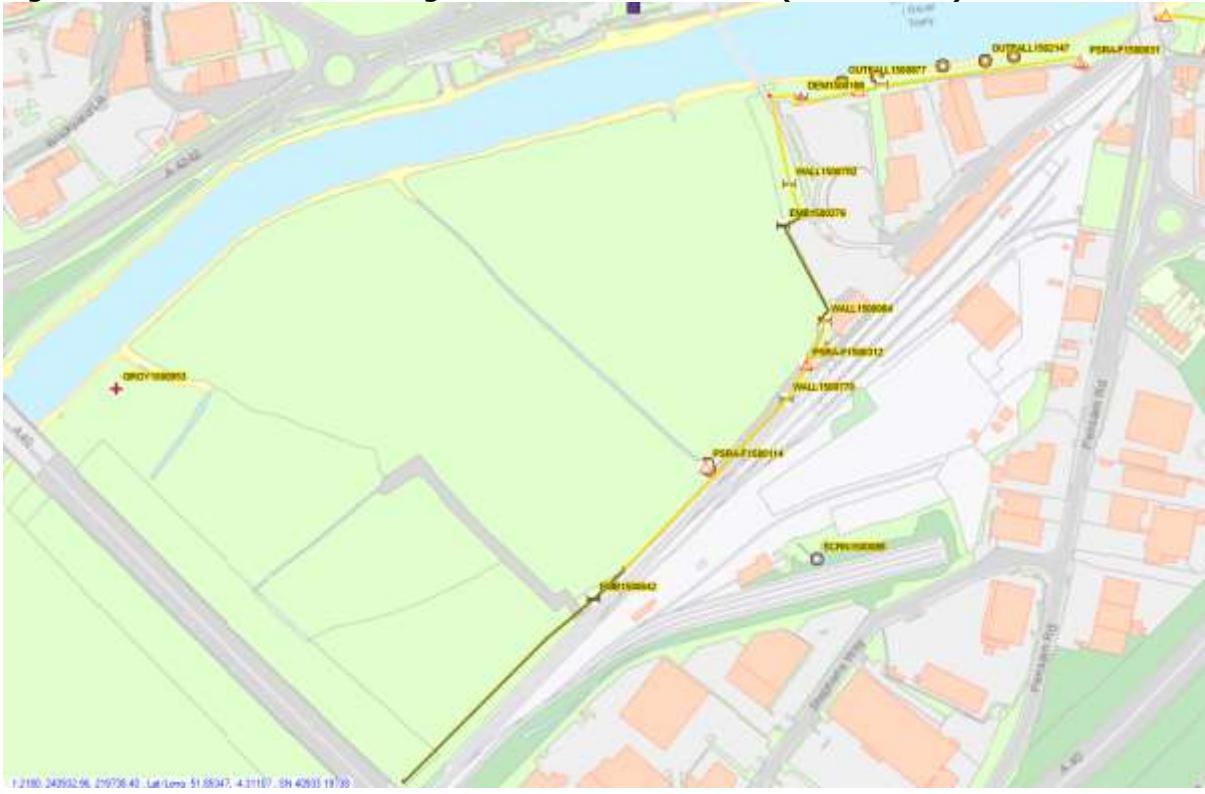
In 1970 a 400-metre long wall was built along Old Llangunnor Road in Pensarn the crest height of which was approximately 7.0 metres AOD. In 1979 that wall overtopped in a flood event which was assessed as a 1 in 50 probability. In 1981 the wall overtopped again in a flood event that was assessed as a 1 in 20 probability.

Figure 20 NRW flood risk management assets in Pensarn (Carmarthen) WEST

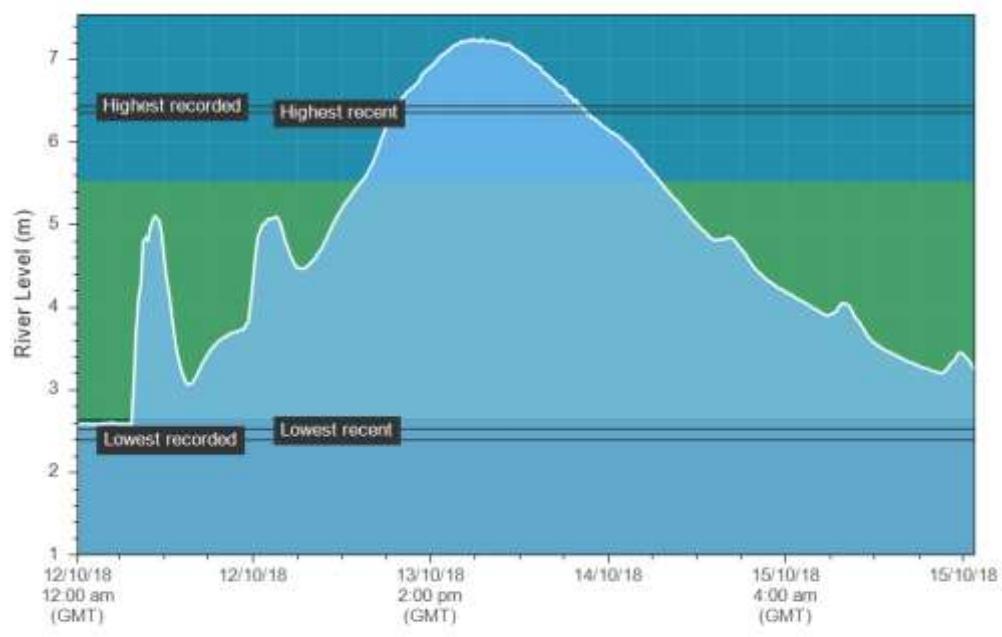
NRW have stated that the flood water peaked at a height of 7.25metres on the 13th October at 18:15.

Figure 22 River Towy at Pothouse Wharf

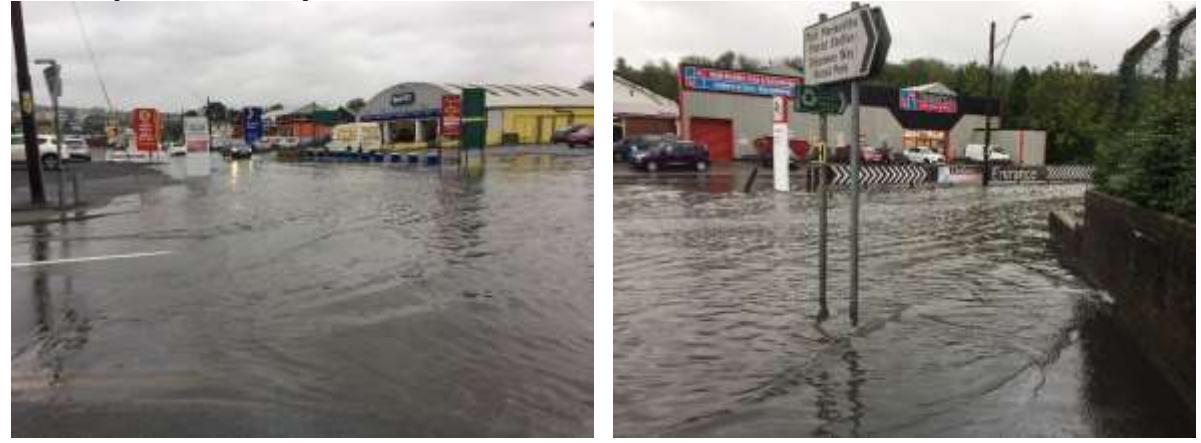
Plate 4 Photographs of the Flooding along Pensarn Road on Saturday 13th October 2018 at 1515 (© B Kathrens)

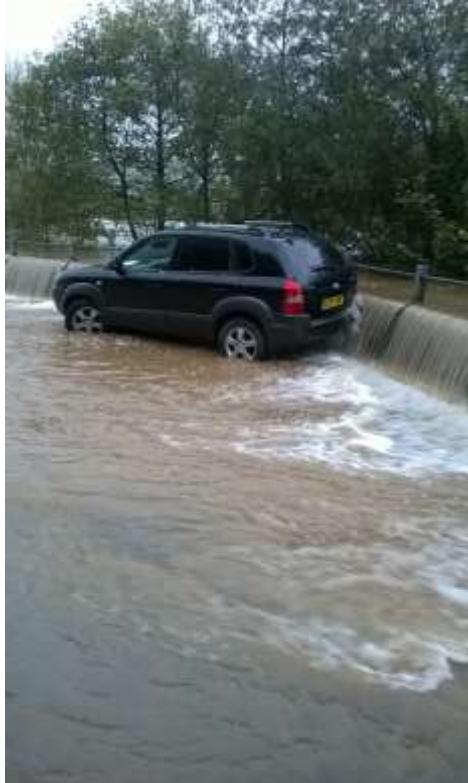
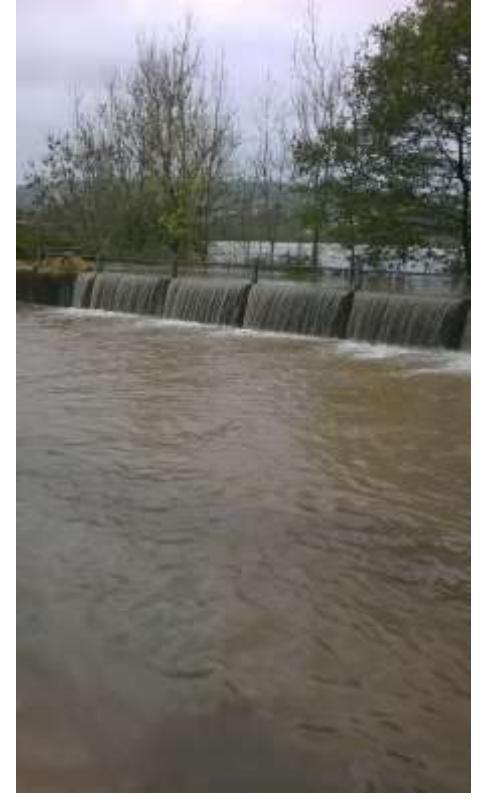
Plate 5 Photographs of the flood defences at Old Llangunnor Road on the afternoon of 18th October2018 (©Natural Resources Wales)

NRW have employed a Panel Engineer to undertake an assessment of the wall and make recommendations to resolve the issues. NRW have no plans to increase the height of the wall at this time.

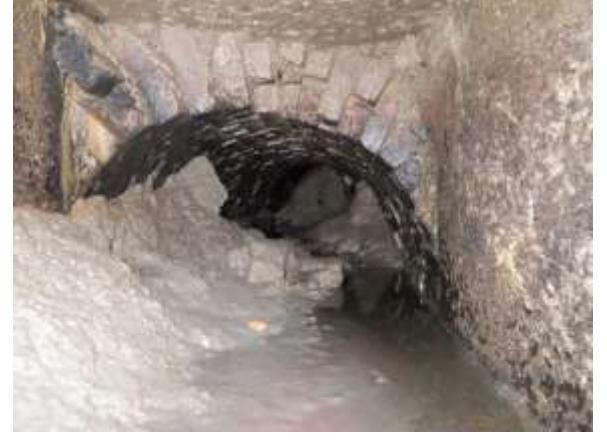
Plate 6: A partially blocked surface water sewer off Old Llangunnor Road, Pensarn (© CCC)

Action 25: Network Rail to investigate and repair the section of blocked culvert at Old Llangunnor Road, West.

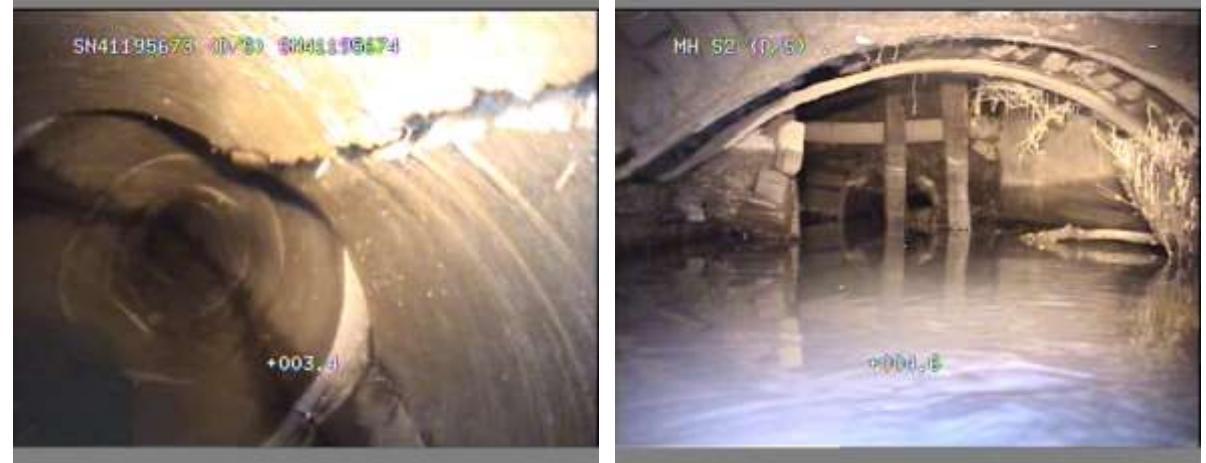
An evaluation of the Sticle surface water sewer concluded that it was a private storm water sewer and that there was sufficient capacity to manage storm flows. However, a CCTV surveys has revealed structural defects that require repair.

Plate 7 Photograph of the defects in the Sticle Surface Water Sewer (© CCC)

Action 32: Ensure the necessary repairs are undertaken to the Sticle Storm Water sewer

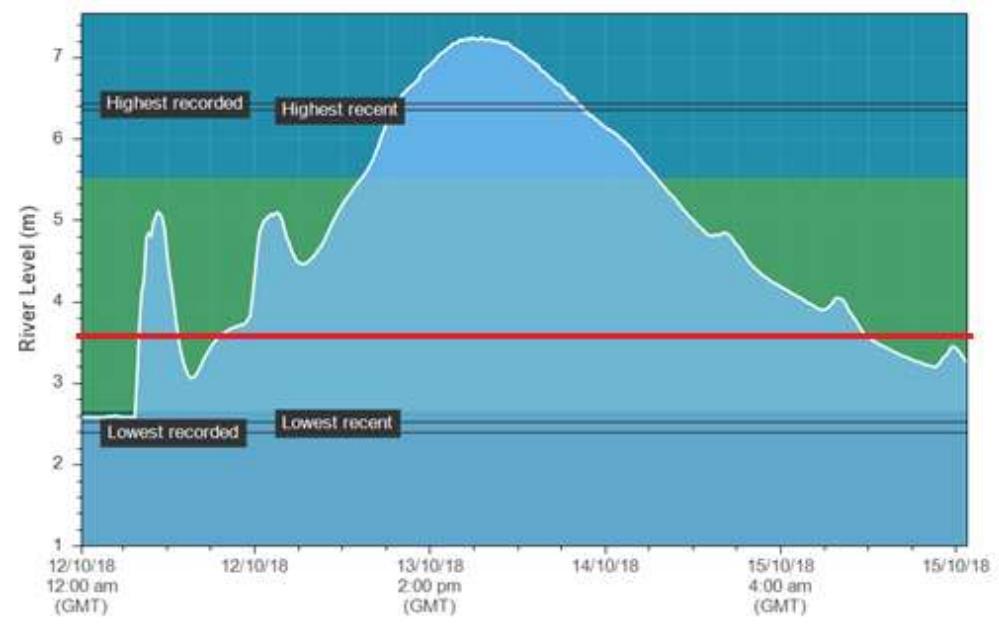
P2.23 Final Version July 2019 on the levels of other outfalls in the area, it is concluded that they would have been impacted over a period of days (see Figure 16). The volumes of surface water entering the system would have exceeded the discharge rate which subsequently resulted in the surface water backing up in the sewer. When capacity in the sewer was reached, water surcharged through manholes and highway gullies.

Figure 23 Graph highlighting the period of time that the River Towy would have limited the functionality of storm outfalls at Stephens Way, Pensarn.

Action 33: Inform the storm water sewer benefactors in Stephen Way of their obligations with regards to the drainage system and advise them to make the repairs identified.

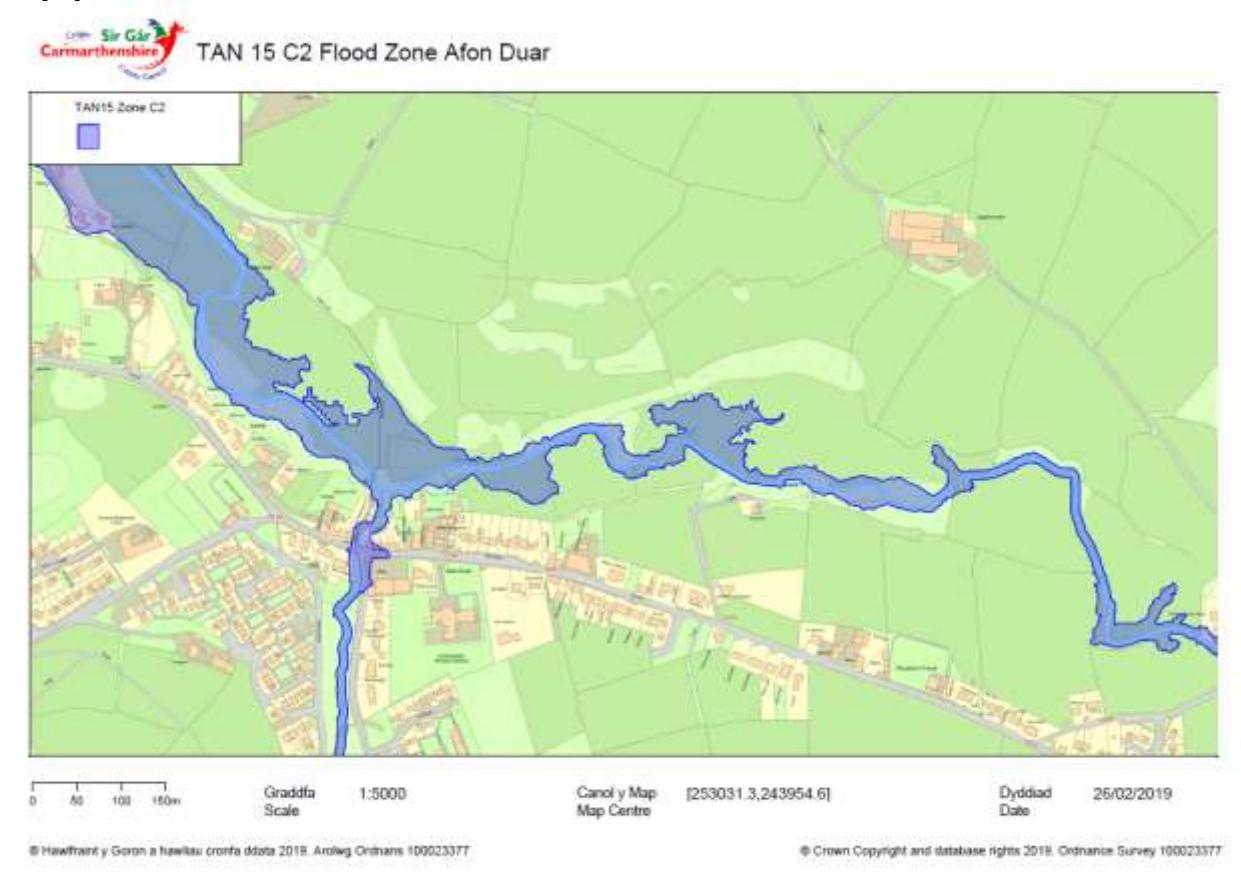
Figure 26 Welsh Government Development Advice Flood Map for the Afon Duar, Llanybydder.

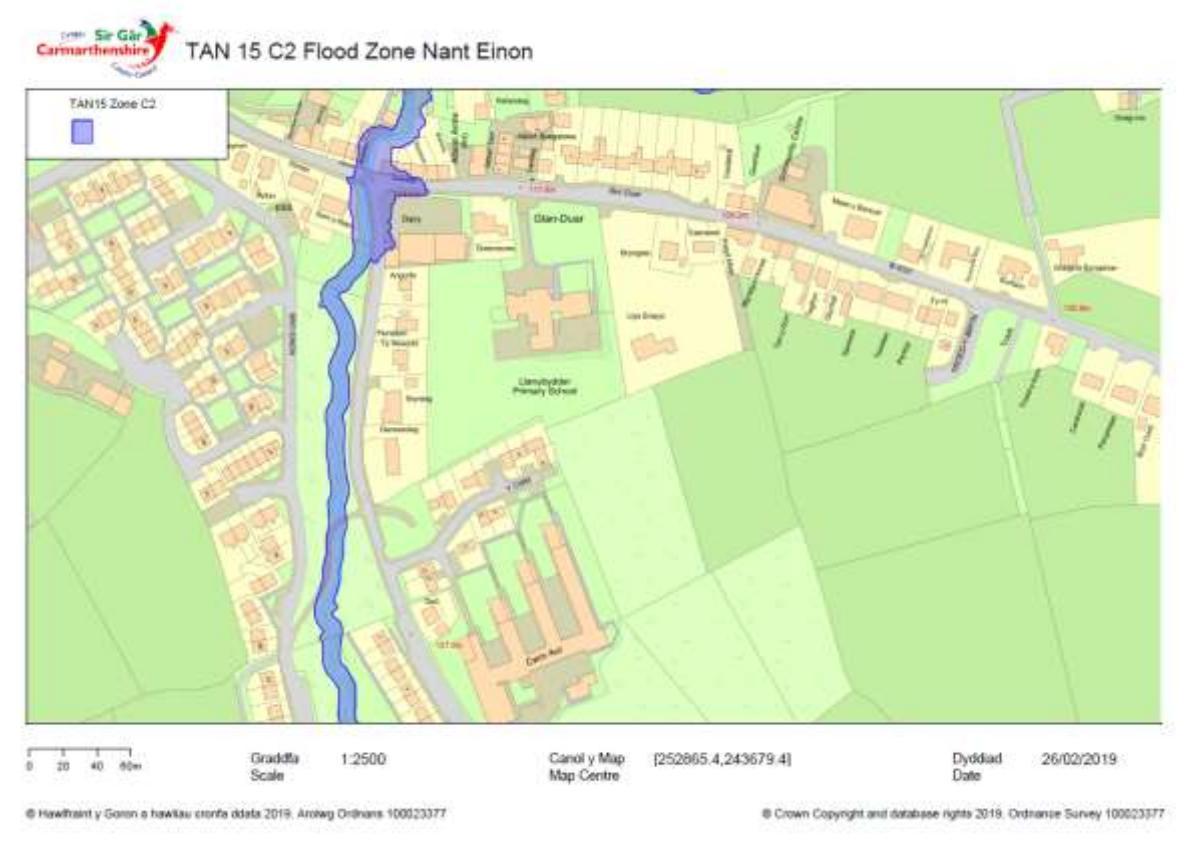
Figure 26 Welsh Government Development Advice Flood Map for the Nant Einon, Llanybydder.

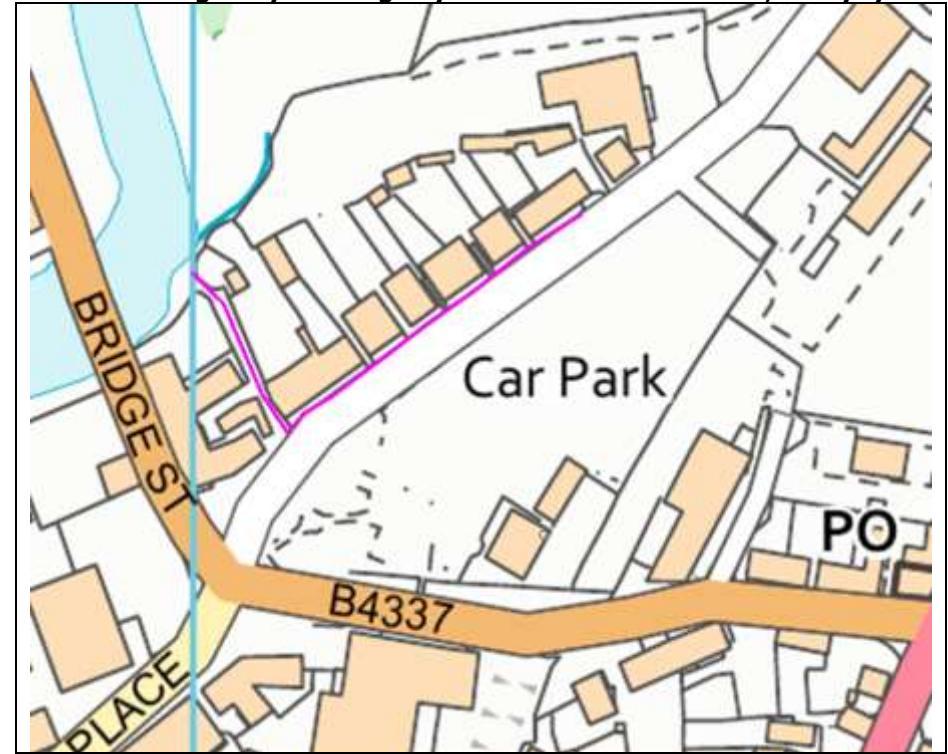
Figure 27 Plan of the highway drainage system at Station Terrace, Llanybydder

At Highmead Terrace, site visits have ascertained that the highway discharges to the adjacent flood plain. At Station Terrace, the Highways Authority have stated that there is an independent highway drainage system. Gullies drain the carriageway and the footway. The drainage system runs southwest down Station Terrace before turning north, alongside No.1 Station Terrace and to the River Teifi. The standard of service and condition of this system in not known.

Action 34 Undertake a CCTV survey of the highways drainage at Station Terrace, to ascertain the condition and standard of service.

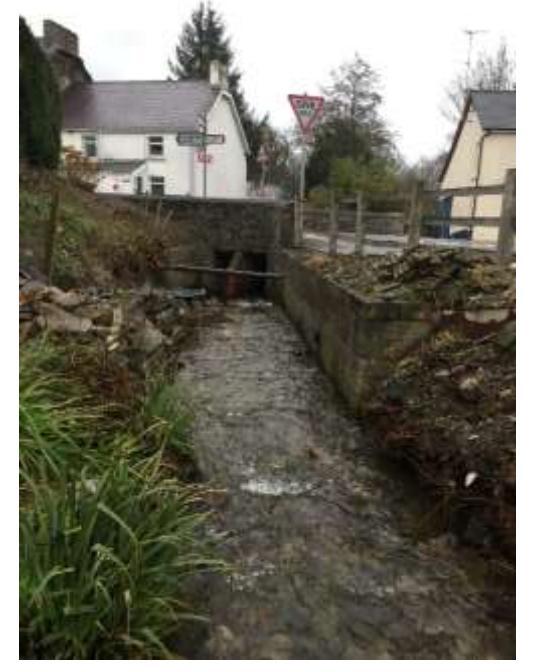
Plate 9 Photograph of the Nant Einon upstream of the B4337 highway culvert.
