Investigation Report into Flooding- Storm Callum 12th-14th October 2018

Title of document	Storm Callum Section 19 Flood Investigation Report			
Document date	March 2019			
Authors	Carmarthenshire County Council			
Service responsible	Flood Defence and Coastal Protection, Waste and Environmental Services.			
Department	Environment			
Review	March 2019 (Multi agency)			
Approval	29 July 2019 (CCC Executive Board)			
Published	September 2019

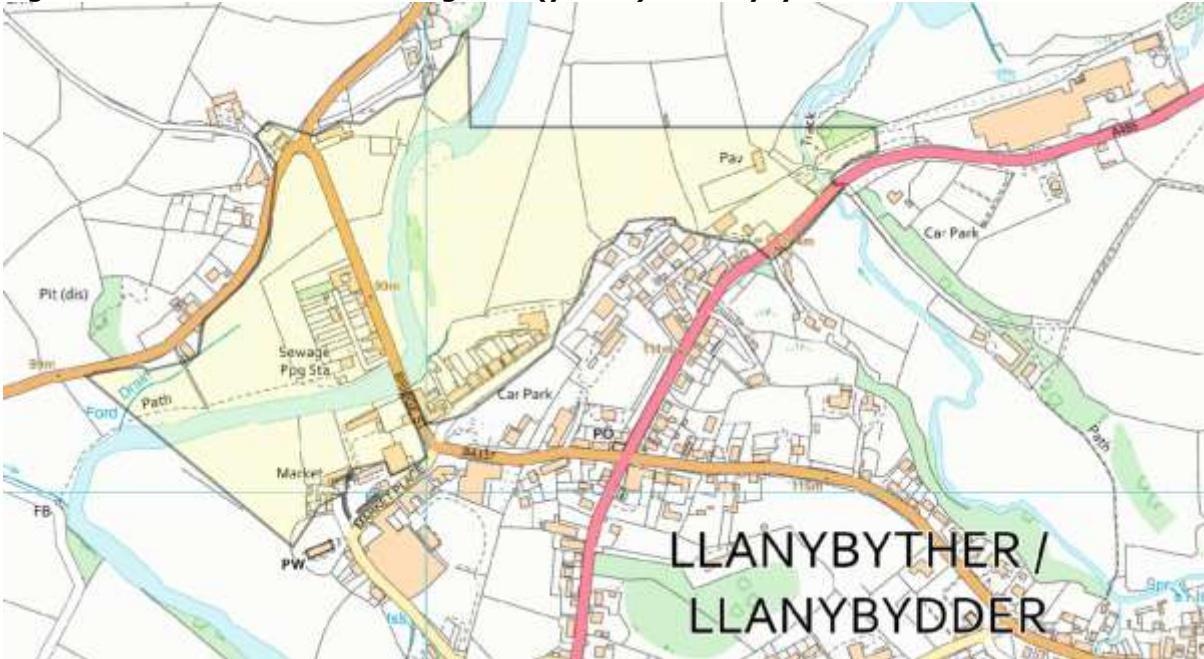
In the Llanybydder flood warning area (as denoted by NRW - not this report, see Figure 21), there are 36 properties fully registered out of the 91 properties at risk, which is 39.56%. However, an additional 25 properties are signed up as 'Extended Direct Warnings' (see explanation below), which means that 61 or 67% of properties could be receiving the flood warnings for Llanybydder.

Figure 28 The NRW flood warning area (yellow) in Llanybydder

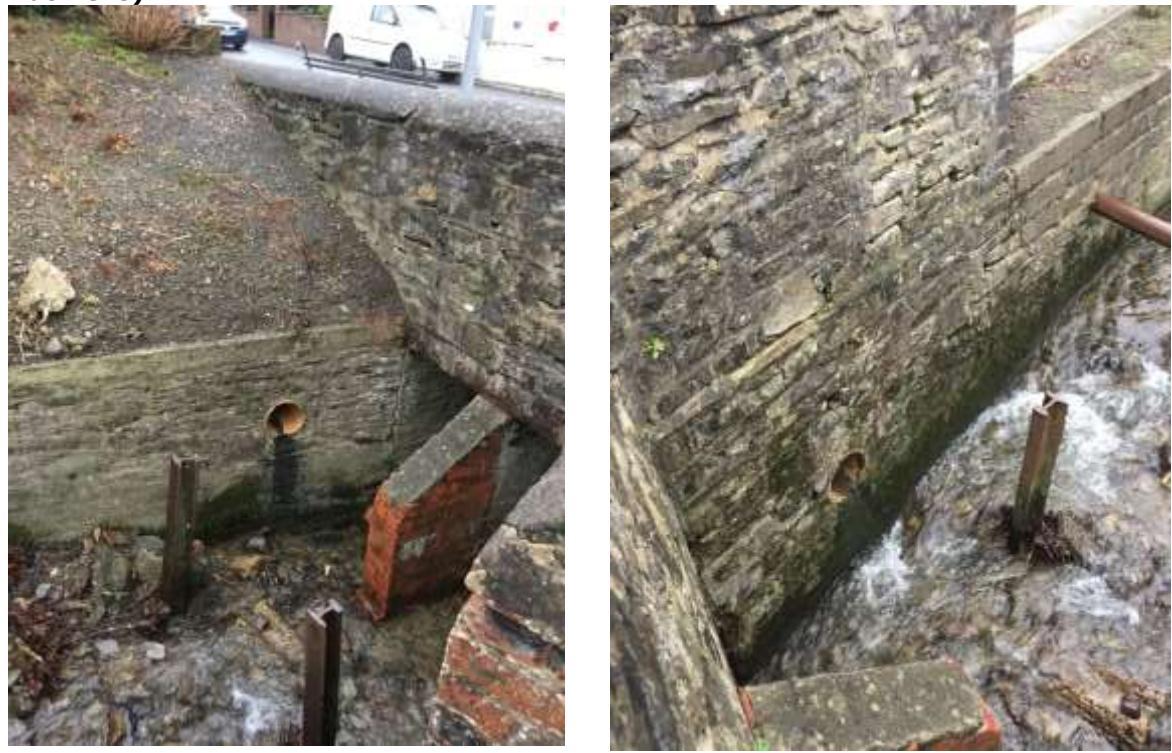
The investigation has identified a number of issues with the highways drainage. As highlighted above, the highway drainage network and its condition is not currently mapped, but this report has come up with a number of actions to assist in the management of flood risk. This includes diverting the highway drainage to discharge downstream of the highway culvert and therefore remove the risk of tide locking. There are currently no flaps on the outfalls and water could potentially travel from the watercourse and back out of the highway gullies during flood events. Plate 10 below highlights this issue. Plate 10 Photographs of un-flapped highway drainage outfalls along the Nant Einon (© Bkathrens)

Action 44: Add flaps to the outfalls of the highway drainage.

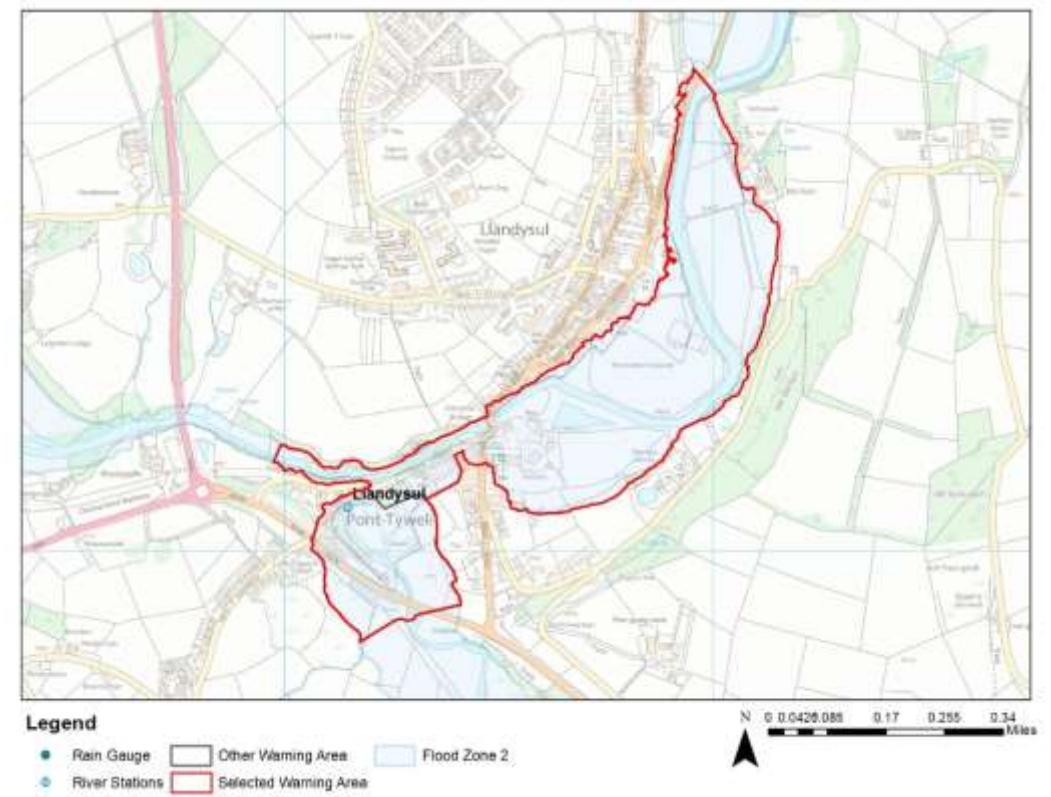
Figure 30 Map depicting the NRW flood warning area in Pont-Tyweli.

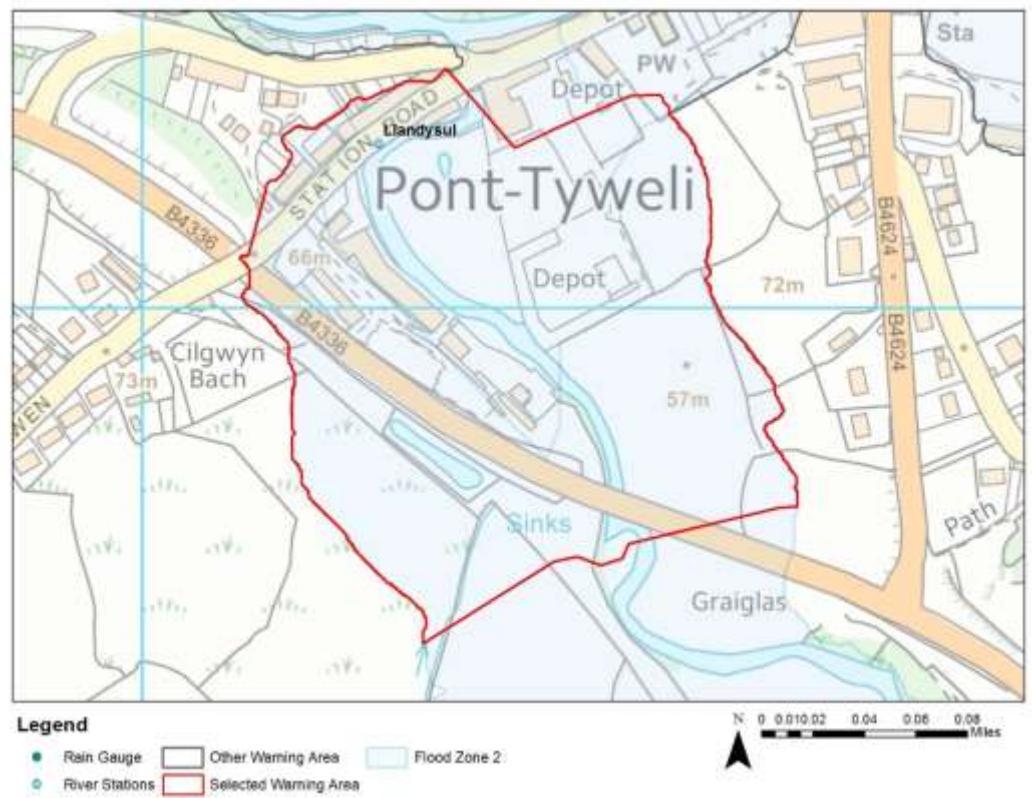
Figure 31 The Pont Tyweli Flood warning area

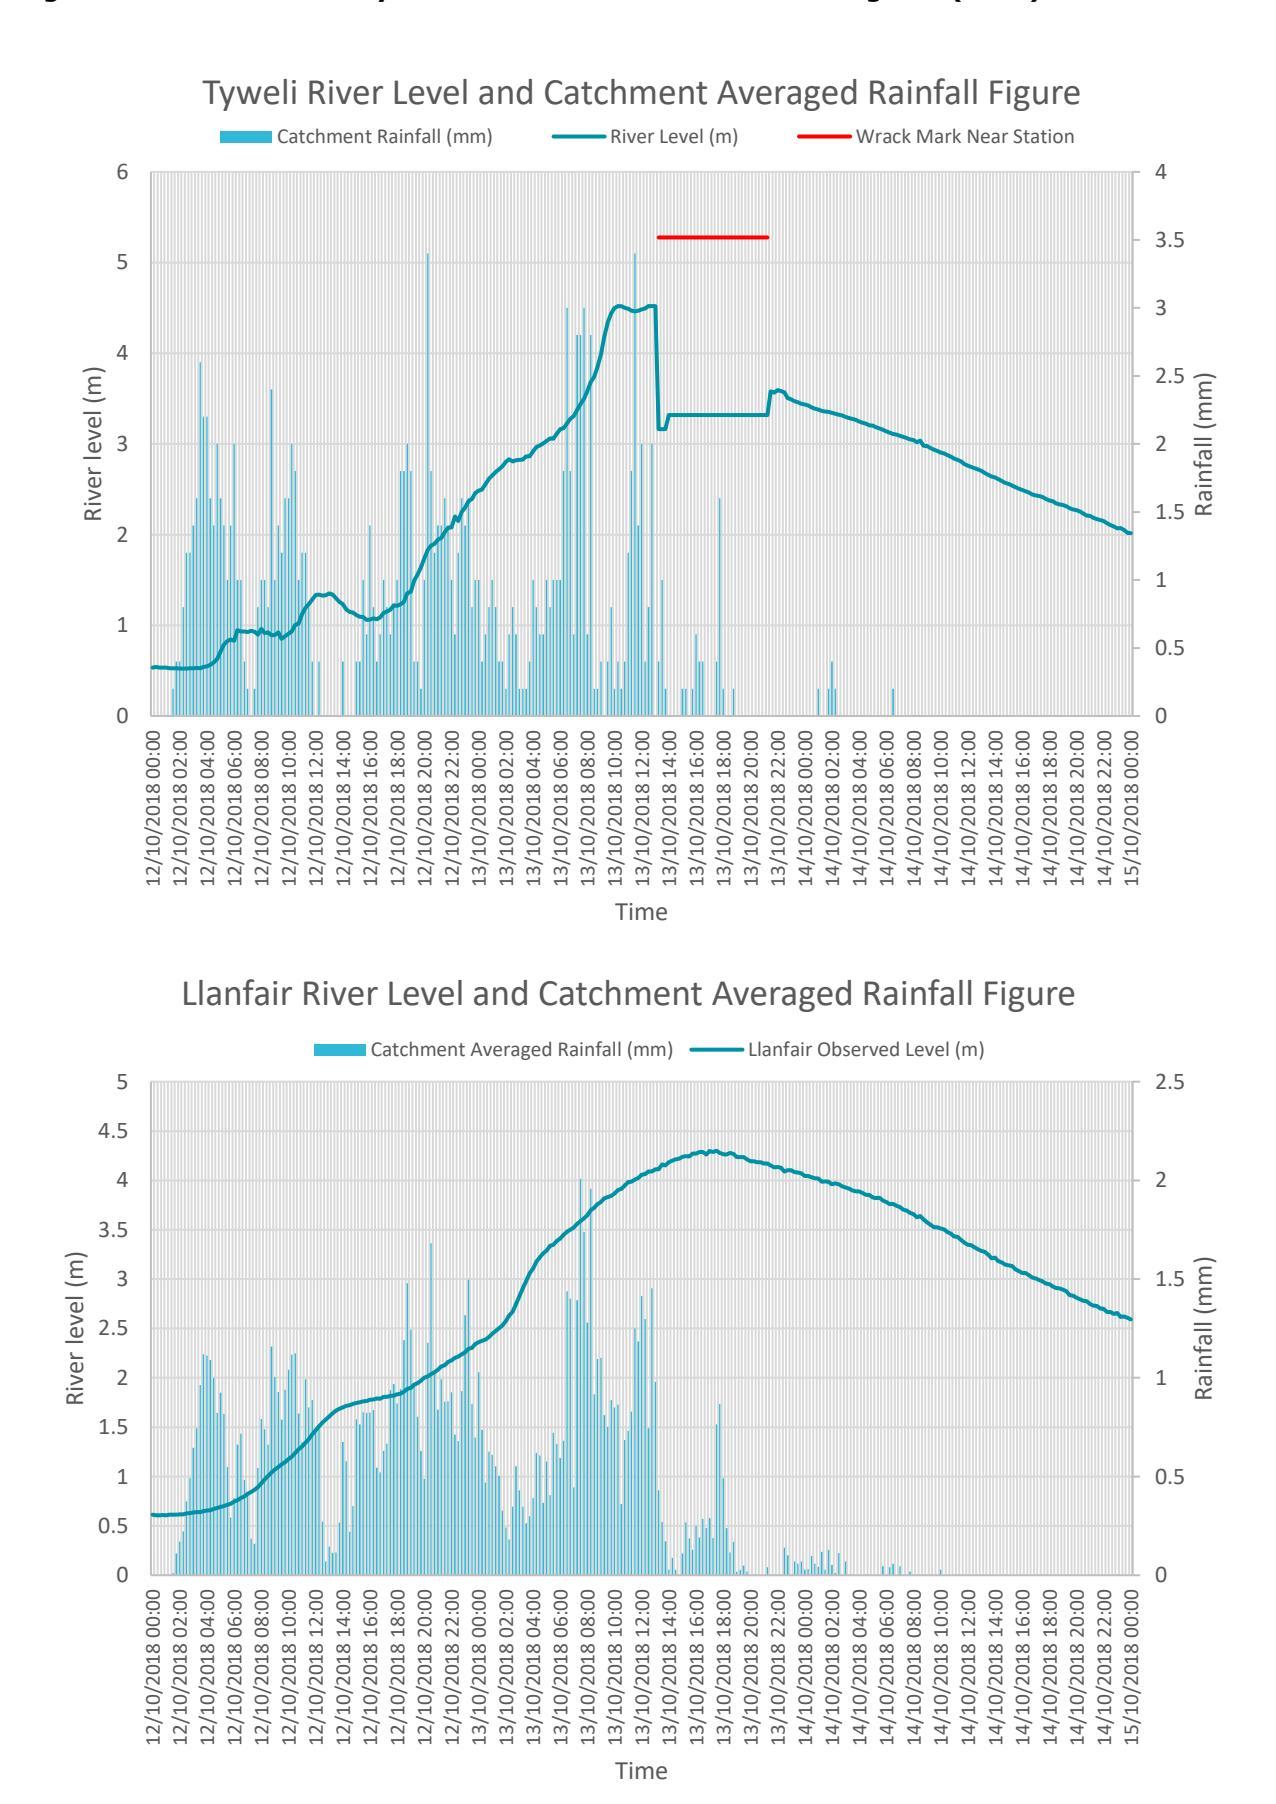
At Pont Tyweli, the gauge flooded during the event and the peak was therefore not recorded. After the event analysis of wrack marks by the gauge, suggest the peak level was 5.277m AOD (Figure 26).

Figure 32 River Teifi and Tyweli Levels & Catchment Rainfall Figures (NRW)

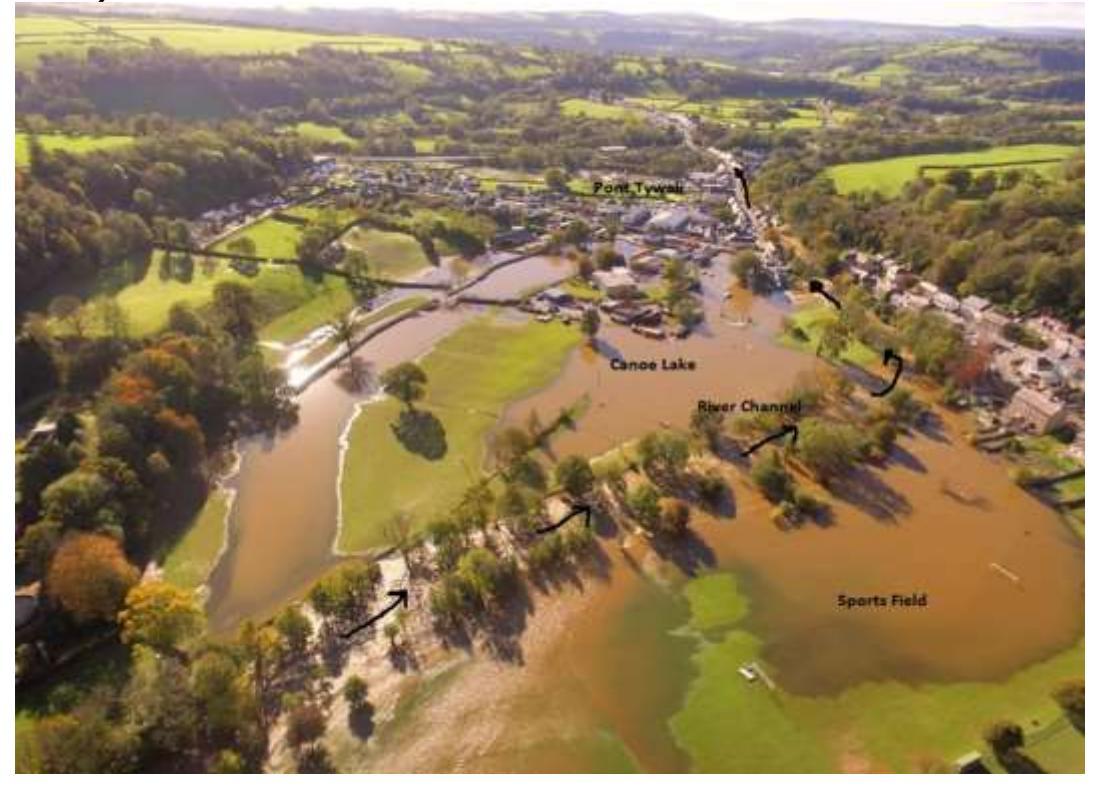
Water then escaped the left bank of the River Teifi, initially into the Paddlers Lake, but soon overwhelming that area. Analysis of aerial pictures highlights that once out of bank at the Paddlers Lake a flood flow channel was created directing flood flows in an overland flow route, parallel to the River Teifi (Plate 11). This channelled water towards the DCWW pumping station, the fire station and the neighbouring commercial and residential properties. Plate 11 Aerial drone footage highlighting the path of the overland flood route (© Sam Bacon)

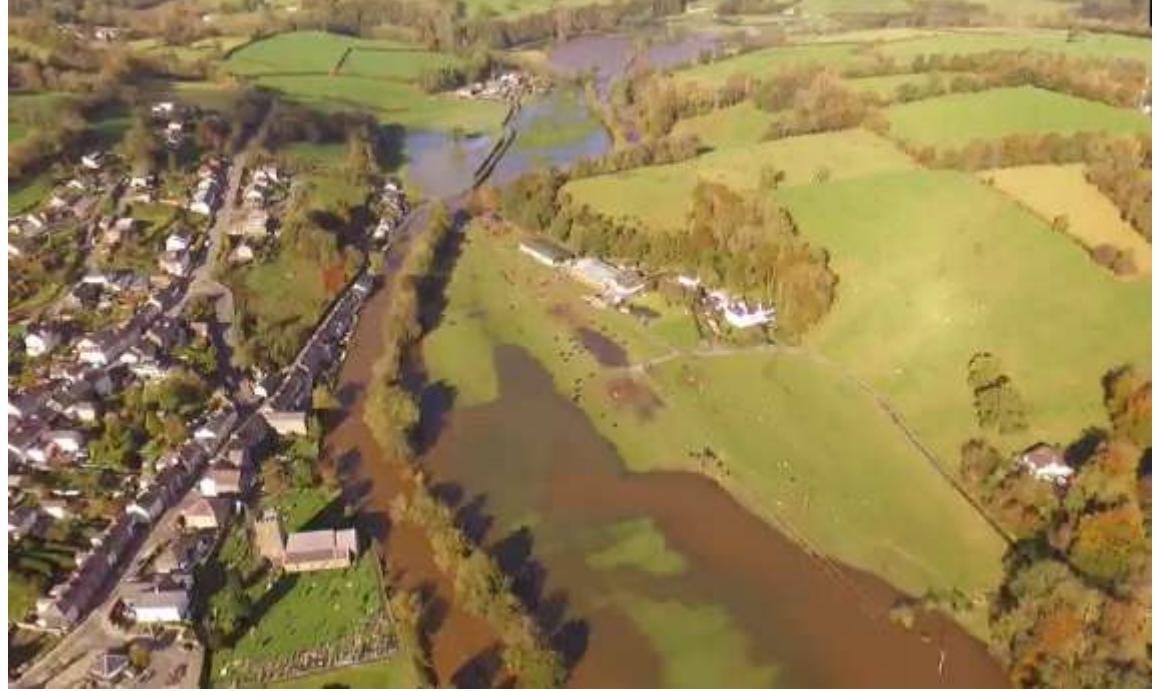
The volume of water was so great that the DCWW pumping station was submerged to a depth of over 2 metres and flood flows reached as far south as the garage and Nisa/Co-op store. This volume of water directed flood flows to the rear of the Lewis Street properties via the lane at the side of the Nisa store.

Plate 12 Aerial drone footage of Llanybydder (© Sam Bacon)

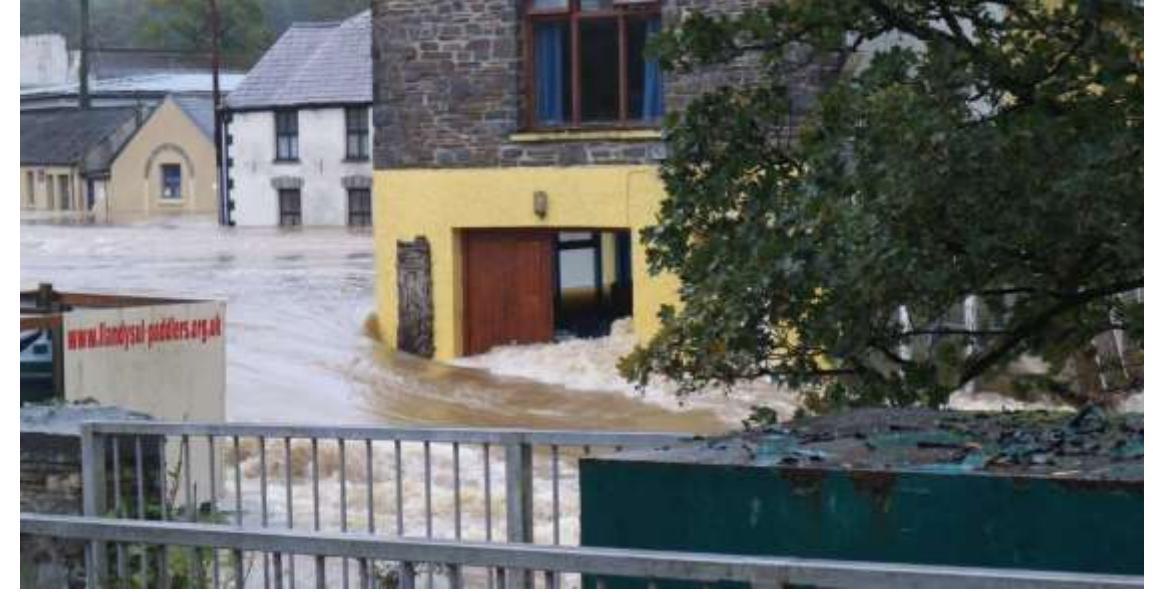
The main overland flood flows appear to have followed the contours of the land south of the paddling pond, through the car park and towards the new Llandysul paddlers club house. Initially water escaped back into the Teifi, immediately downstream of the road bridge, but as water volumes increased, flood flows were directed along Lewis Street. Plate 13 shows the volume of water trying to re-enter the River Teifi below the Llandysul road bridge.

Plate 13 Flood flows at Llandysul Paddlers escaping back into the Teifi (© Resident)

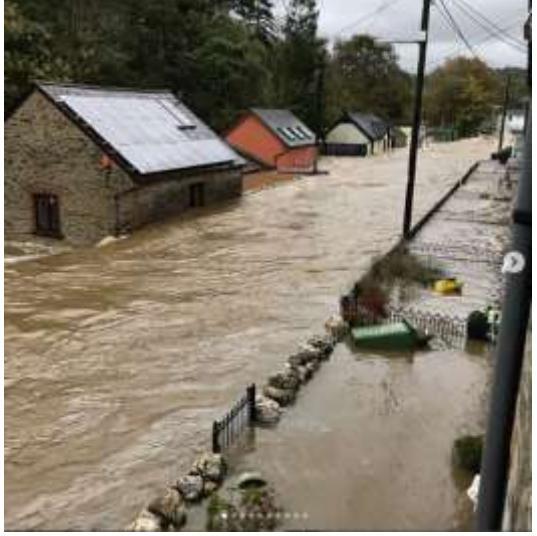
It is believed that the highway drainage initially captured the water along Lewis Street but this was quickly overwhelmed. The investigation has highlighted that the overland flood flows could not drain back into the Teifi from Lewis Street as there were insufficient breaks in boundary walls to allow water to re-enter the main channel. As such the flooding was channelled south west towards Pont Tyweli. Plate 14 below shows the level of flood flows along Lewis Street. Plate 14 Flood water at Lewis Street, Pont Tyweli(© Resident)

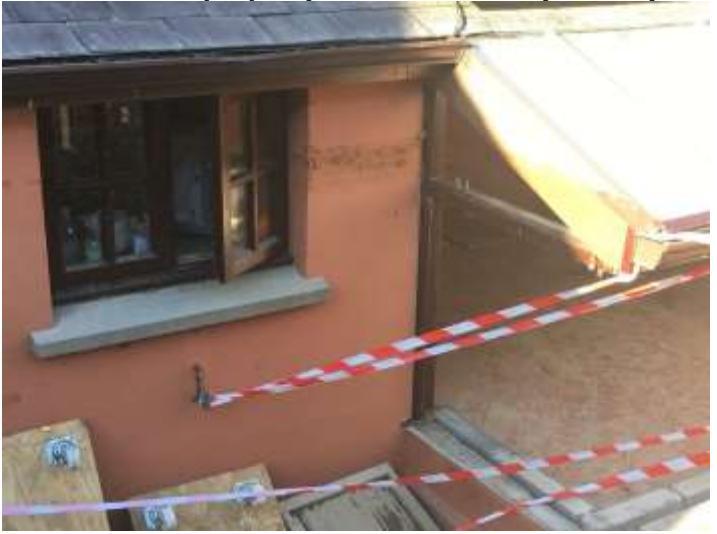
At the southern end of Lewis Street, it was reported that flood water flowed into the OJ Williams yard. Investigation have shown that the yard is lower than the level of the highway and subsequently water naturally flowed there and combined with flood flows from the River Tyweli.

Plate 15 The flood <u>`tide mark' on property in Lewis Street (© NRW)</u>
